Steam

(Educational) (Assets)
(Masterplan)

COMMUNITY CONVERSATION NO. 1

WESTON, CT

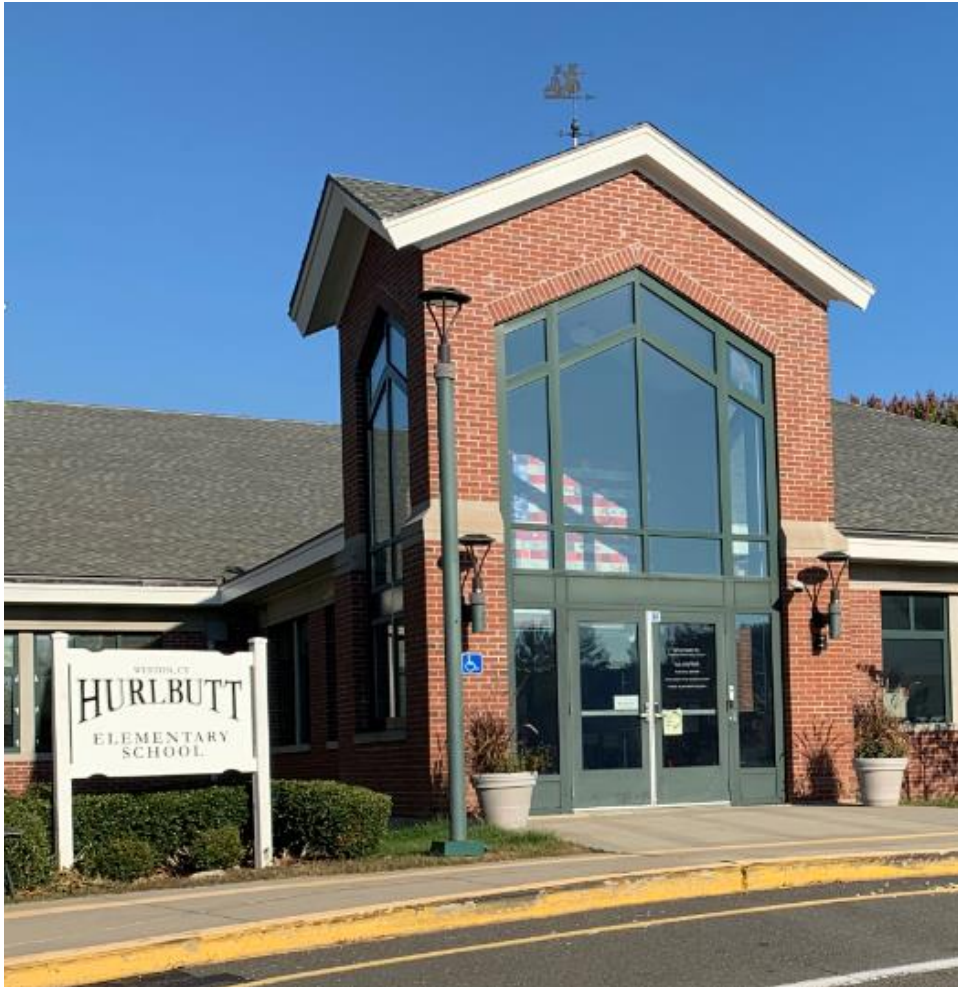
Hurlbutt Elementary ~ 24 School Road

Building Area/Site	88,895 sf / Shared Campus
Age/Construction	1940 (demo), 1950 (71), 1953 (68), 1965 (56), 1991(30), 1996 (25)

- 1 Site** ~ Poor/limited separation of school parking from senior center, access control on site a challenge due to adjacent town uses, poor accessibility to various site features
- 2 Building Exterior** ~ Persistent roof leaks, several areas of deteriorated concrete & steel columns, spalling masonry
- 3 Architectural Interior** ~ durable and overall well maintained, most areas past useful life, humidity concerns at North House
- 4 Code/Accessibility** ~ No sprinkler system, some combustible construction, several ADA floor and reach clearance concerns, limited to no accessibility access to presentation areas.
- 5 Building Systems** ~ Plumbing original to each building & past its useful life, uneven temperature control throughout, electrical distribution multiple vintages, difficult to maintain, older fluorescent lighting, and fire alarm nearing end of useful life.

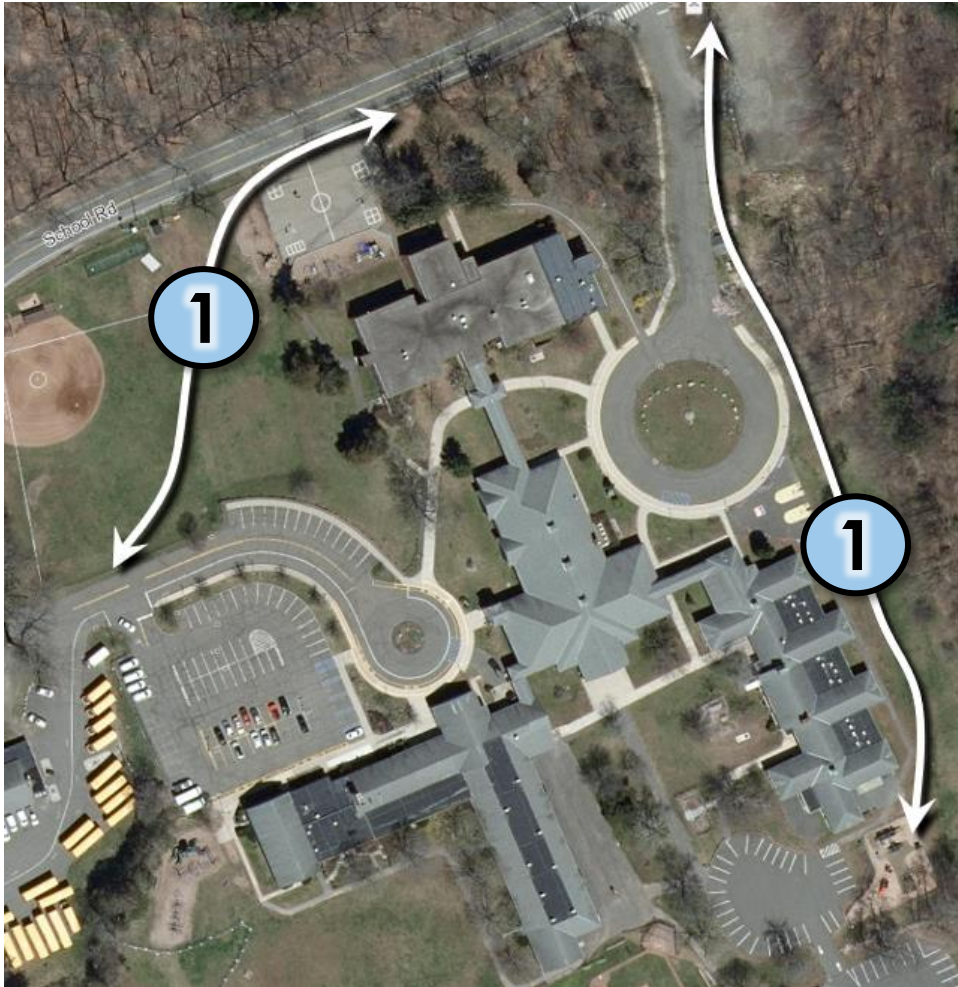
Hurlbutt Elementary ~ 24 School Road

- ① **Site** ~ Poor/limited separation of school parking from senior center, access control on site a challenge due to adjacent town uses, poor accessibility to various site features

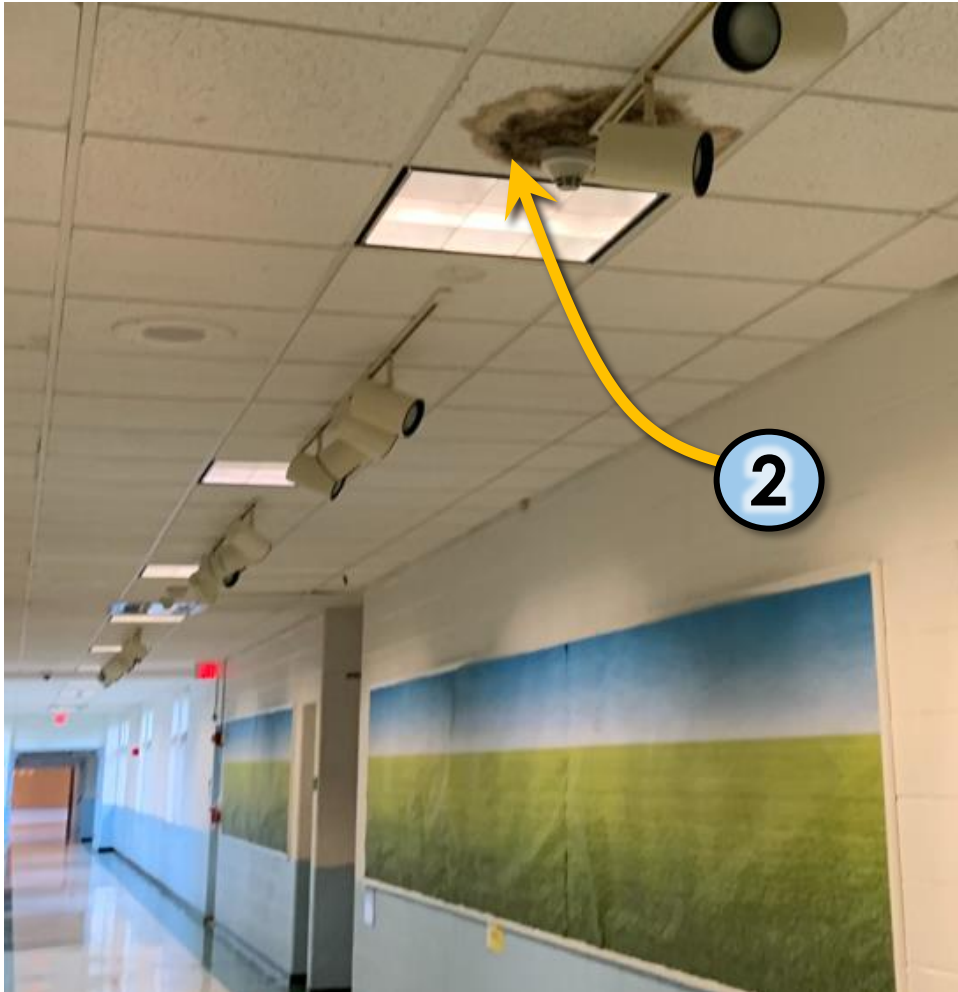
Hurlbutt Elementary ~ 24 School Road

- ① **Site** ~ Poor/limited separation of school parking from senior center, access control on site a challenge due to adjacent town uses, poor accessibility to various site features
- ② **Building Exterior** ~ Persistent roof leaks, several areas of deteriorated concrete & steel columns, spalling masonry

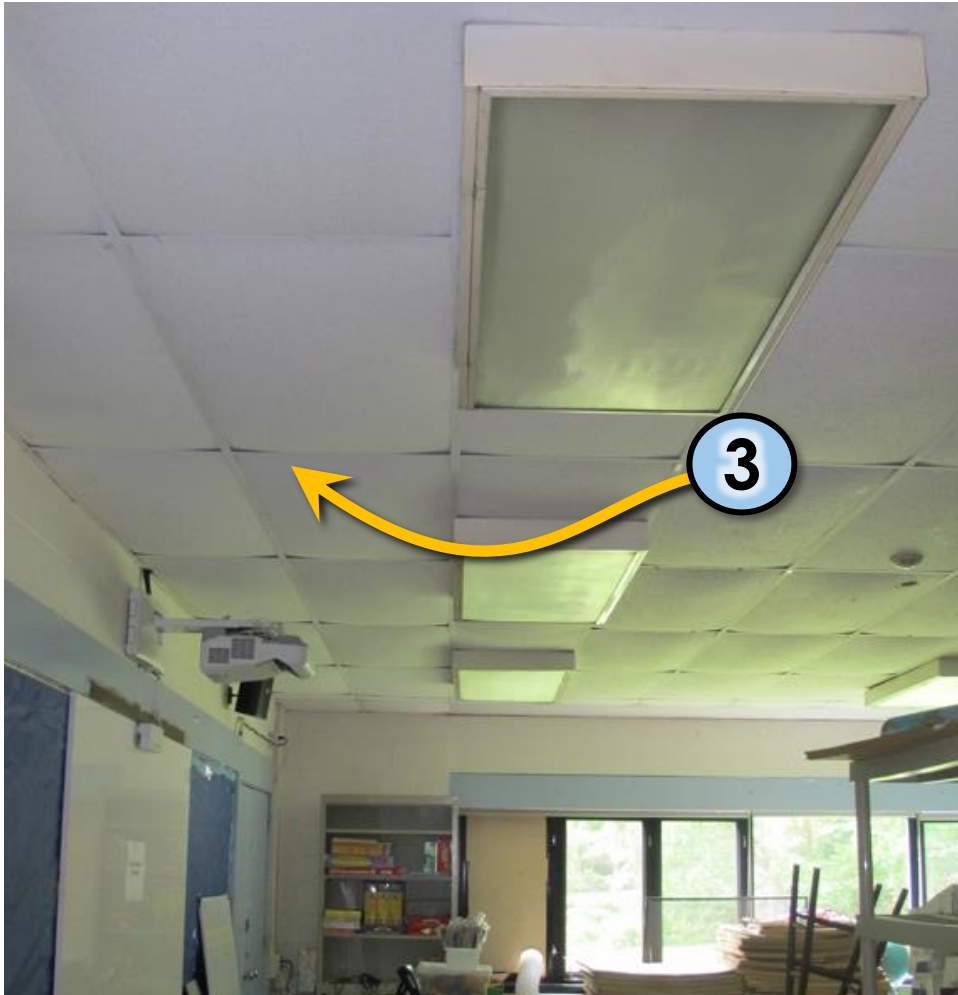
Hurlbutt Elementary ~ 24 School Road

- ① **Site** ~ Poor/limited separation of school parking from senior center, access control on site a challenge due to adjacent town uses, poor accessibility to various site features
- ② **Building Exterior** ~ Persistent roof leaks, several areas of deteriorated concrete & steel columns, spalling masonry
- ③ **Architectural Interior** ~ durable and overall well maintained, most areas past useful life, humidity concerns at North House

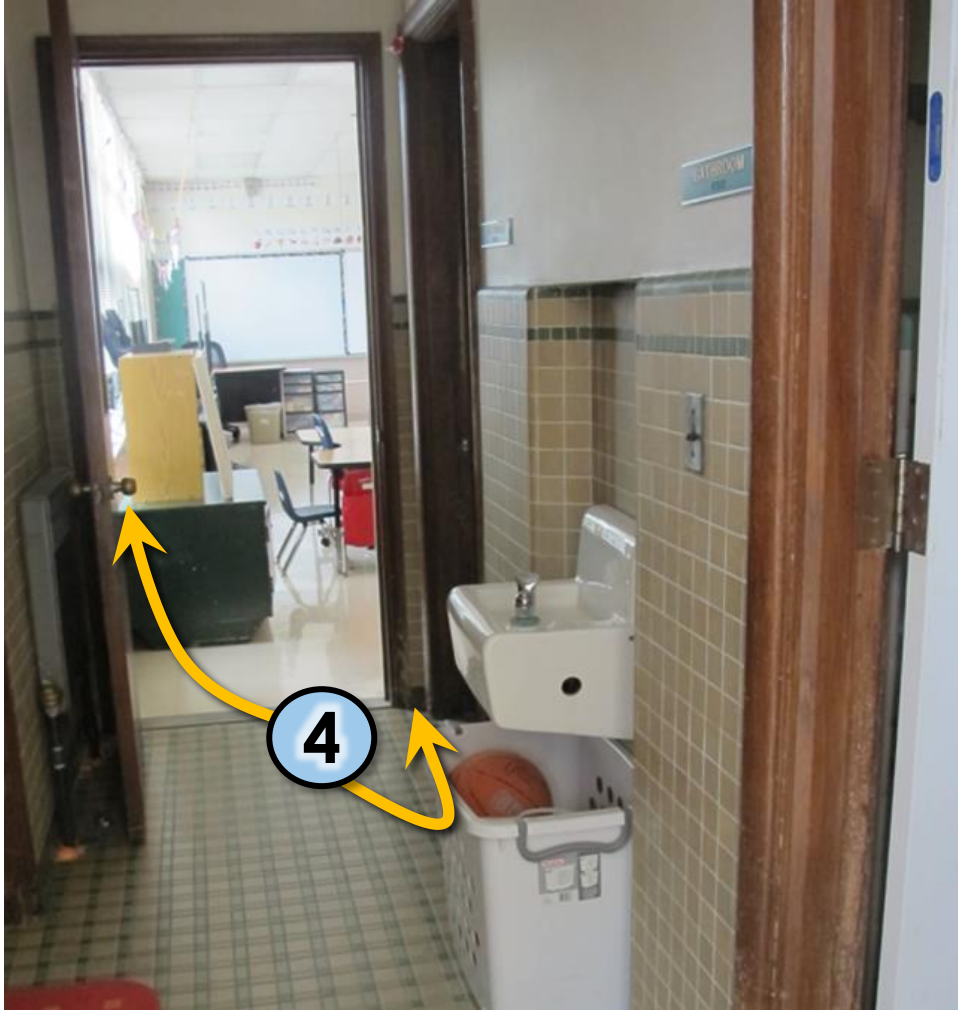
Hurlbutt Elementary ~ 24 School Road

- ① **Site** ~ Poor/limited separation of school parking from senior center, access control on site a challenge due to adjacent town uses, poor accessibility to various site features
- ② **Building Exterior** ~ Persistent roof leaks, several areas of deteriorated concrete & steel columns, spalling masonry
- ③ **Architectural Interior** ~ durable and overall well maintained, most areas past useful life, humidity concerns at North House
- ④ **Code/Accessibility** ~ No sprinkler system, some combustible construction, several ADA floor and reach clearance concerns, limited to no accessibility access to presentation areas.

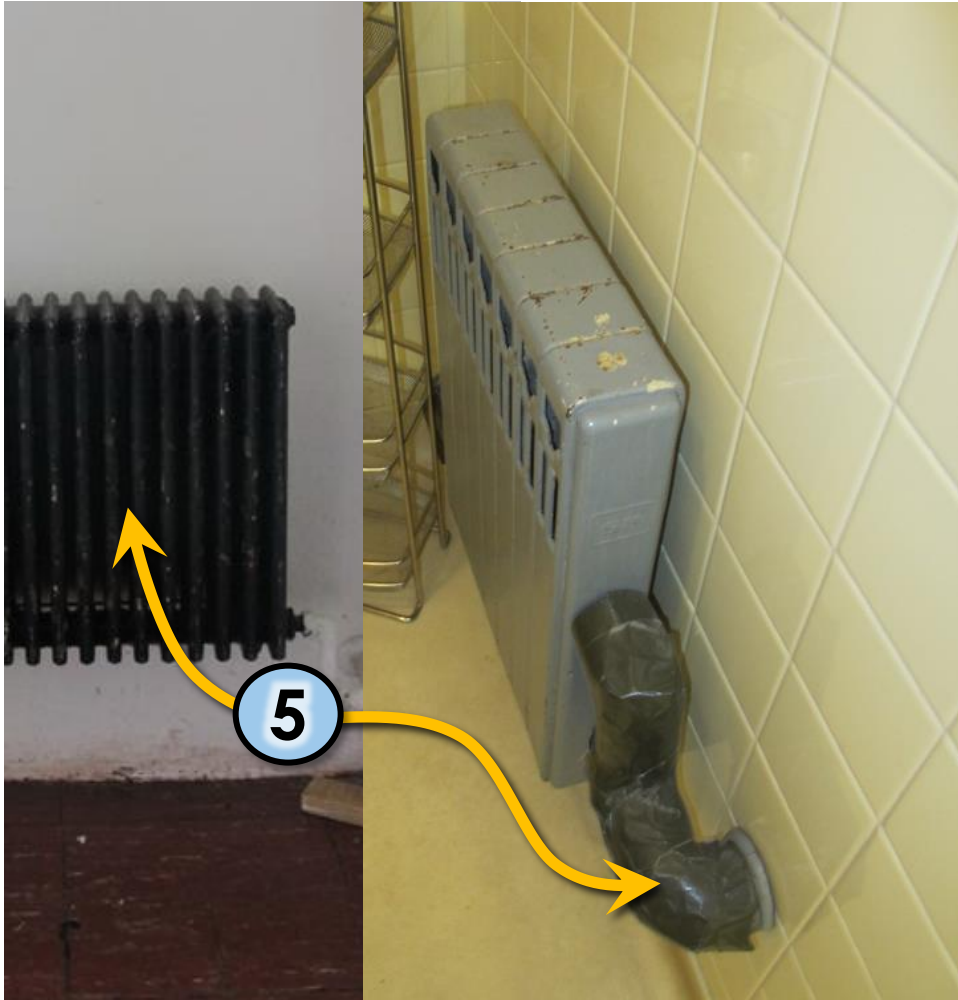
Hurlbutt Elementary ~ 24 School Road

- 1** **Site** ~ Poor/limited separation of school parking from senior center, access control on site a challenge due to adjacent town uses, poor accessibility to various site features
- 2** **Building Exterior** ~ Persistent roof leaks, several areas of deteriorated concrete & steel columns, spalling masonry
- 3** **Architectural Interior** ~ durable and overall well maintained, most areas past useful life, humidity concerns at North House
- 4** **Code/Accessibility** ~ No sprinkler system, some combustible construction, several ADA floor and reach clearance concerns, limited to no accessibility access to presentation areas.
- 5** **Building Systems** ~ Plumbing original to each building & past its useful life, uneven temperature control throughout, electrical distribution multiple vintages, difficult to maintain, older fluorescent lighting, and fire alarm nearing end of useful life.

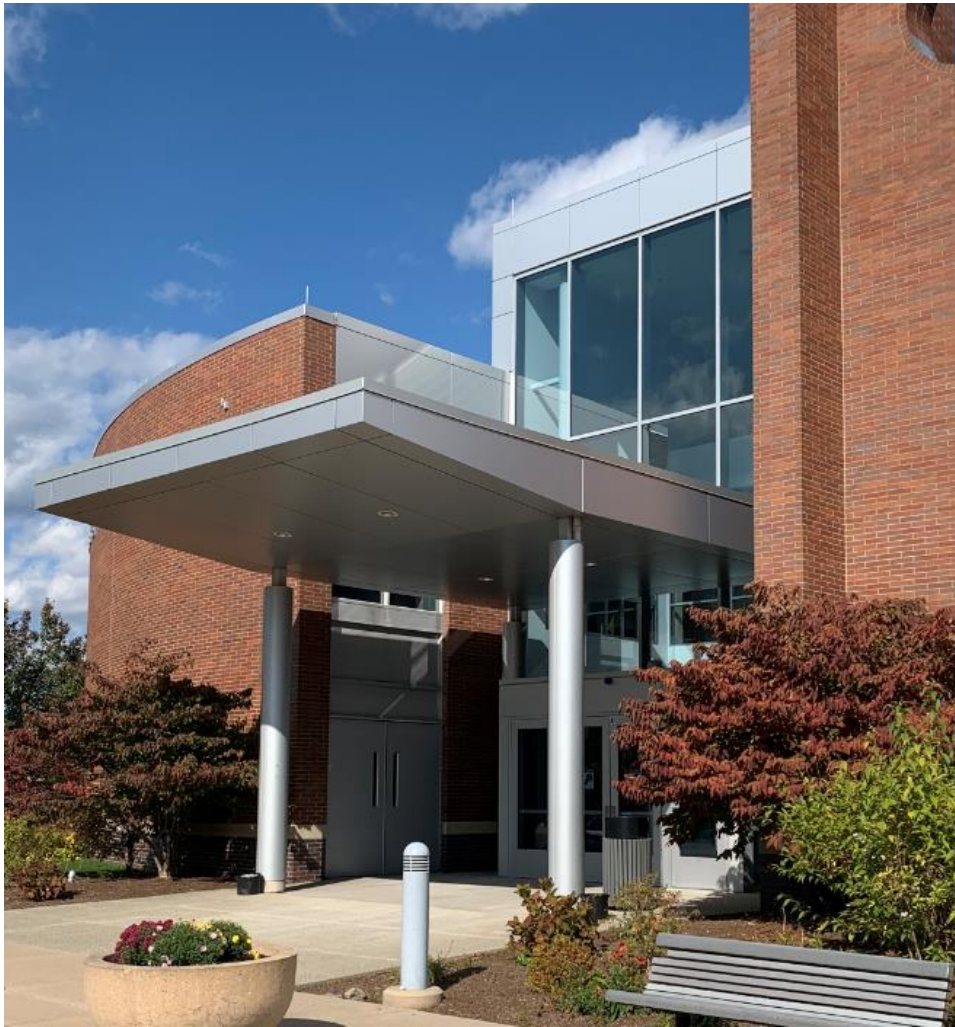
Weston Intermediate School ~ 95 School Road

- 1 Building Envelope** ~ sill replacement ongoing, brick repointing & caulking plan required, several leaks @ roof and parapet flashing.
- 2 Building Interior** ~ Well maintained, good condition overall, some millwork delamination (age/use), limited ceiling and floor replacement, isolated flooring issues at main hall
- 3 Fire Alarm System** ~ beginning to experience issues, requires repairs frequently
- 4 Plumbing** ~ No hot water recirculation system, results in poor water temperature (maintain by temperature maintenance cable ~ unreliable)
- 5 HVAC** ~ BMS (Building management system) good but starting to fail and requires frequent replacement. CO2 sensors fail often, "Good building, difficult to run"

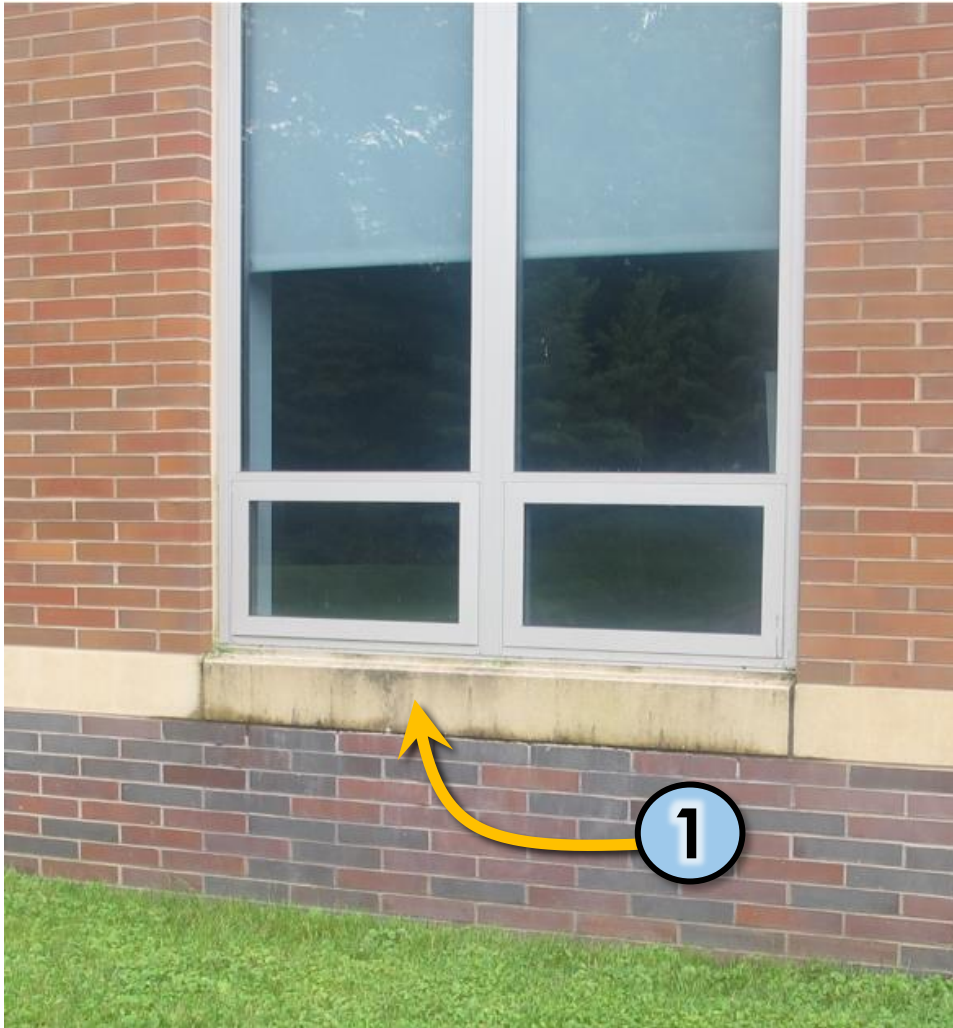
Weston Intermediate School ~ 95 School Road

- ① **Building Envelope** ~ sill replacement ongoing, brick repointing & caulking plan required, several leaks @ roof and parapet flashing.

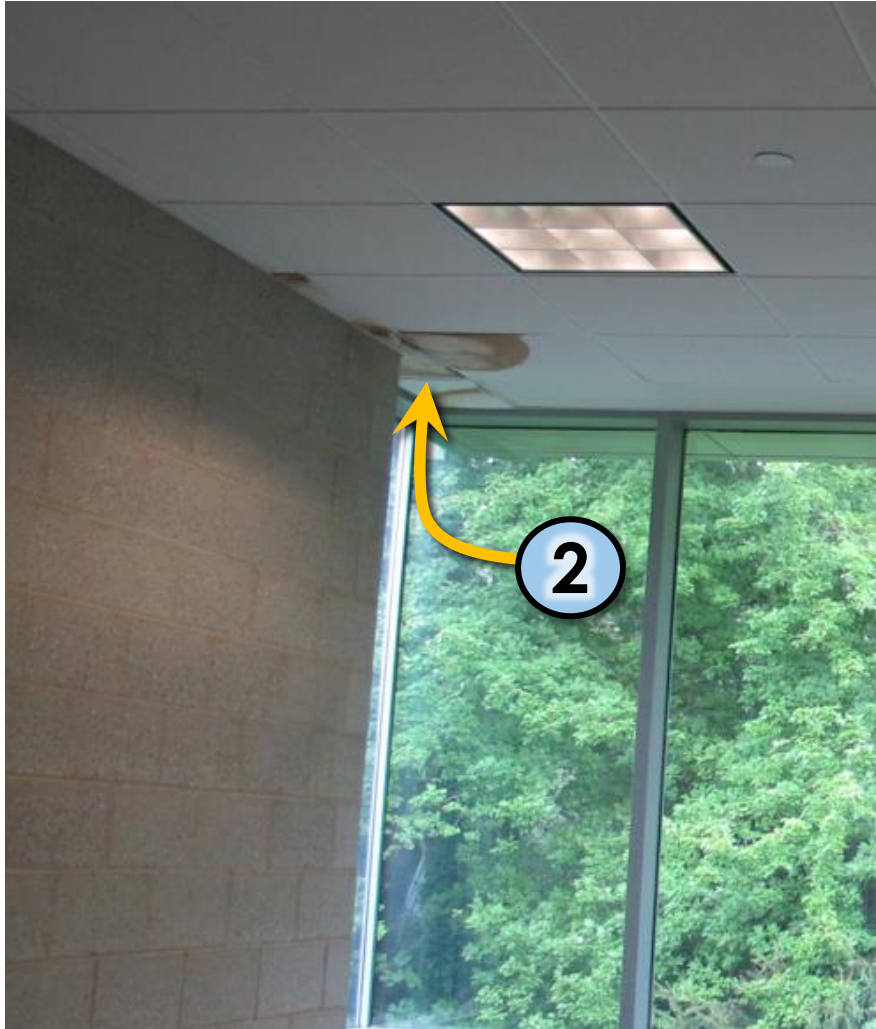
Weston Intermediate School ~ 95 School Road

- 1** **Building Envelope** ~ sill replacement ongoing, brick repointing & caulking plan required, several leaks @ roof and parapet flashing.
- 2** **Building Interior** ~ Well maintained, good condition overall, some millwork delamination (age/use), limited ceiling and floor replacement, isolated flooring issues at main hall

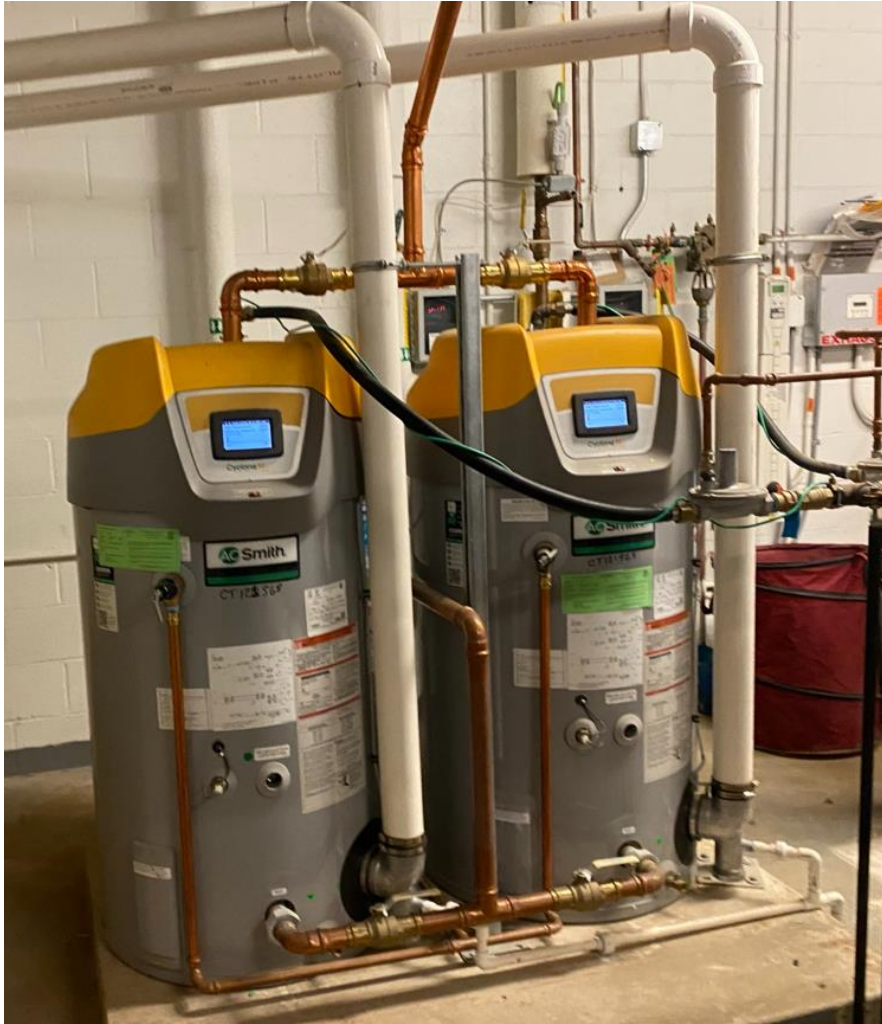
Weston Intermediate School ~ 95 School Road

- 1 **Building Envelope** ~ sill replacement ongoing, brick repointing & caulking plan required, several leaks @ roof and parapet flashing.
- 2 **Building Interior** ~ Well maintained, good condition overall, some millwork delamination (age/use), limited ceiling and floor replacement, isolated flooring issues at main hall
- 3 **Fire Alarm System** ~ beginning to experience issues, requires repairs frequently
- 4 **Plumbing** ~ No hot water recirculation system, results in poor water temperature (maintain by temperature maintenance cable ~ unreliable)

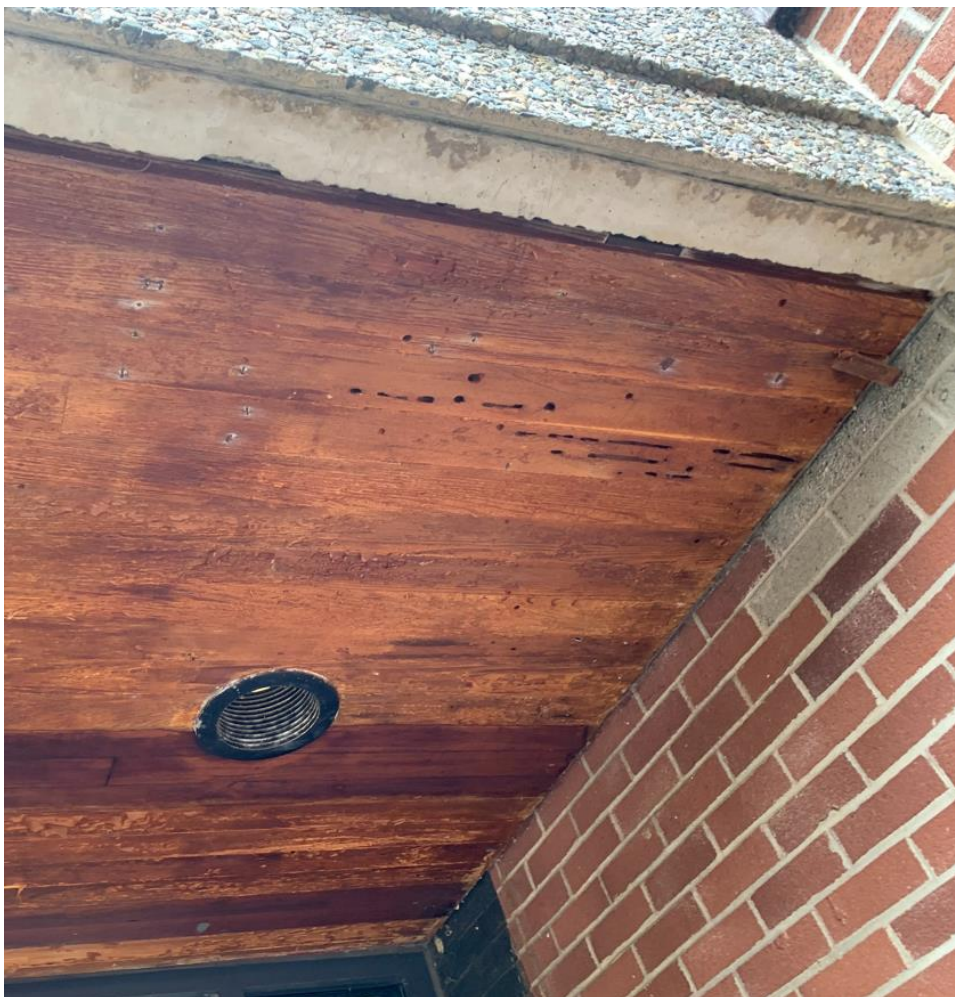
Weston Middle School ~ 135 School Road

Exterior Envelope ~ Roof and windows replaced & in good/fair condition overall, wood soffit has decay and insect concern, masonry in fair/good condition – repointing/caulking plan req.

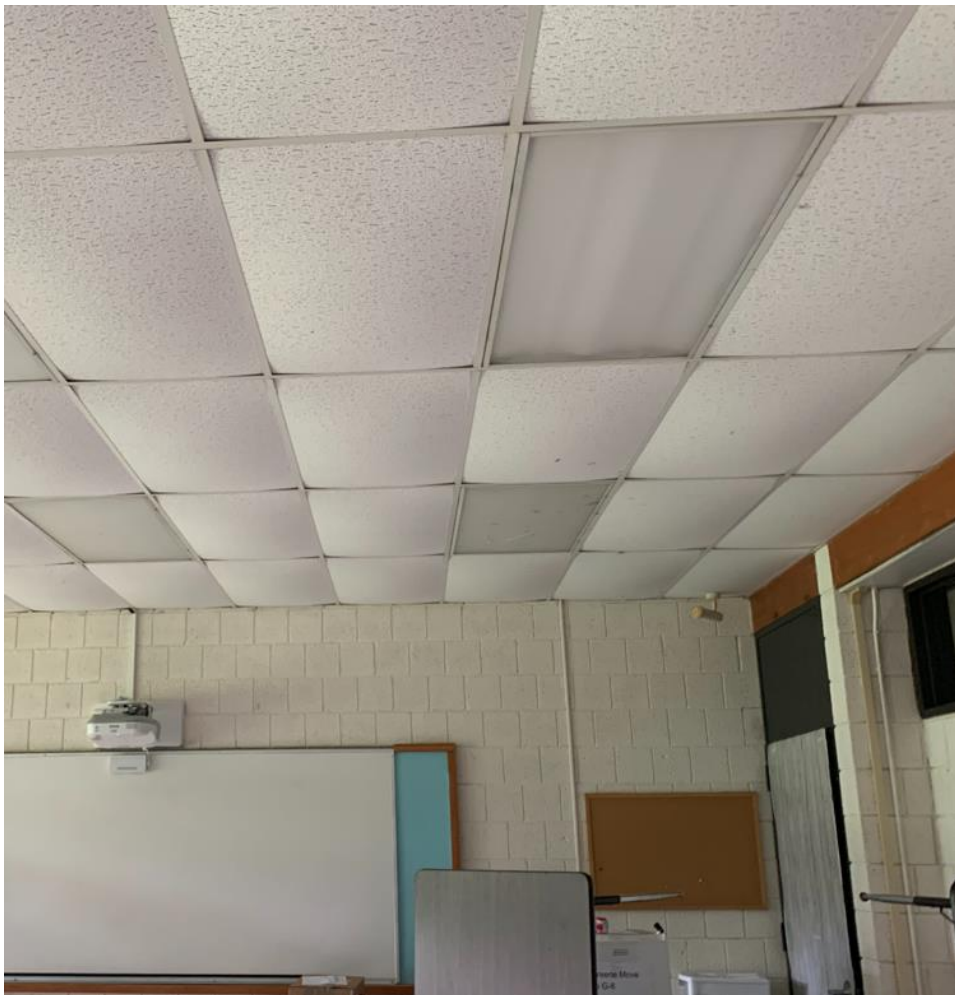
Weston Middle School ~ 135 School Road

- 1** **Exterior Envelope** ~ Roof and windows replaced & in good/fair condition overall, wood soffit has decay and insect concern, masonry in fair/good condition – repointing/caulking plan req.
- 2** **Interior** ~ Several modifications and improvement (learning commons, project lead the way), block wall cracks @ “new” gym, sag to ceiling tile representative of humidity concerns. Remaining original portions (1960/71) in fair to poor condition, past useful life (millwork, finishes, equipment).

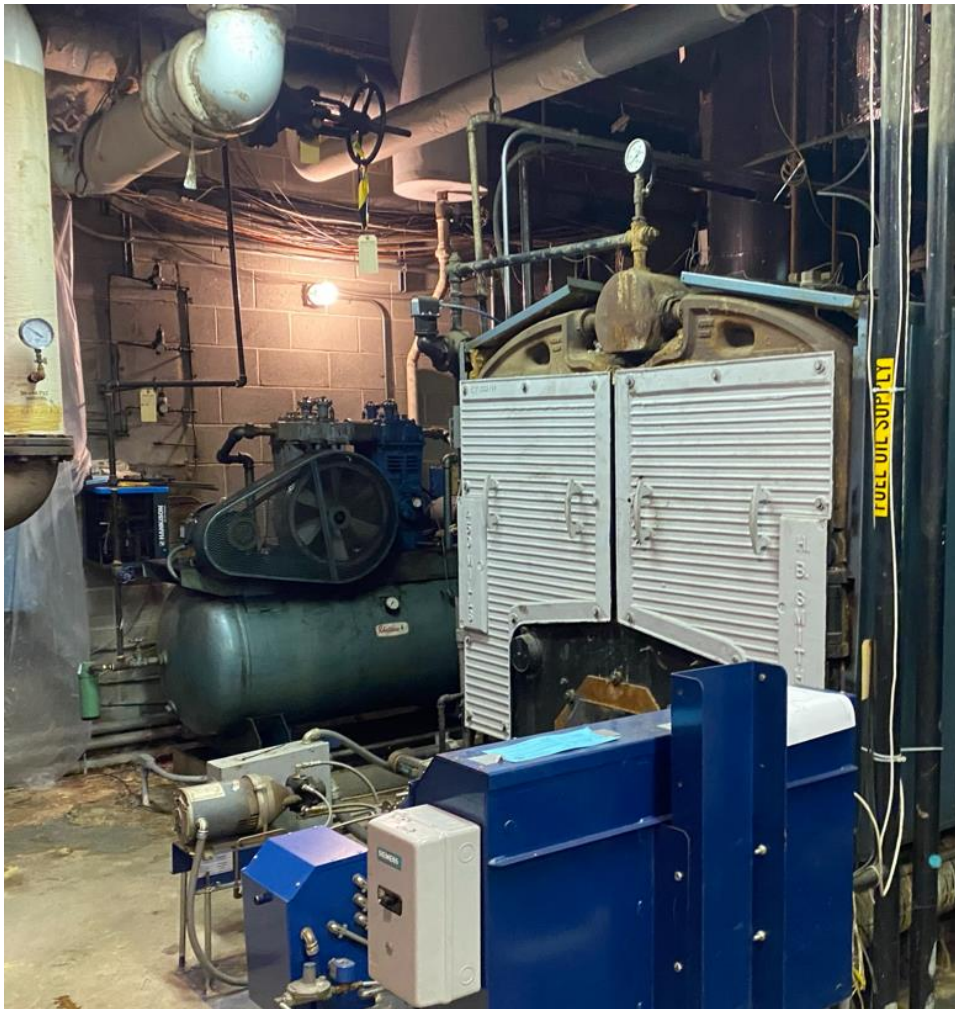
Weston Middle School ~ 135 School Road

- 1** **Exterior Envelope** ~ Roof and windows replaced & in good/fair condition overall, wood soffit has decay and insect concern, masonry in fair/good condition – repointing/caulking plan req.
- 2** **Interior** ~ Several modifications and improvement (learning commons, project lead the way), block wall cracks @ “new” gym, sag to ceiling tile representative of humidity concerns. Remaining original portions (1960/71) in fair to poor condition, past useful life (millwork, finishes, equipment).
- 3** **Fire Protection** ~ None.
- 4** **Plumbing** ~ Limited number of fixtures in classrooms, some not functioning due to sanitary line issues, original distribution piping
- 5** **HVAC** ~ Humidity control concerns throughout building, no AC in Gym or Café space, combination of pneumatic and electronic controls, majority of systems past useful life.

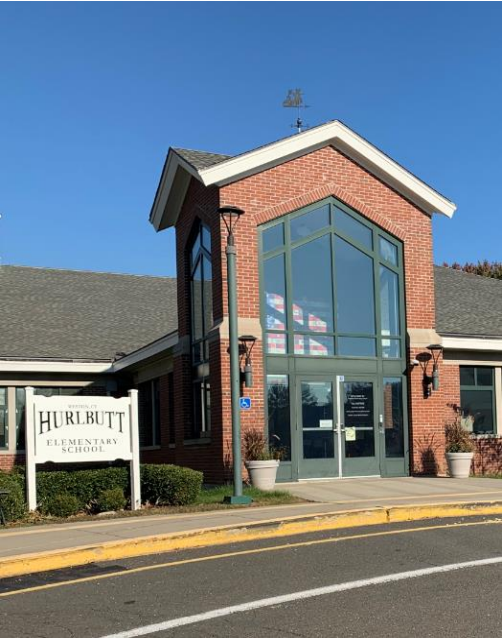
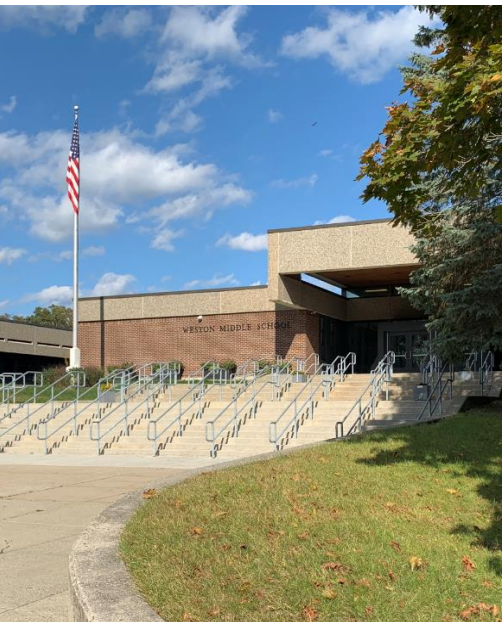
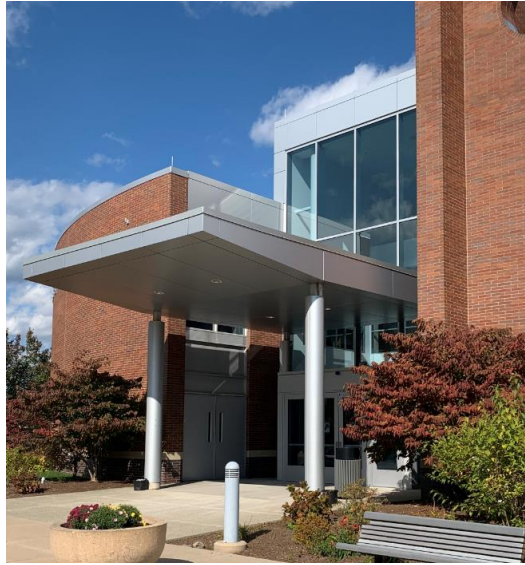
Consistent findings include

- 1 Useable area ratio less than typical,**
(multiple additions, change in use, inefficient layout)
- 2 Majority of classrooms “right” sized**
(Most meet standard, some larger due to change in use, arrangement limits grade placement flexibility)
- 3 Core spaces larger than typically found, some duplication** *(2 kitchens/cafeterias, Learning Commons size)*
- 4 Evolution of Special Education**
(Need for small group and 1 on 1 instruction led to reuse/adaptation of existing classrooms/storage/etc.)

1. Utilized MML 11.20.2020 Enrollment Projection.
2. State requires highest student enrollment from 8-year projection at time of grant application.
3. SF Area calculations in appendix.

Its important to identify the causes of the variance and the options that may result from it.

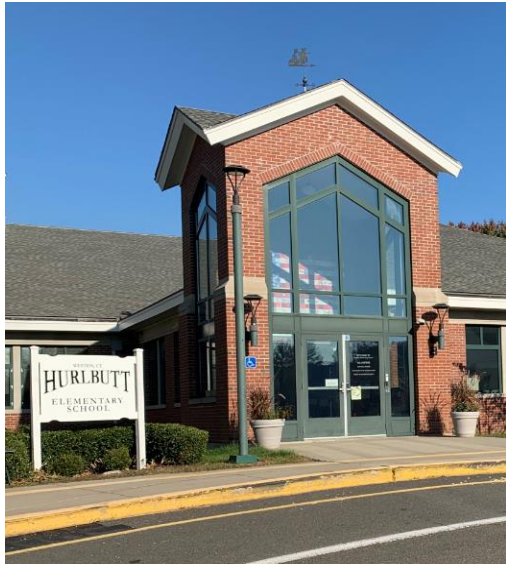
Hurlbutt Elementary School

Useable area ratio less than typical & Duplicative Core Space
(multiple additions, change in use, inefficient layout)

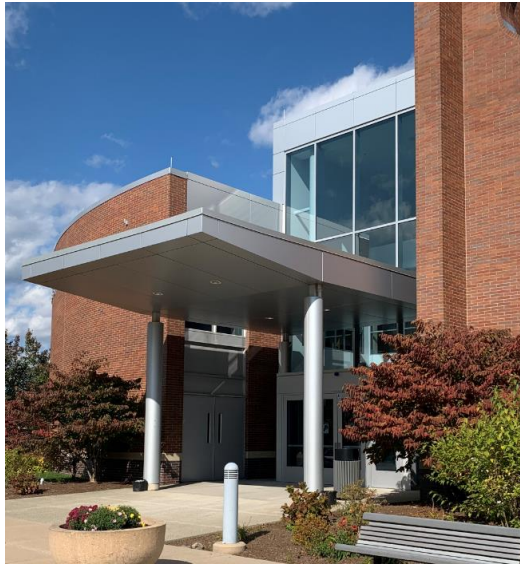
Weston Intermediate School

Dedicated educational space for "specials"
(Music(2), Science, Spanish, Health, gifted/talented)

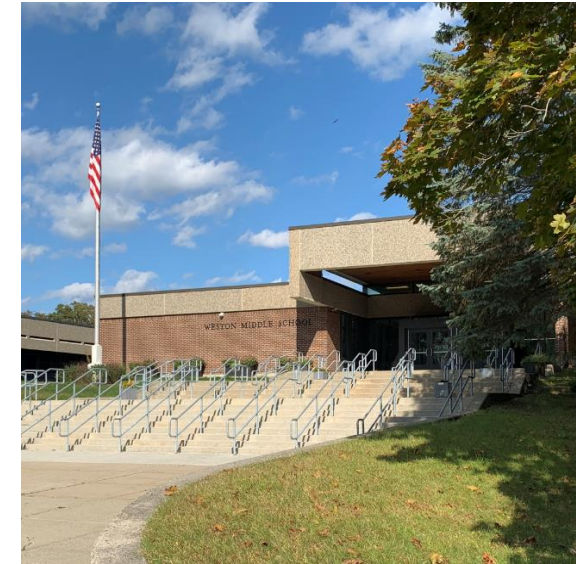
Weston Middle School

Inefficient circulation paths due to relationship of original/addition, duplication of Gym(s)
(Left many spaces with limited natural daylight, poor circulation routes)

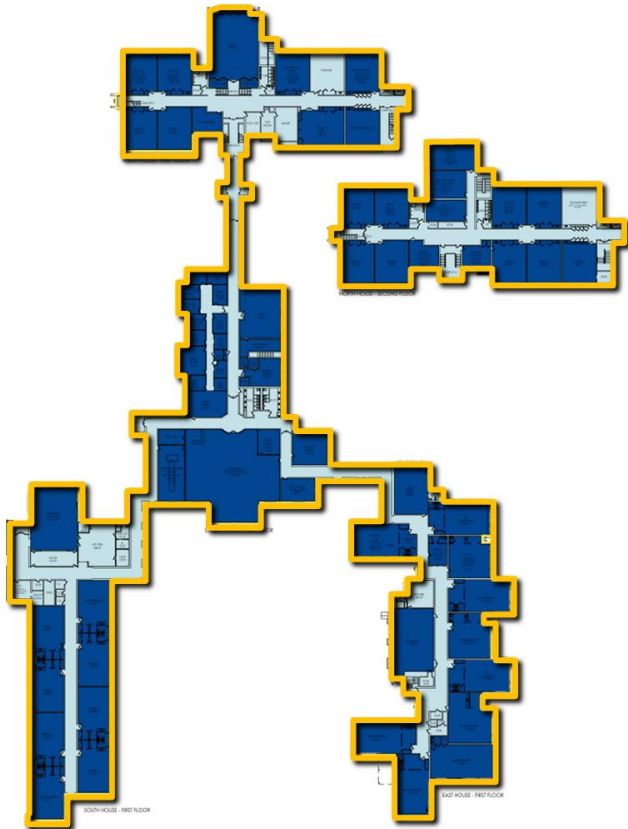
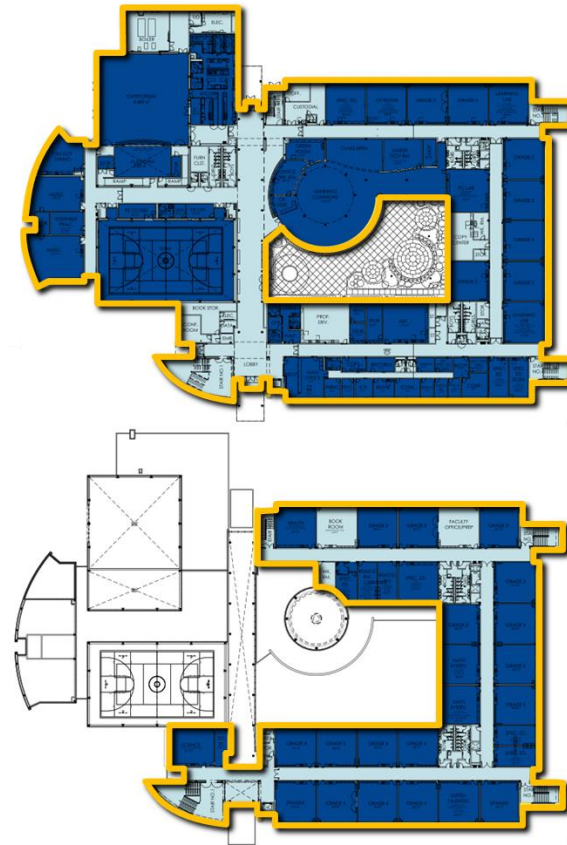
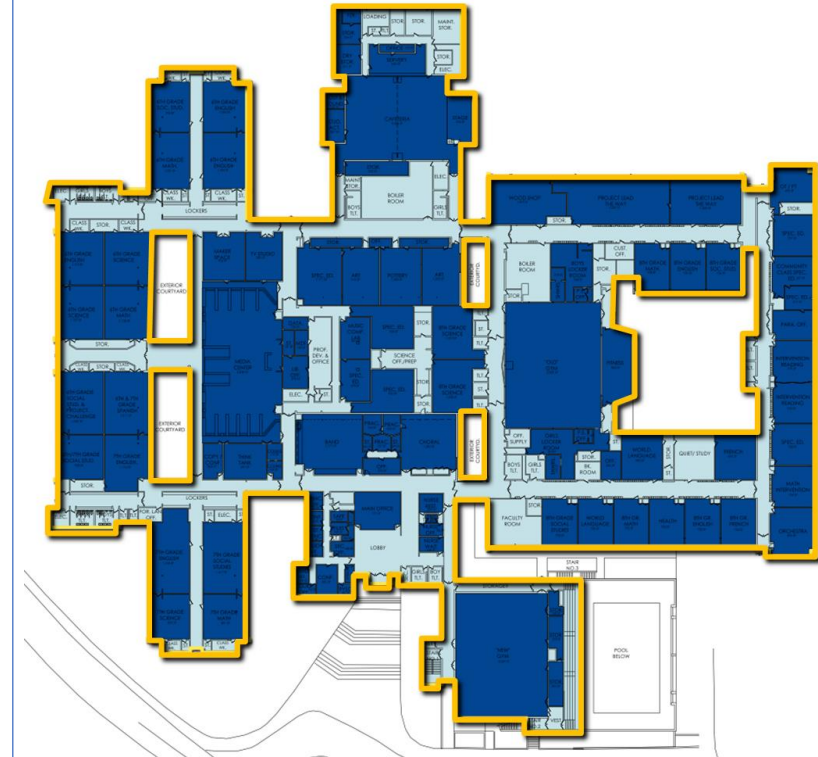
Use and Area Analysis ~ Review and verify

Expected gross to net useable area averages range from 25-30%

Hurlbutt Elementary
school is **40.4%**

Weston Intermediate
school is **42.3%**

Weston Middle school is
40.1%

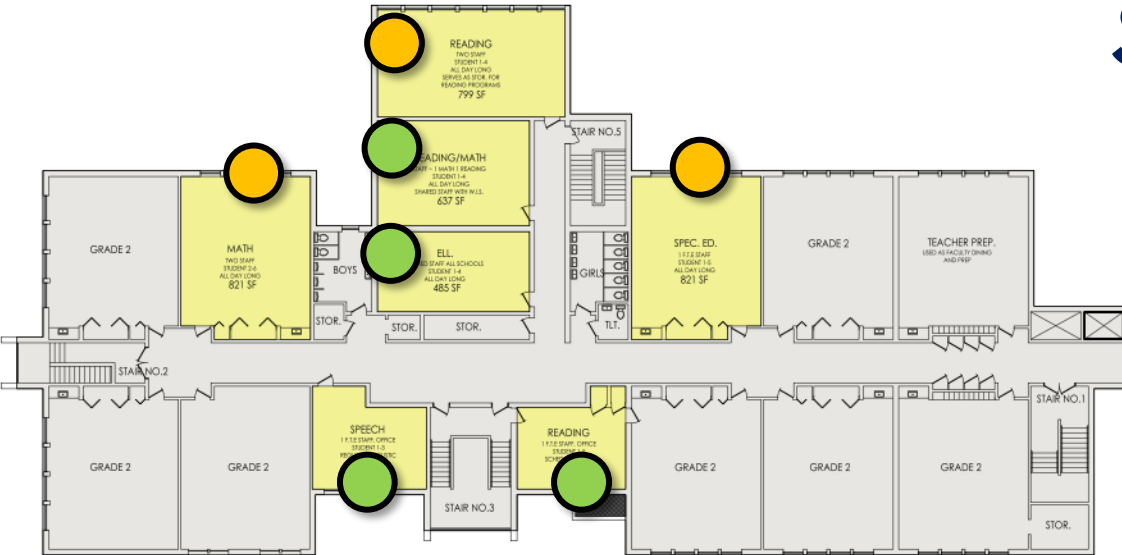
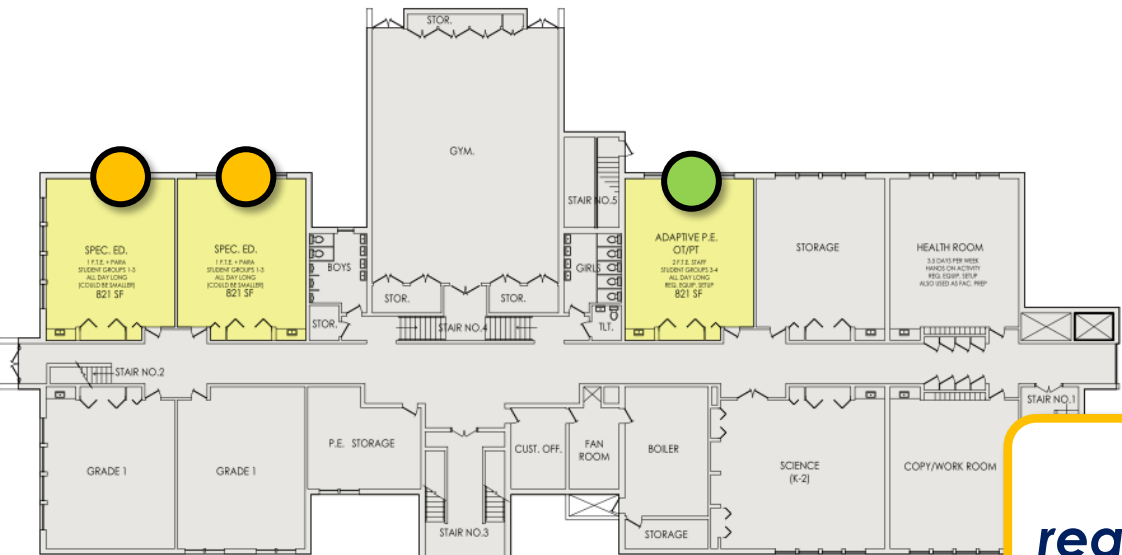
NORTH HOUSE - FIRST FLOOR

Useable Area Analysis				
Spec. Ed. Uses	Area	Occ.	Stand.	Delta
Math	821	2-6	400	421
Speech	416	1-3	250	166
Reading	383	1-5	250	133
Spec. Ed.	821	1-5	250	571
ELL	485	1-4	250	235
Reading/Math	637	1-4	250	387
Reading	799	1-4	250	549
Spec. Ed.	821	1-3	250	571
Spec. Ed.	821	1-3	250	571
Adaptive PE	821	3-4	600	221
Learning Lab	1,106	3-6	900	206
Speech	312	3-4	250	62
OT/PT	970	3-4	900	70
Gross Floor Area	9,213	0	5,050	4,163

Some programs delivered in larger spaces than required, largely because those spaces are available.
