Appendix

APPENDIX
VINTAGE PLANS

APPENDIX
EXISTING CONDITIONS SUMMARY

HURLBUTT ELEMENTARY SCHOOL
EXISTING CONDITIONS SUMMARY

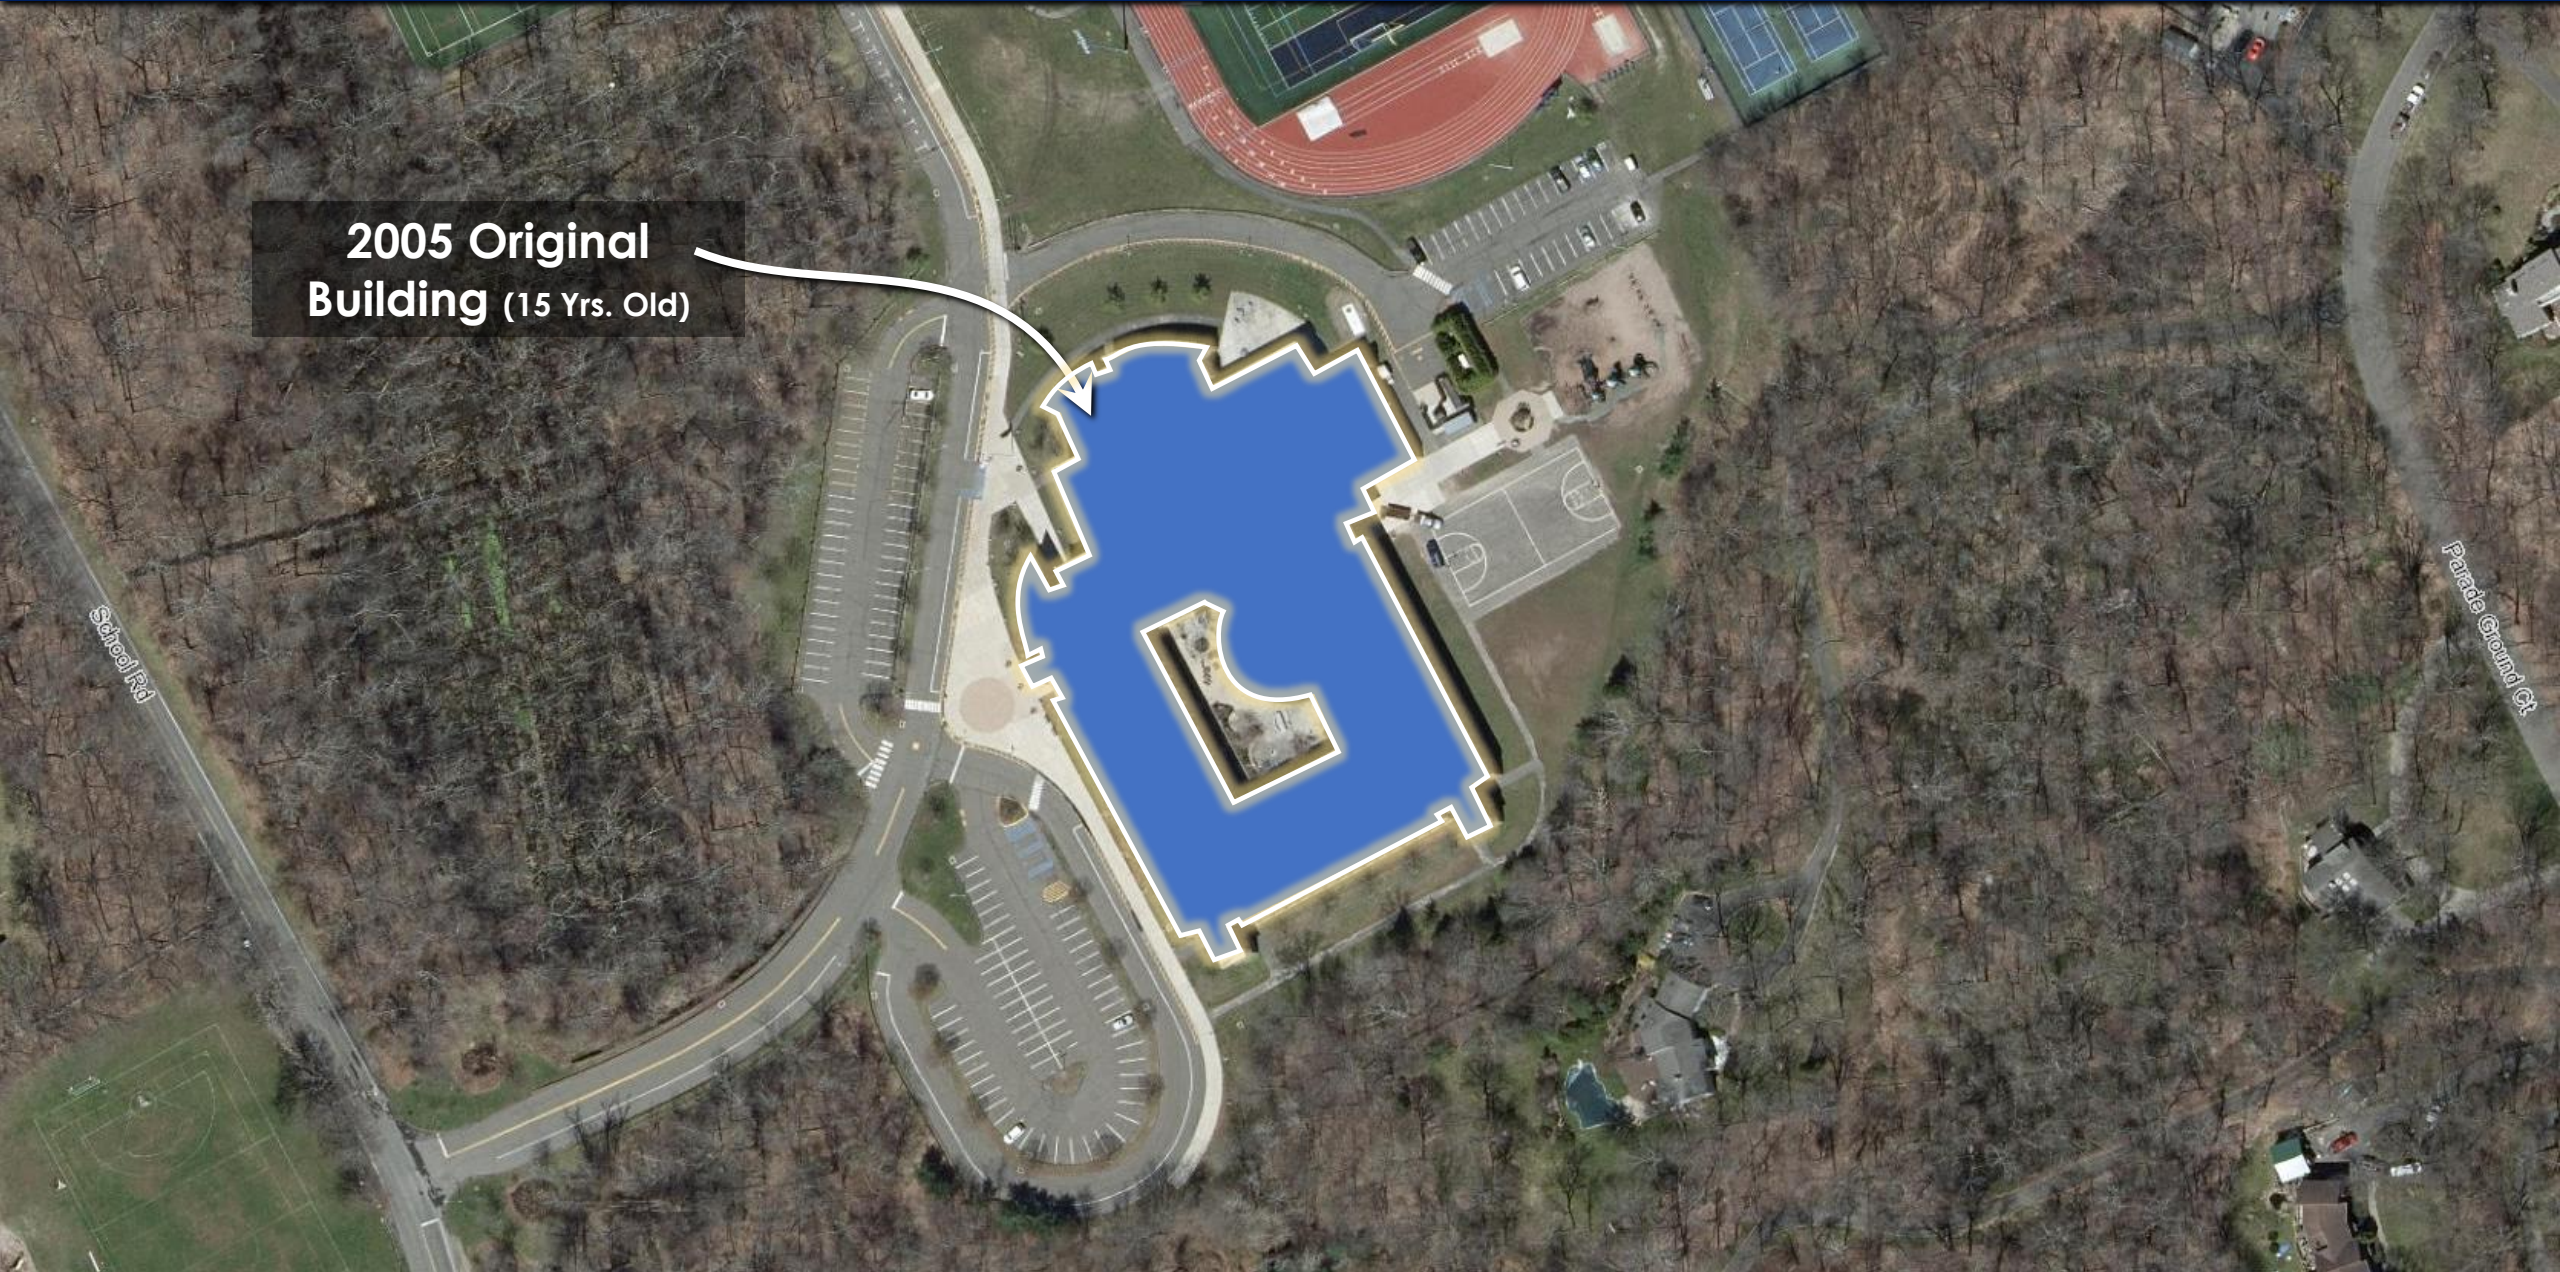
Vintage Plan Diagram ~ Weston Intermediate School

**2005 Original
Building (15 Yrs. Old)**

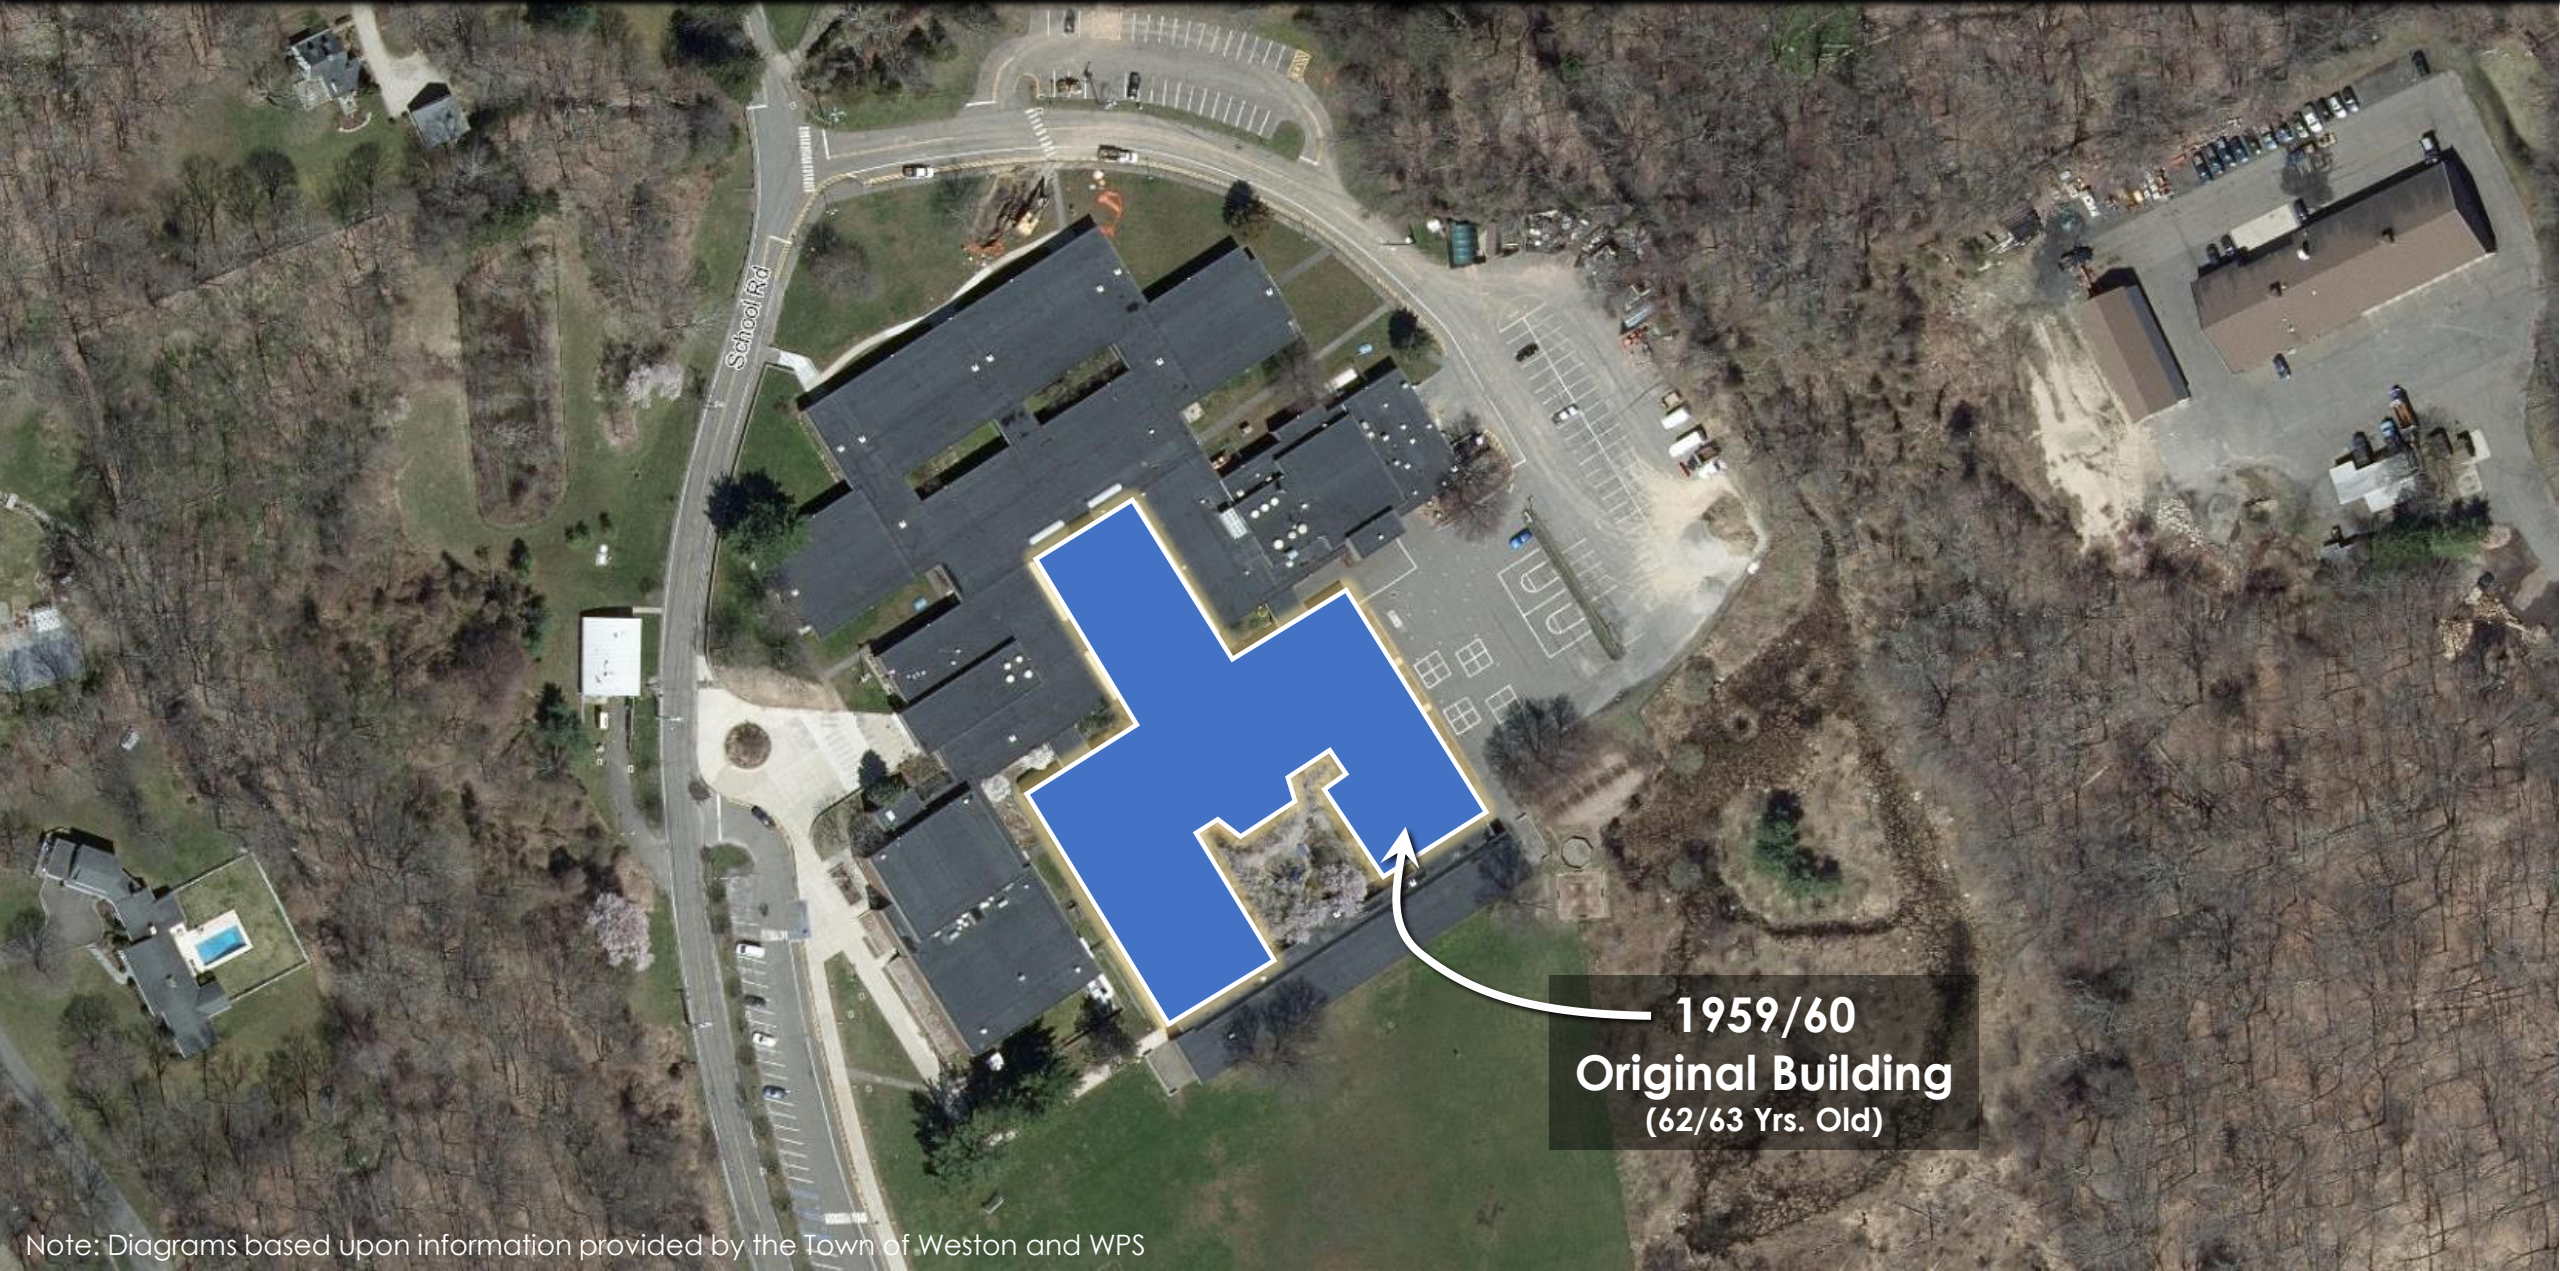
Vintage Plan Diagram ~ Weston Middle School

1959/60
Original Building
(62/63 Yrs. Old)

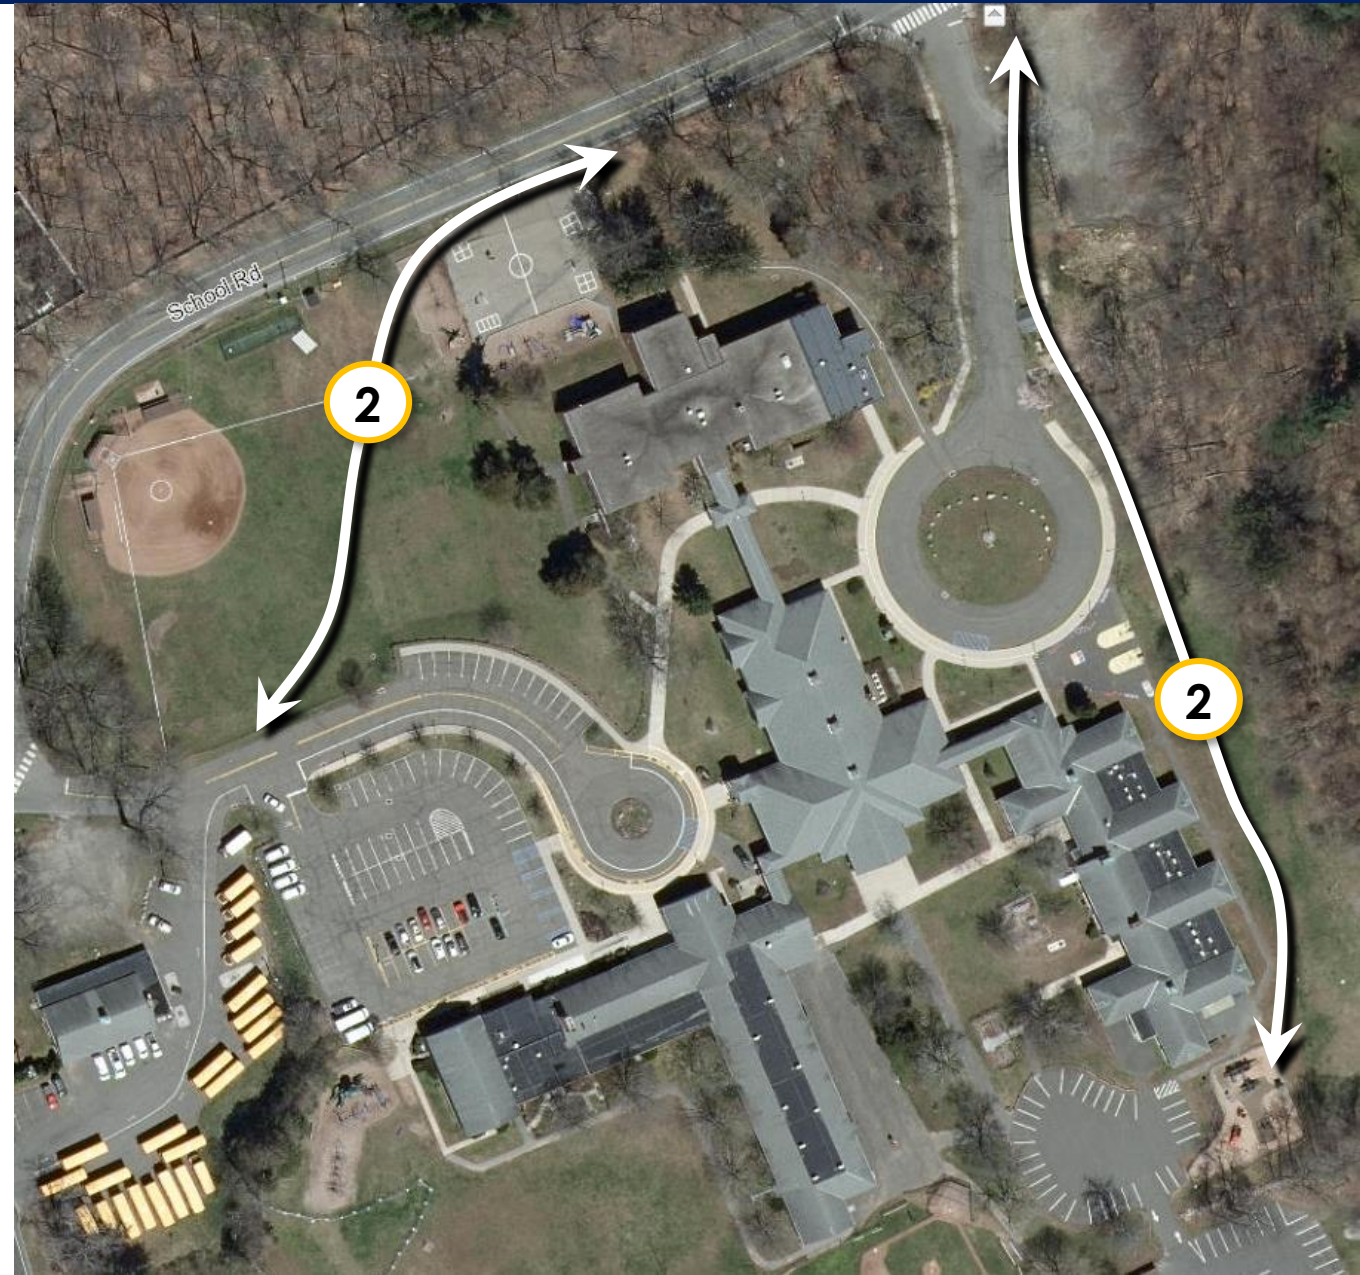
Existing Conditions ~ Hurlbutt Elementary School

- 4 Various and persistent roof leaks throughout, specifically at the cupolas
- 5 Poor accessibility throughout the site, to/from building, does not meet accessibility codes
- 6 Several areas of deteriorated concrete and steel columns, spalling brick, loose/decayed mortar joints

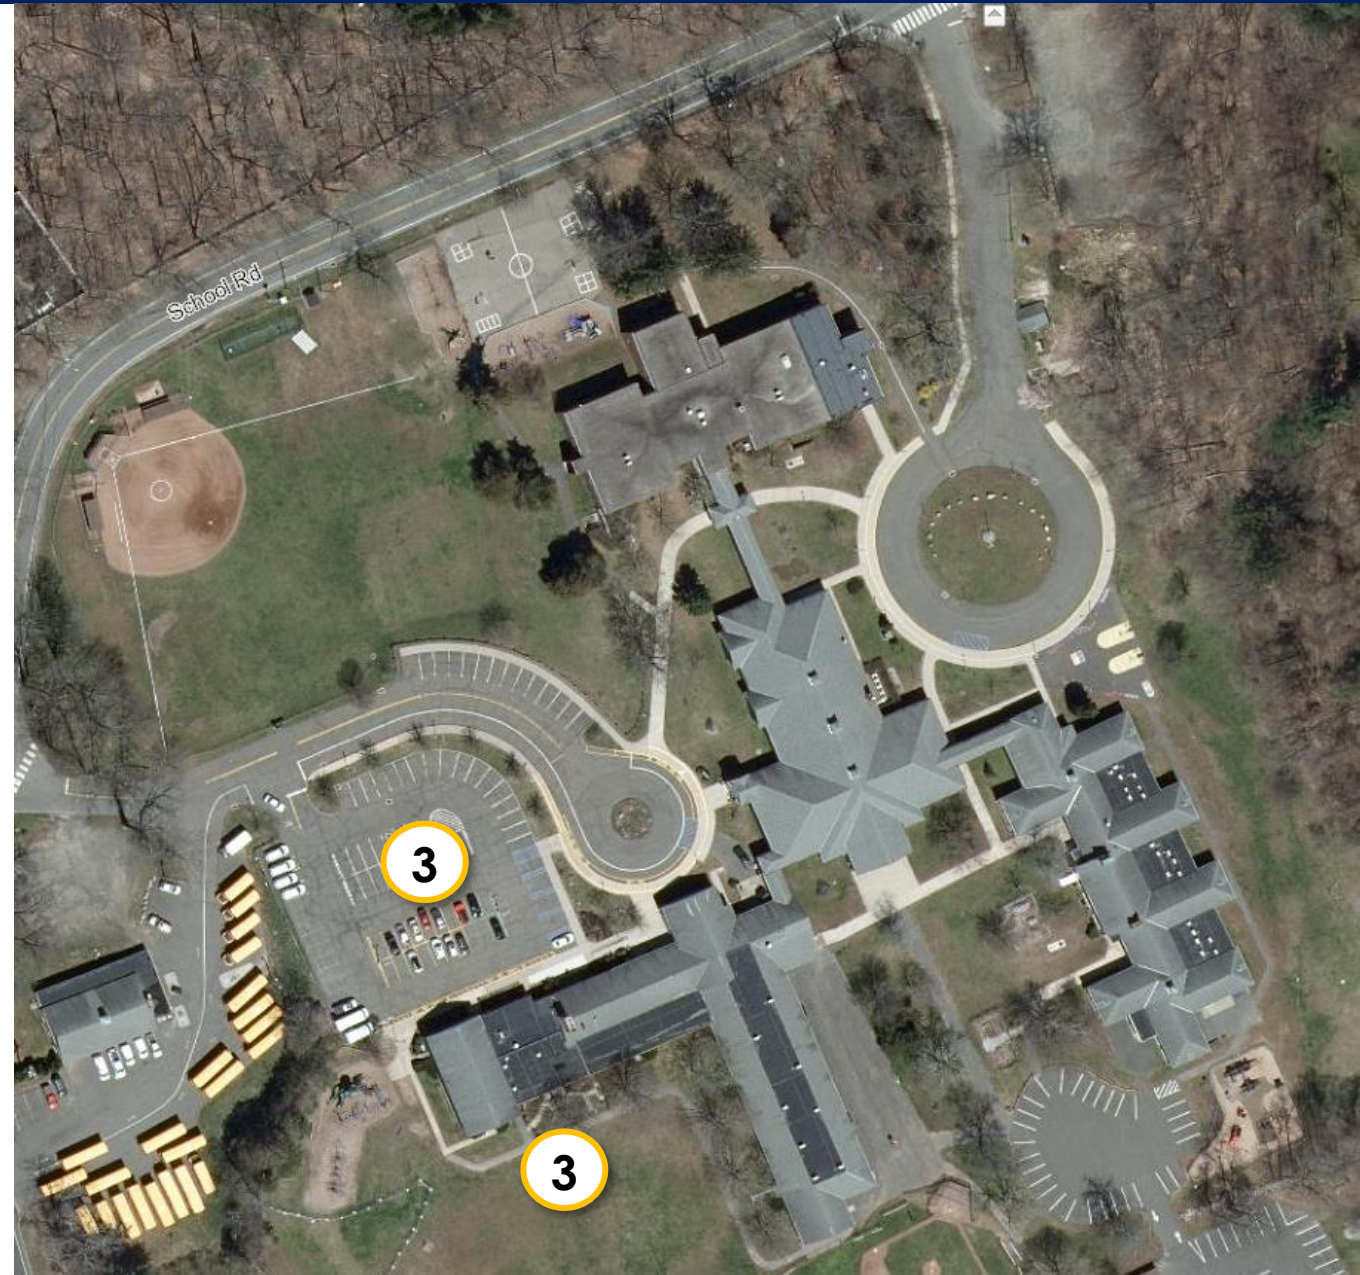
Existing Conditions ~ Hurlbutt Elementary School

- 4 Various and persistent roof leaks throughout, specifically at the cupolas
- 5 Poor accessibility throughout the site, to/from building, does not meet accessibility codes
- 6 Several areas of deteriorated concrete and steel columns, spalling brick, loose/decayed mortar joints

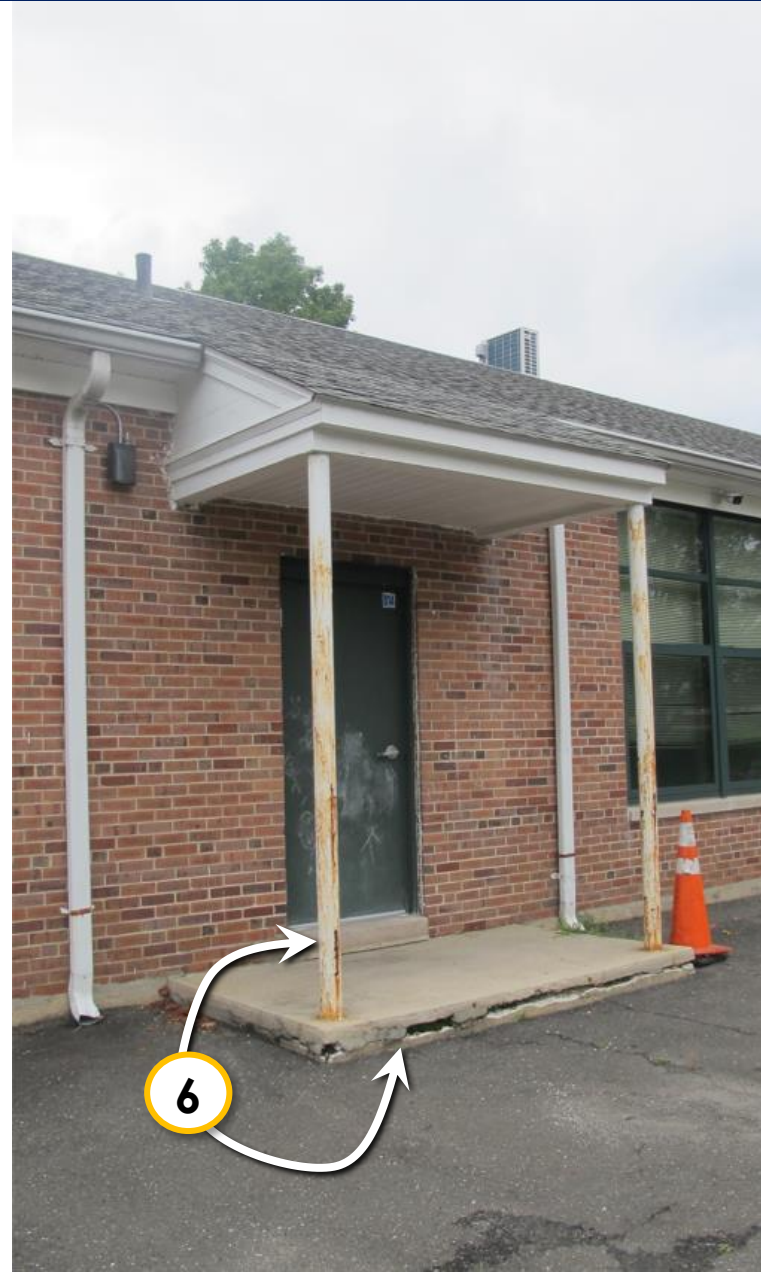
- 1** Building has been well maintained overall, built from mostly durable materials, block walls, ceramic tile walls/floors, however most of the areas are past their useful life.
- 2** Portions of the North house suffer from humidity and moisture control concerns. In some instances, it has affected quality and condition of finishes.
- 3** Areas of building still contain ACM at tiles, either in storage rooms or concealed under new finishes

- 7** Portions of building are wood frame construction

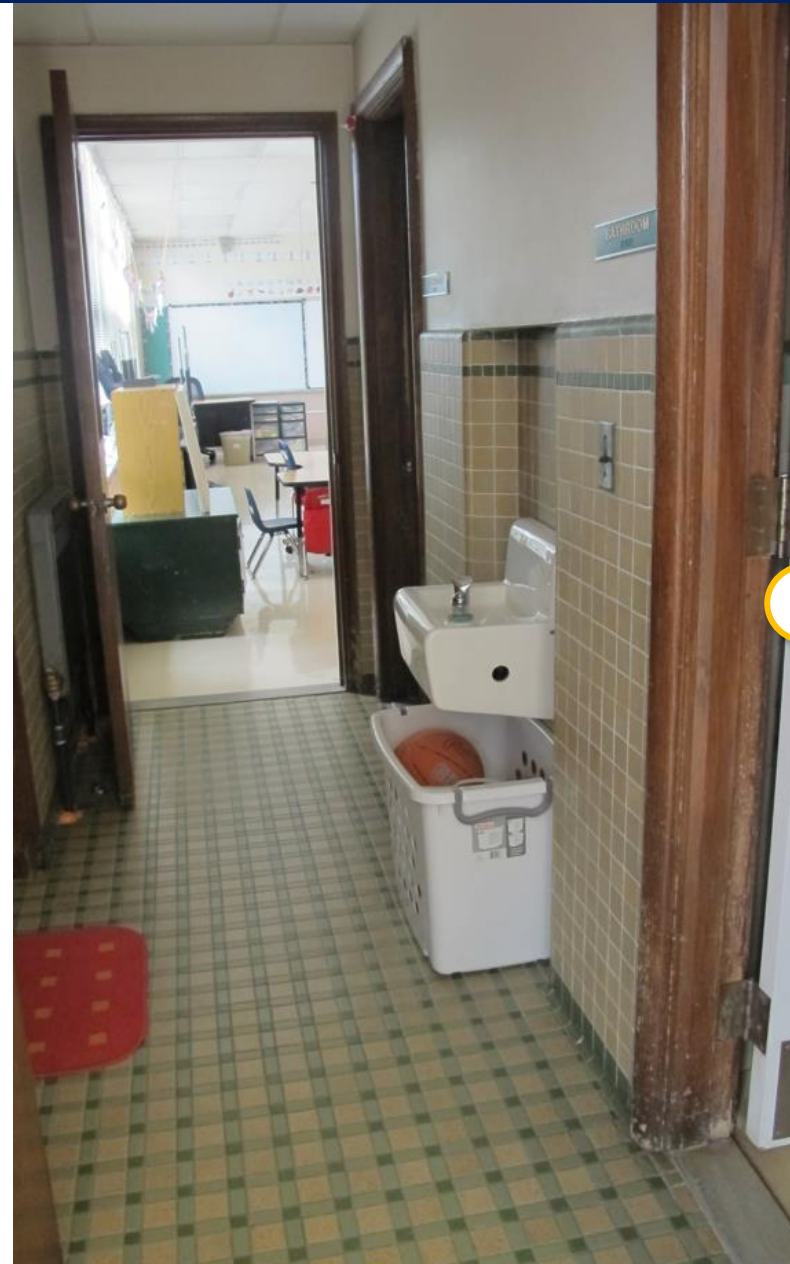
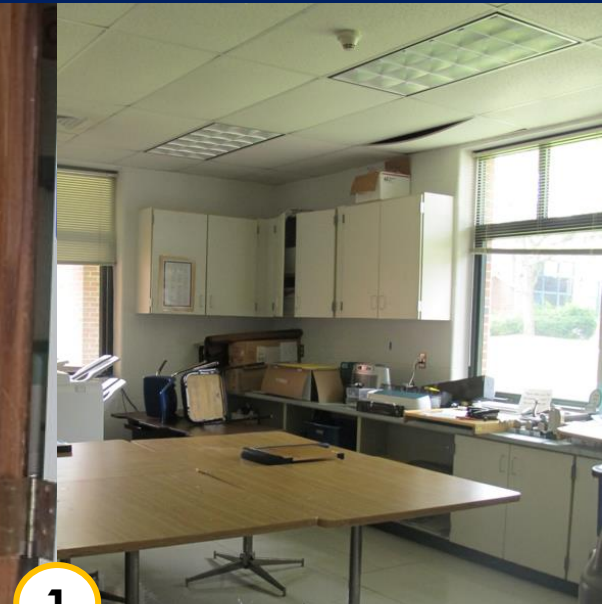
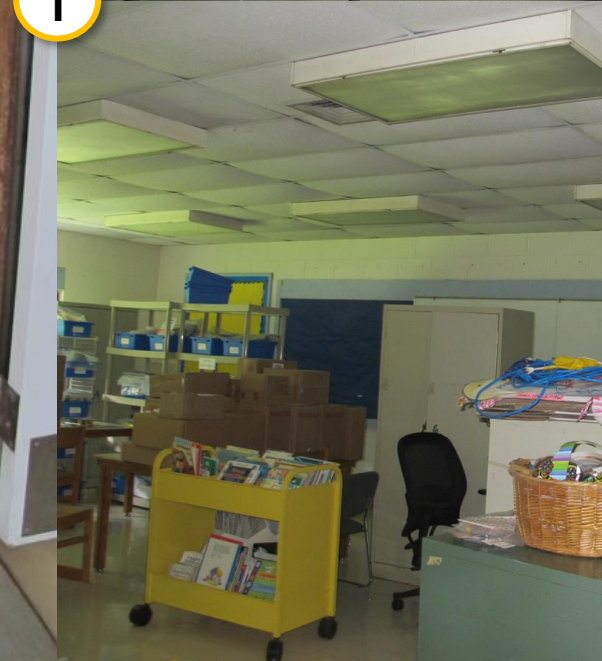
Portions of the North house suffer from humidity and moisture control concerns. In some instances, it has affected quality and condition of finishes.

Portions of building are wood frame construction

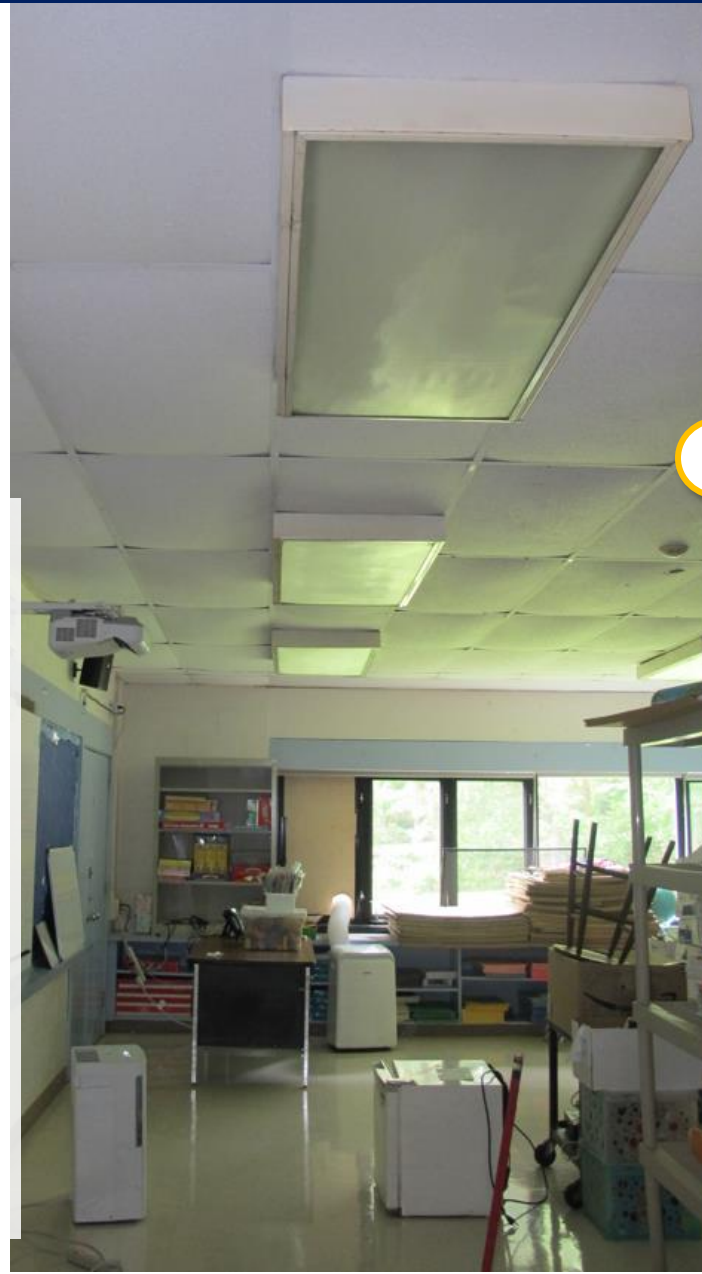
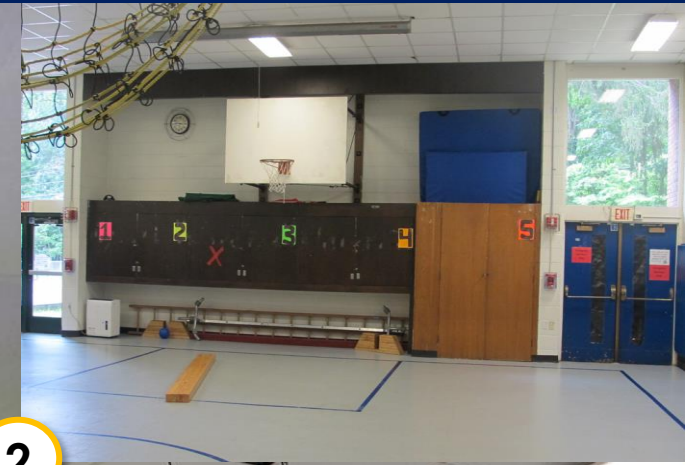
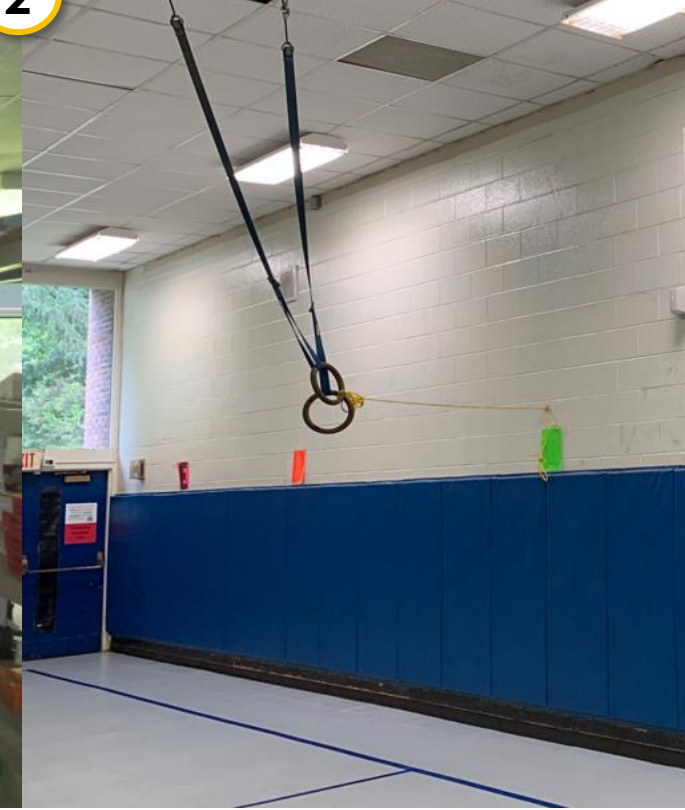
Portions of the North house suffer from humidity and moisture control concerns. In some instances, it has affected quality and condition of finishes.

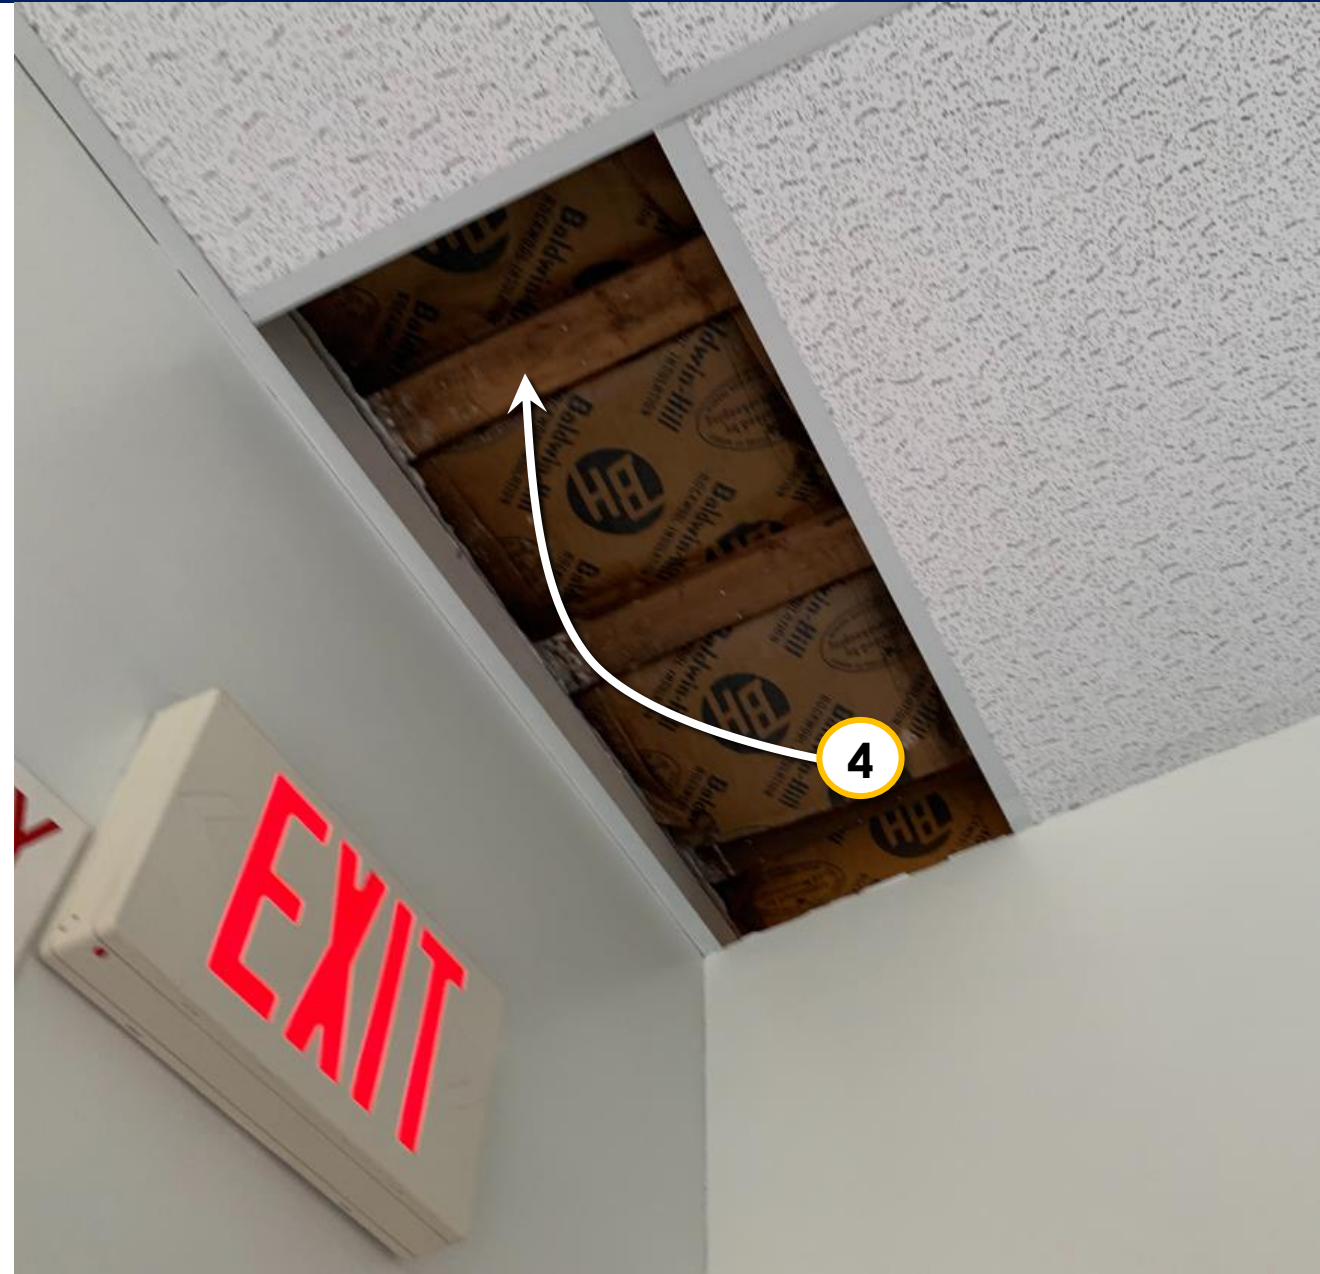
- 1 Building has been well maintained overall, built from mostly durable materials, block walls, ceramic tile walls/floors, however most of the areas are past their useful life.
- 2 Portions of the North house suffer from humidity and moisture control concerns. In some instances, it has affected quality and condition of finishes.
- 3 Areas of building still contain ACM at tiles, either in storage rooms or concealed under new finishes

- 7 Portions of building are wood frame construction

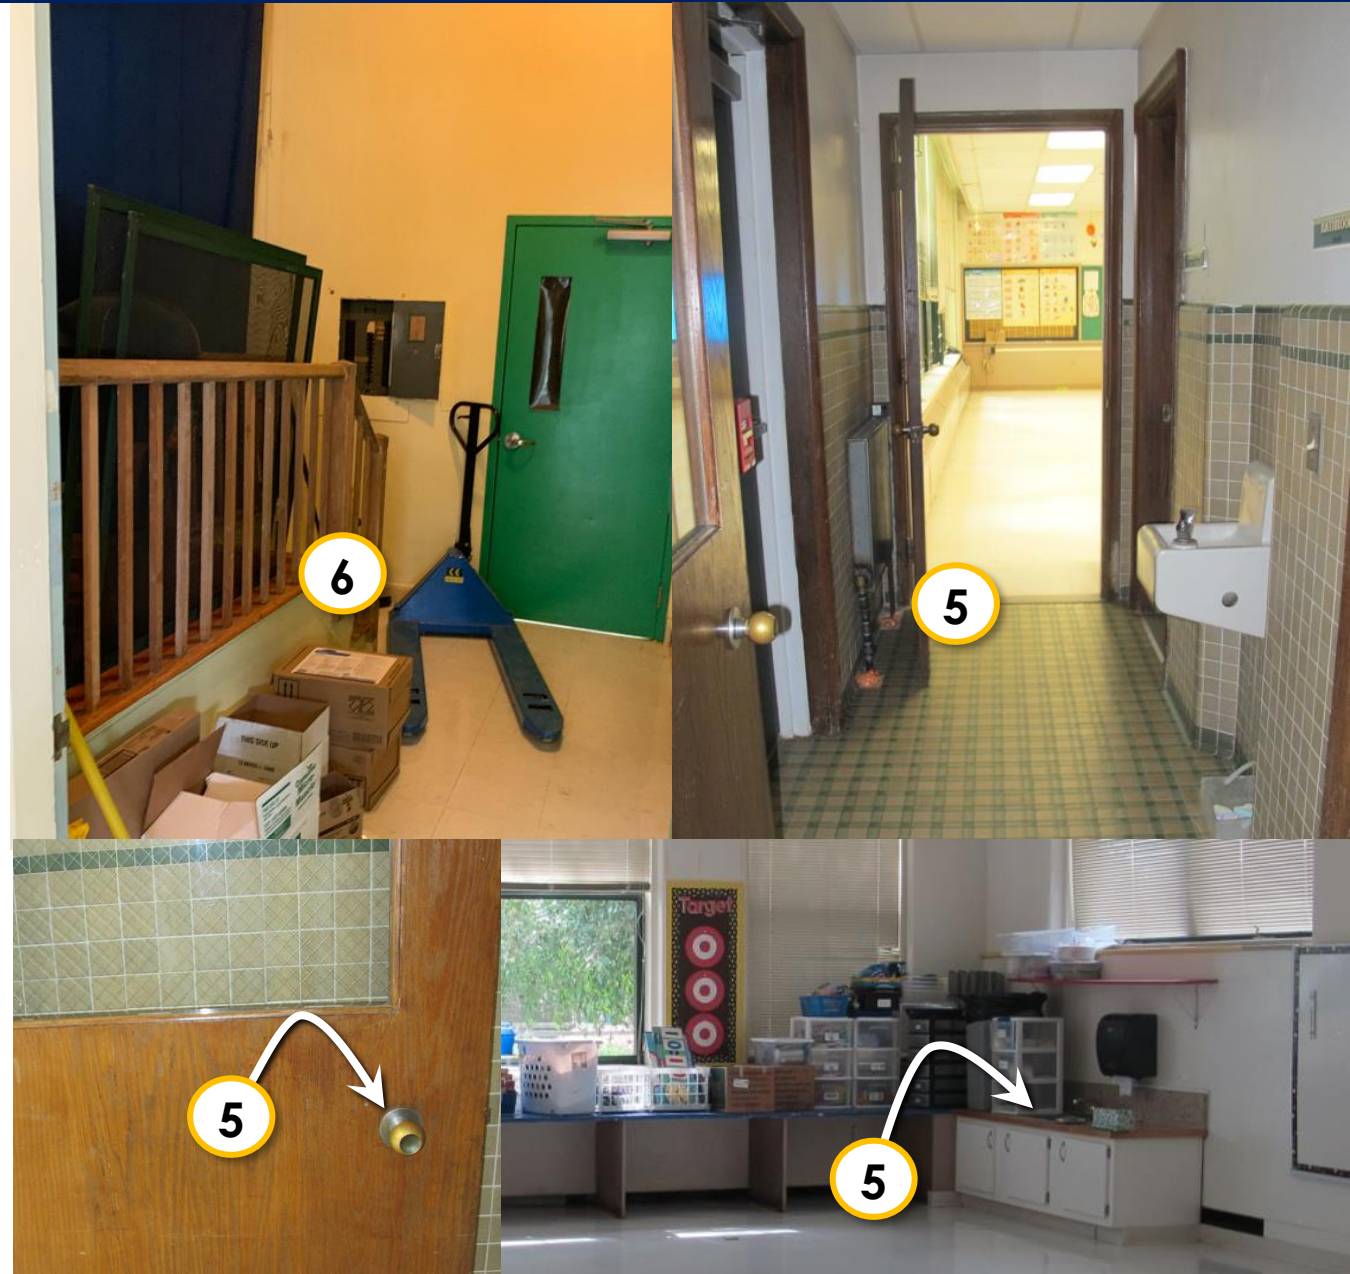
Fire Protection ~ No Sprinkler System

- No AC except Media Center Core Area, Chiller Replaced 2019. Remainder of systems old.
- Some Steam, Uneven Temperatures.
- Multiple Oil Tanks
- Controls not working.

- Service Good Condition, Distribution is multiple vintages. Mostly older.
- Lighting mostly fluorescent.
- Generator in basement.
- Fire Alarm ~ Nearing the end of its useful life but has an Addressable panel.

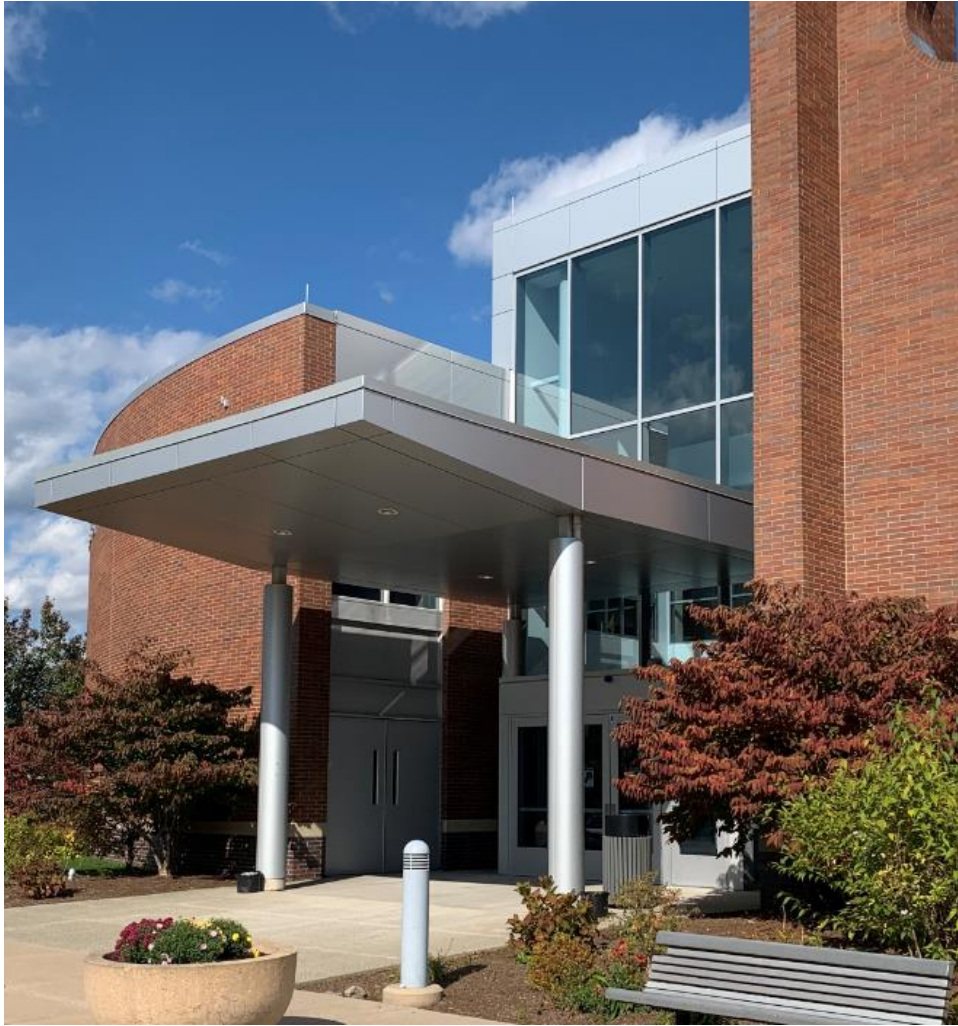
- ① **Building Envelope** ~ lintel replacement ongoing, brick repointing & caulking plan required, several leaks @ roof and parapet flashing.

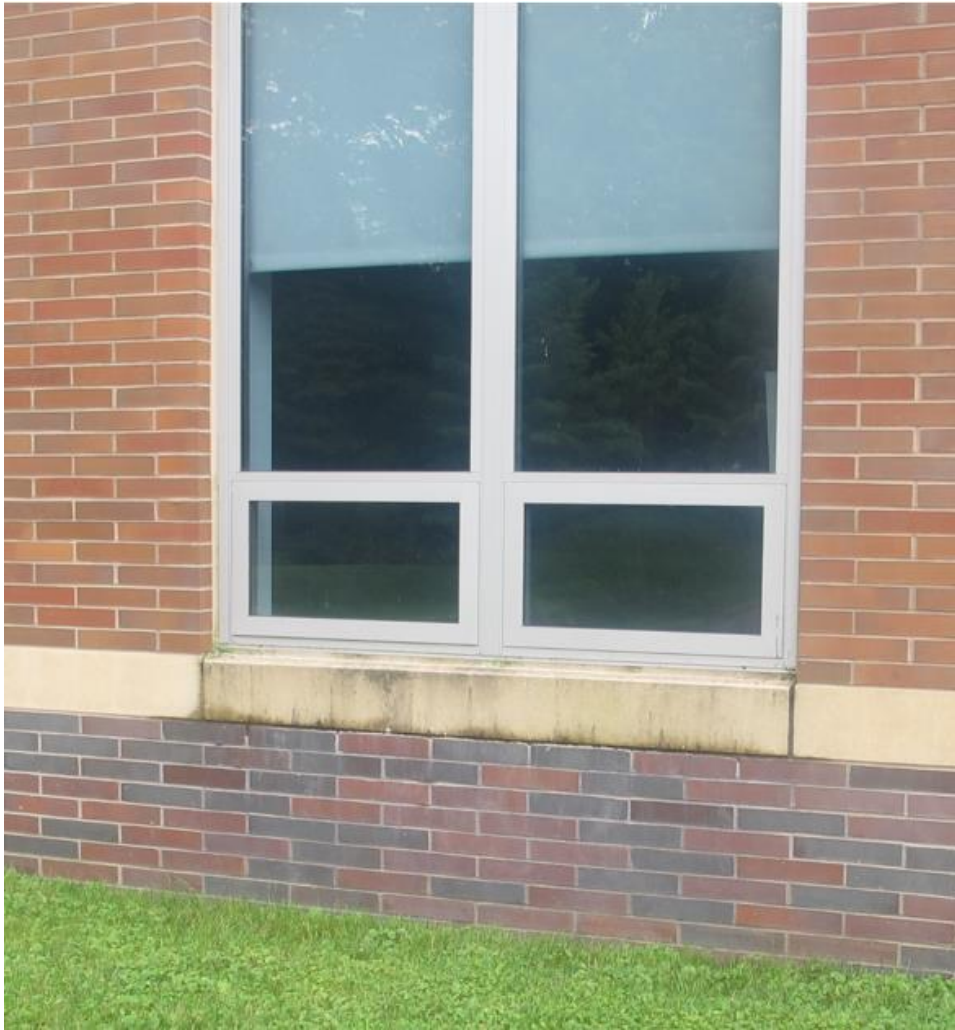
Weston Intermediate School ~ 95 School Road

- ① **Building Envelope** ~ sill replacement ongoing, brick repointing & caulking plan required, several leaks @ roof and parapet flashing.

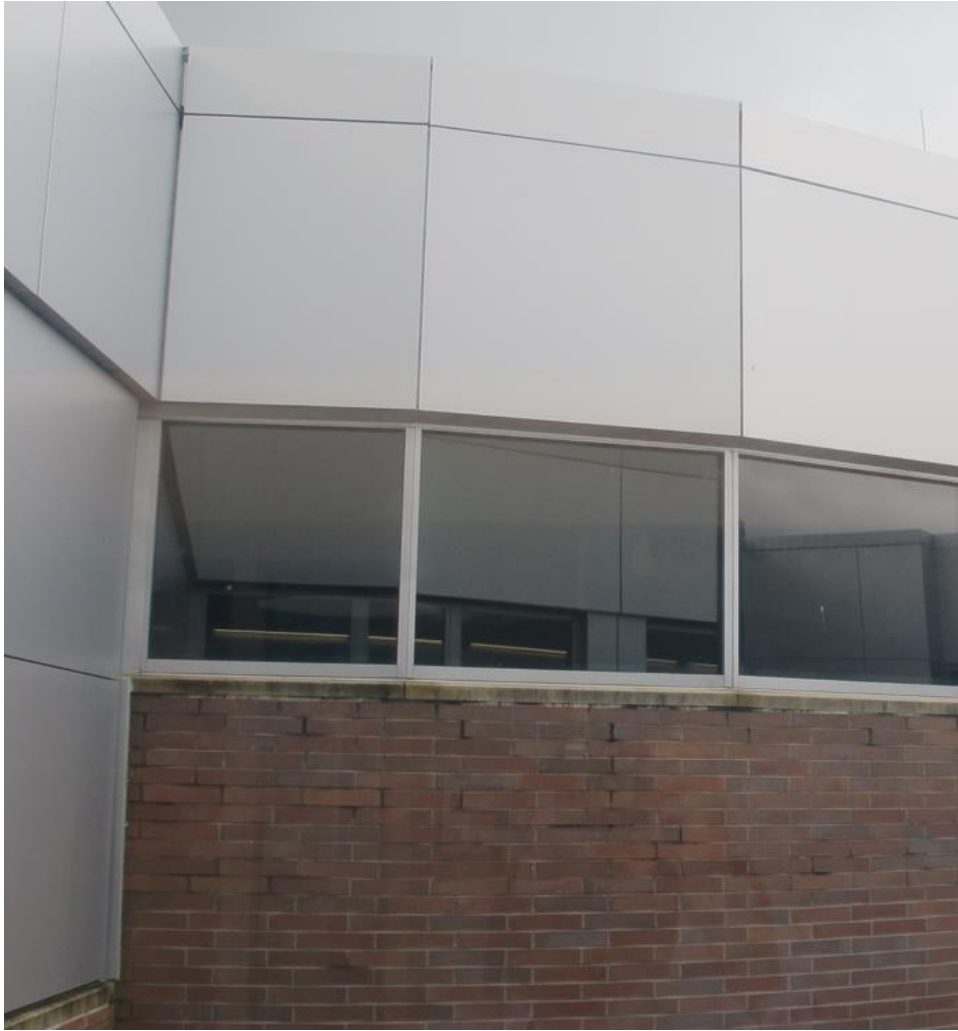
Weston Intermediate School ~ 95 School Road

- ① **Building Envelope** ~ sill replacement ongoing, brick repointing & caulking plan required, several leaks @ roof and parapet flashing.

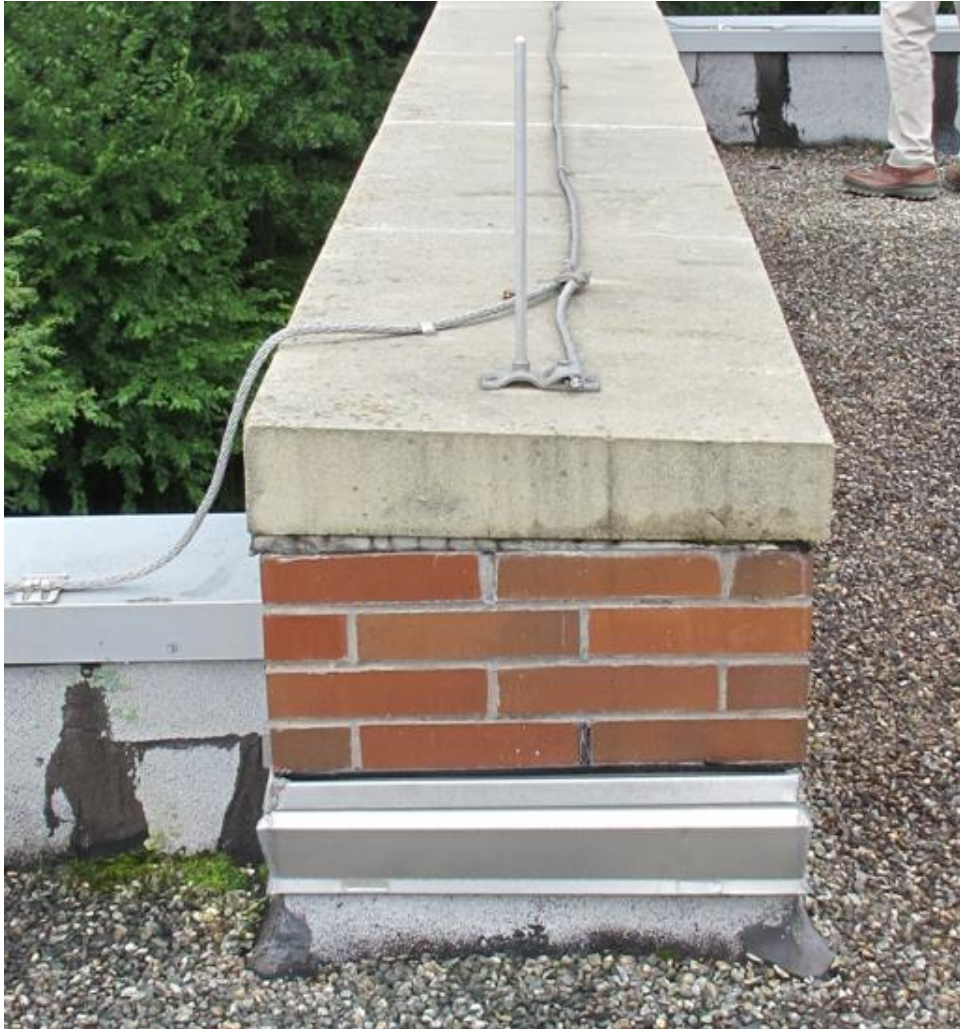
Weston Intermediate School ~ 95 School Road

- ① **Building Envelope** ~ sill replacement ongoing, brick repointing & caulking plan required, several leaks @ roof and parapet flashing.
