Appendix

APPENDIX
VINTAGE PLANS

APPENDIX
EXISTING CONDITIONS SUMMARY

HURLBUTT ELEMENTARY SCHOOL
EXISTING CONDITIONS SUMMARY

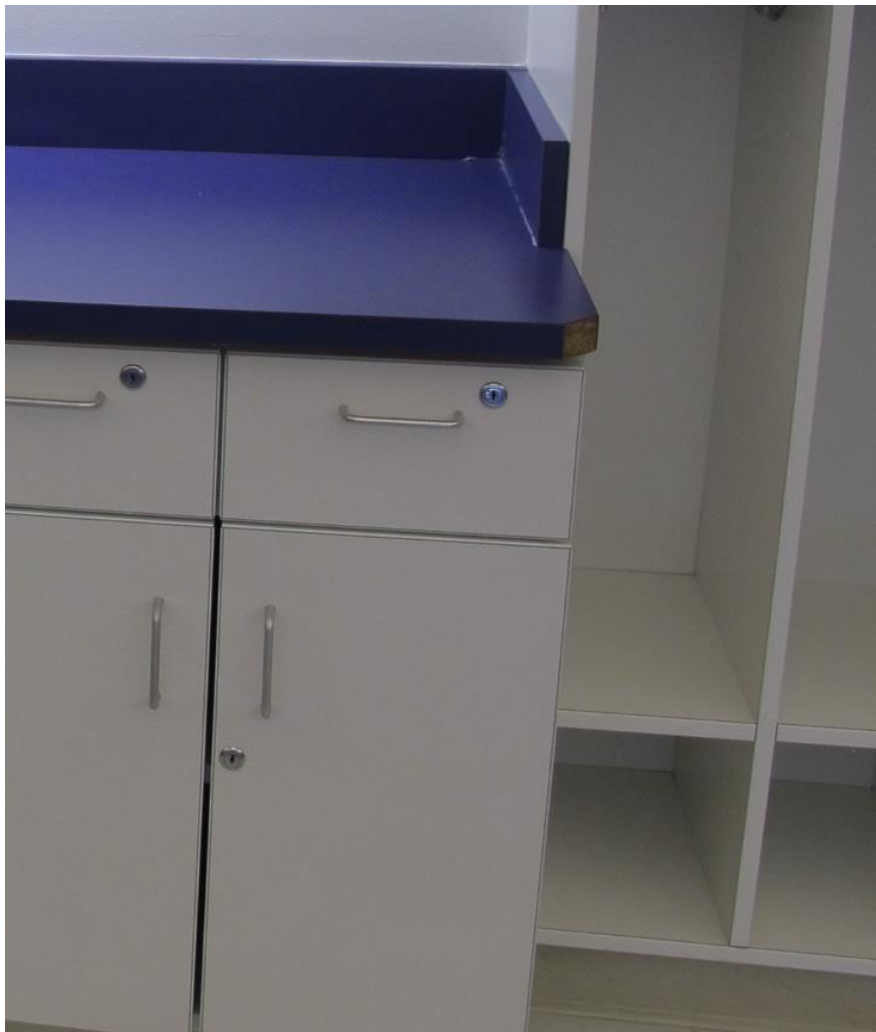
Weston Intermediate School ~ 95 School Road

- ① **Building Envelope** ~ sill replacement ongoing, brick repointing & caulking plan required, several leaks @ roof and parapet flashing.
- ② **Building Interior** ~ Well maintained, good condition overall, some millwork delamination (age/use), limited ceiling and floor replacement, isolated flooring issues at main hall

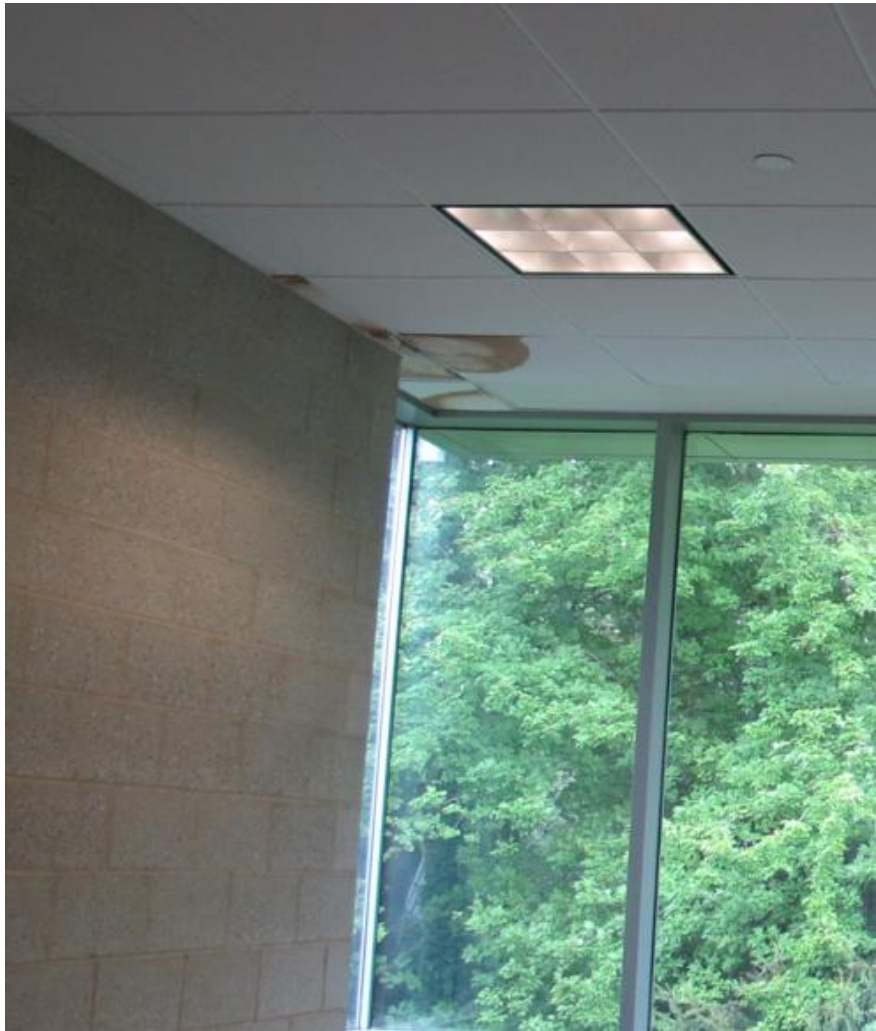
Weston Intermediate School ~ 95 School Road

- ① **Building Envelope** ~ sill replacement ongoing, brick repointing & caulking plan required, several leaks @ roof and parapet flashing.
- ② **Building Interior** ~ Well maintained, good condition overall, some millwork delamination (age/use), limited ceiling and floor replacement, isolated flooring issues at main hall

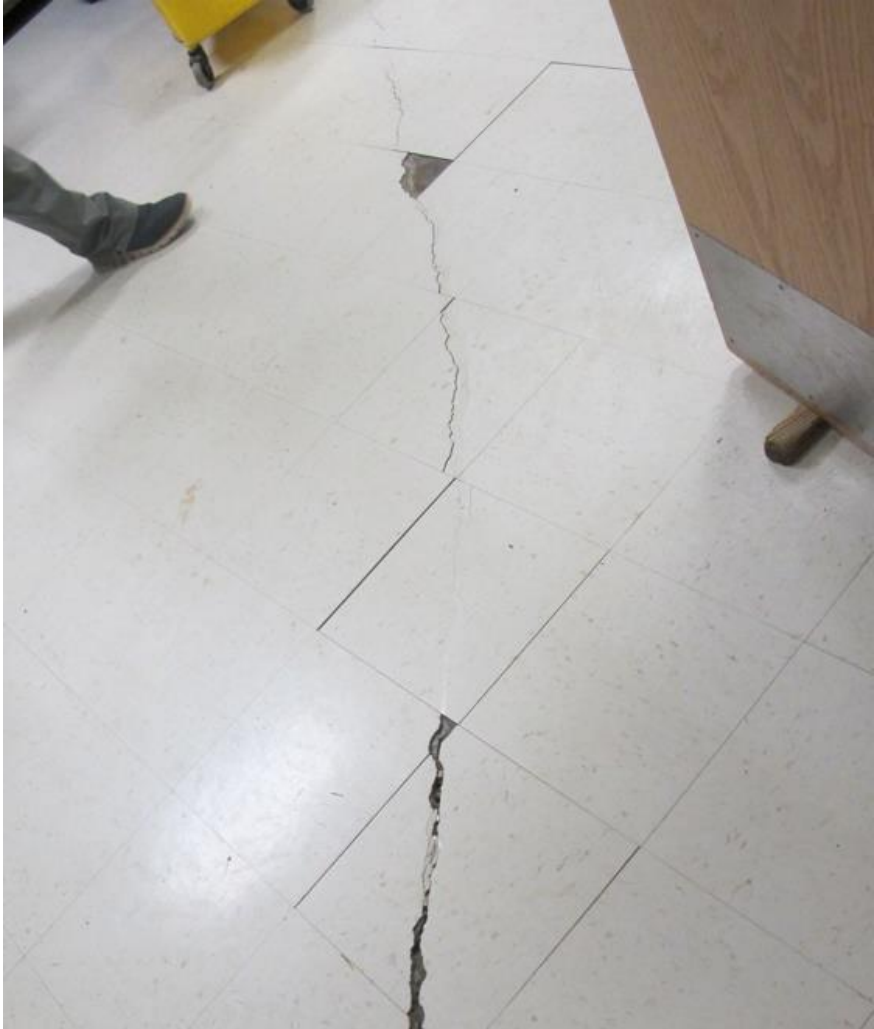
Weston Intermediate School ~ 95 School Road

- ① **Building Envelope** ~ sill replacement ongoing, brick repointing & caulking plan required, several leaks @ roof and parapet flashing.
- ② **Building Interior** ~ Well maintained, good condition overall, some millwork delamination (age/use), limited ceiling and floor replacement, isolated flooring issues at main hall

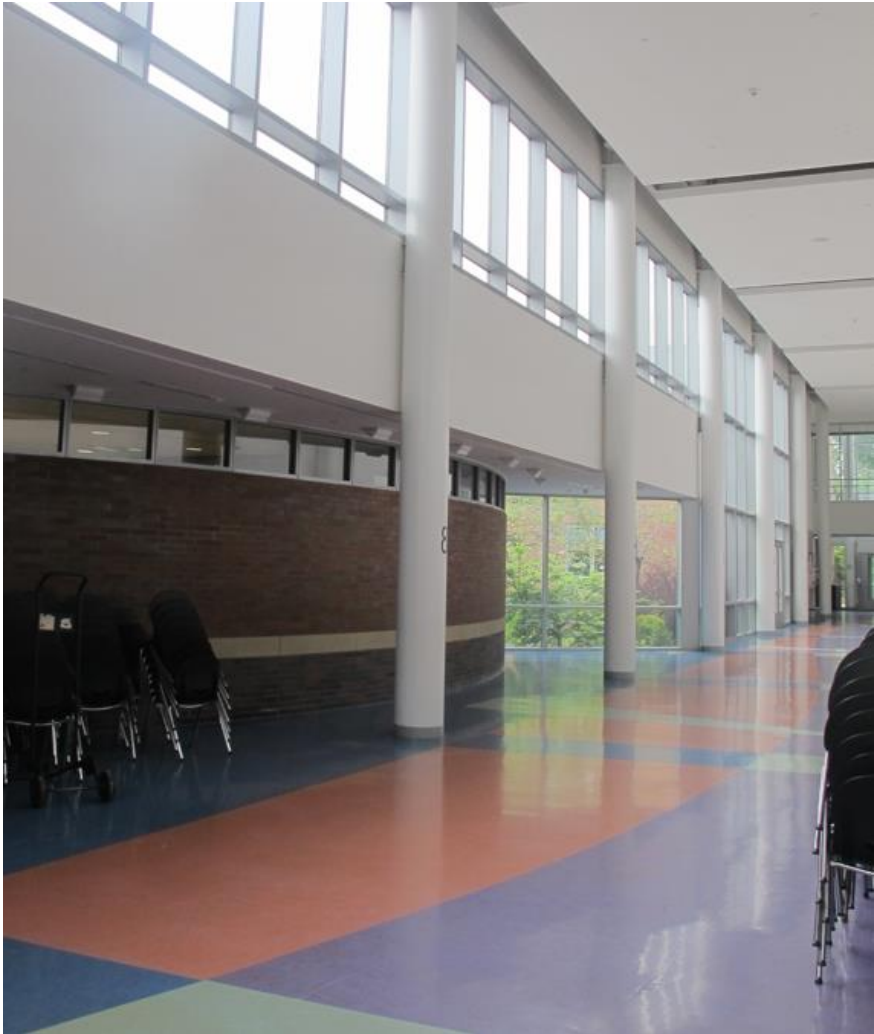
Weston Intermediate School ~ 95 School Road

- 1** **Building Envelope** ~ sill replacement ongoing, brick repointing & caulking plan required, several leaks @ roof and parapet flashing.
- 2** **Building Interior** ~ Well maintained, good condition overall, some millwork delamination (age/use), limited ceiling and floor replacement, isolated flooring issues at main hall

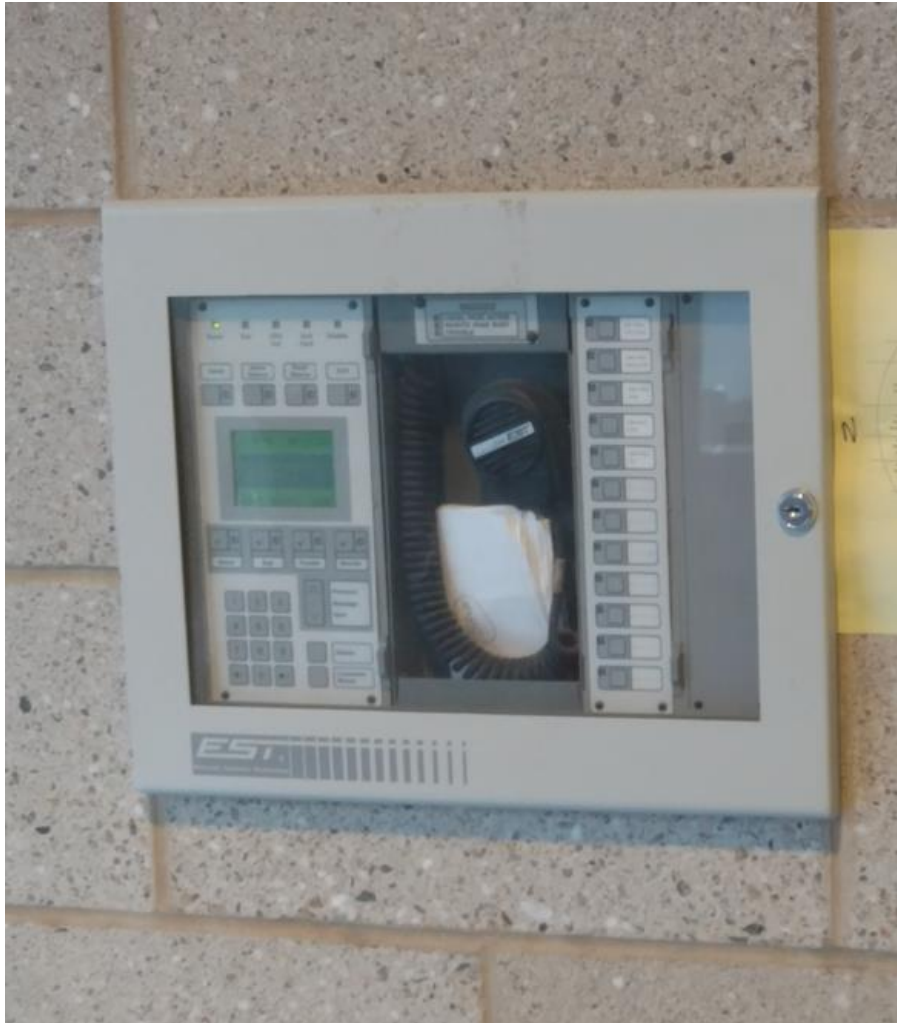
Weston Intermediate School ~ 95 School Road

- ① **Building Envelope** ~ sill replacement ongoing, brick repointing & caulking plan required, several leaks @ roof and parapet flashing.
- ② **Building Interior** ~ Well maintained, good condition overall, some millwork delamination (age/use), limited ceiling and floor replacement, isolated flooring issues at main hall
- ③ **Fire Alarm System** ~ beginning to experience issues, requires repairs frequently

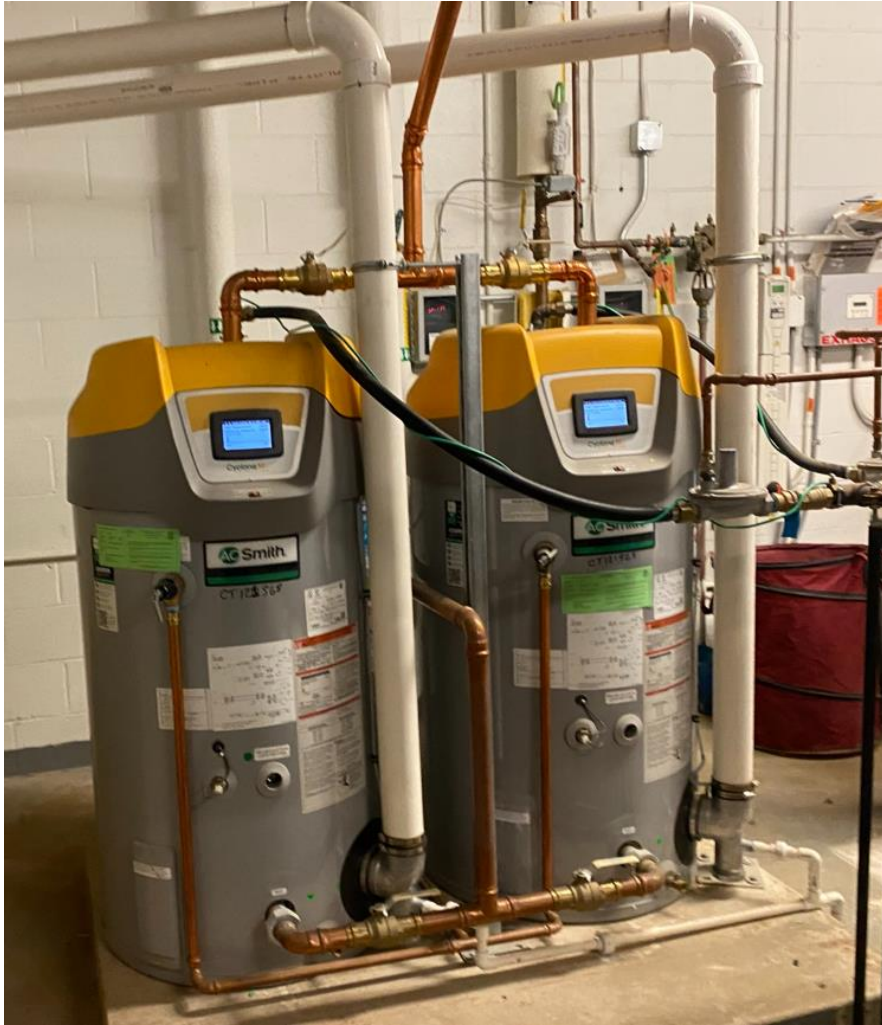
Weston Intermediate School ~ 95 School Road

- 1 **Building Envelope** ~ sill replacement ongoing, brick repointing & caulking plan required, several leaks @ roof and parapet flashing.
- 2 **Building Interior** ~ Well maintained, good condition overall, some millwork delamination (age/use), limited ceiling and floor replacement, isolated flooring issues at main hall
- 3 **Fire Alarm System** ~ beginning to experience issues, requires repairs frequently
- 4 **Plumbing** ~ No hot water recirculation system, results in poor water temperature (maintain by temperature maintenance cable ~ unreliable)

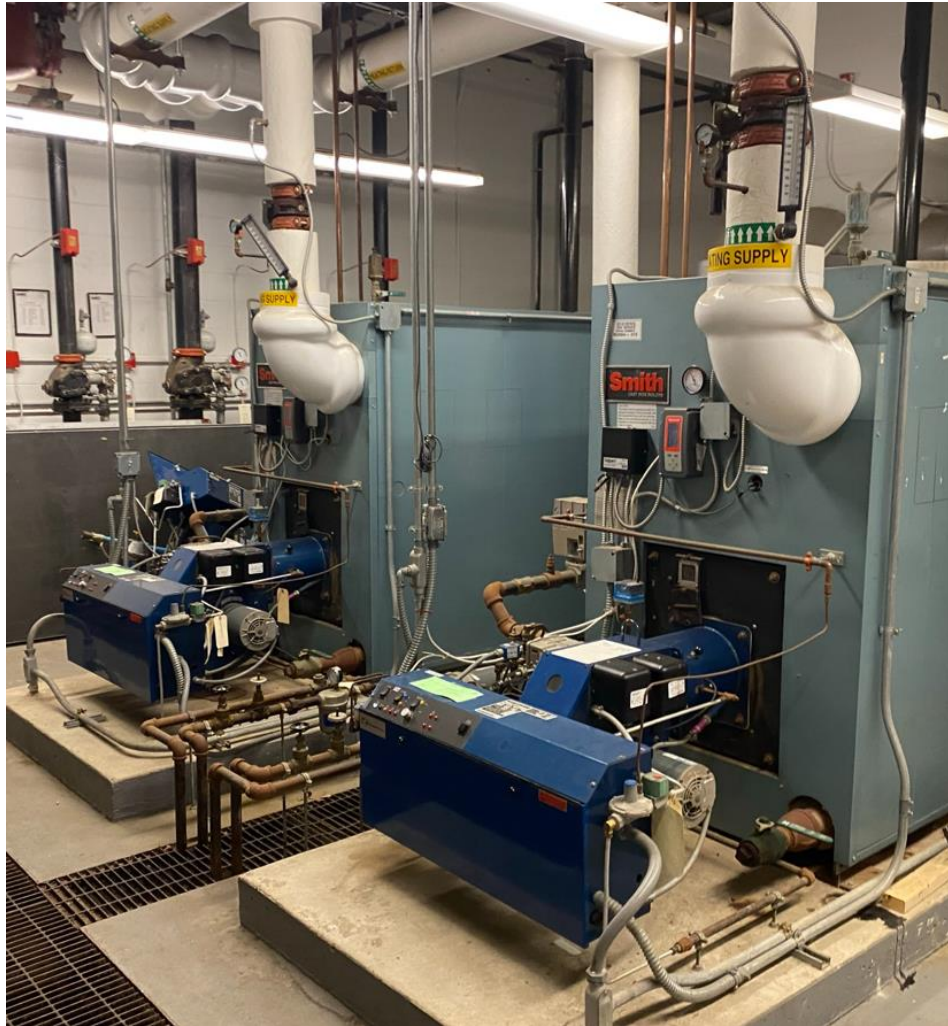
Weston Intermediate School ~ 95 School Road

- 1 **Building Envelope** ~ sill replacement ongoing, brick repointing & caulking plan required, several leaks @ roof and parapet flashing.
- 2 **Building Interior** ~ Well maintained, good condition overall, some millwork delamination (age/use), limited ceiling and floor replacement, isolated flooring issues at main hall
- 3 **Fire Alarm System** ~ beginning to experience issues, requires repairs frequently
- 4 **Plumbing** ~ No hot water recirculation system, results in poor water temperature (maintain by temperature maintenance cable ~ unreliable)
- 5 **HVAC** ~ BMS (Building management system) good but starting to fail and requires frequent replacement. CO2 sensors fail often, "Good building, difficult to run"

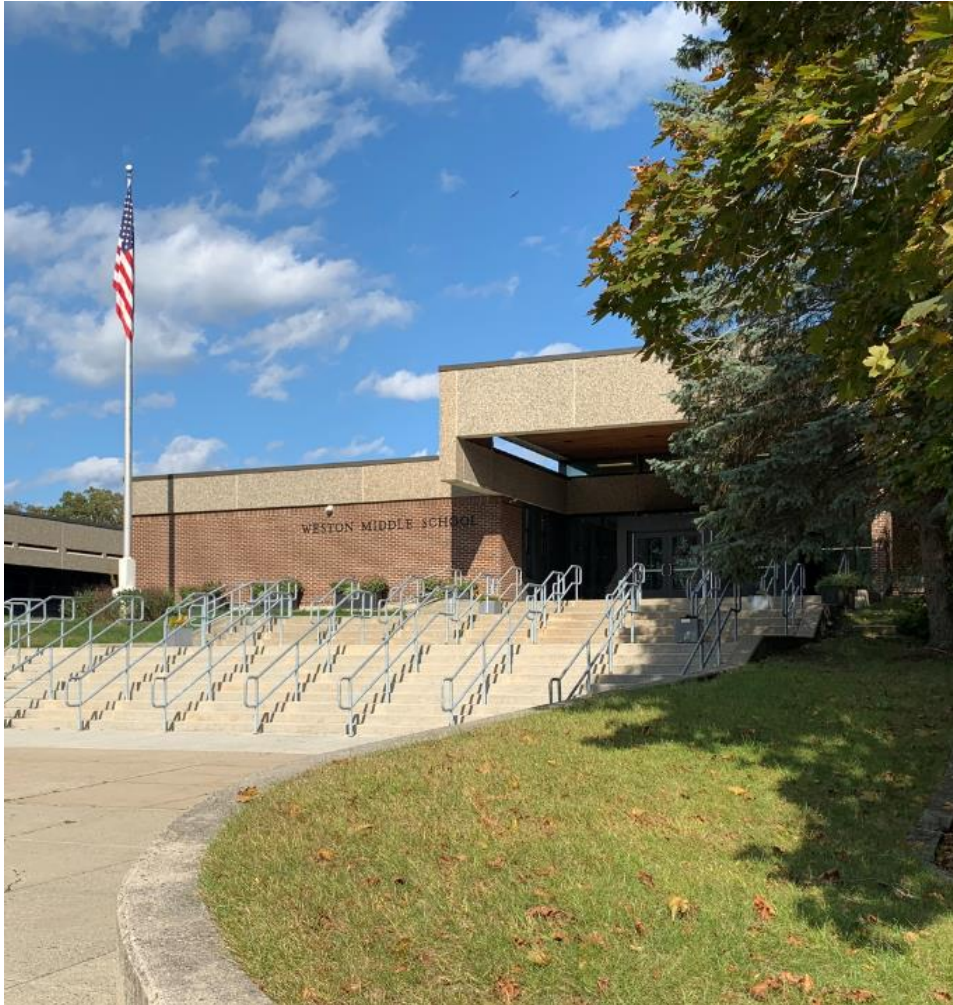
Exterior Envelope ~ Roof and windows replaced & in good/fair condition overall, wood soffit has decay and insect concern, masonry in fair/good condition – repointing/caulking plan req.

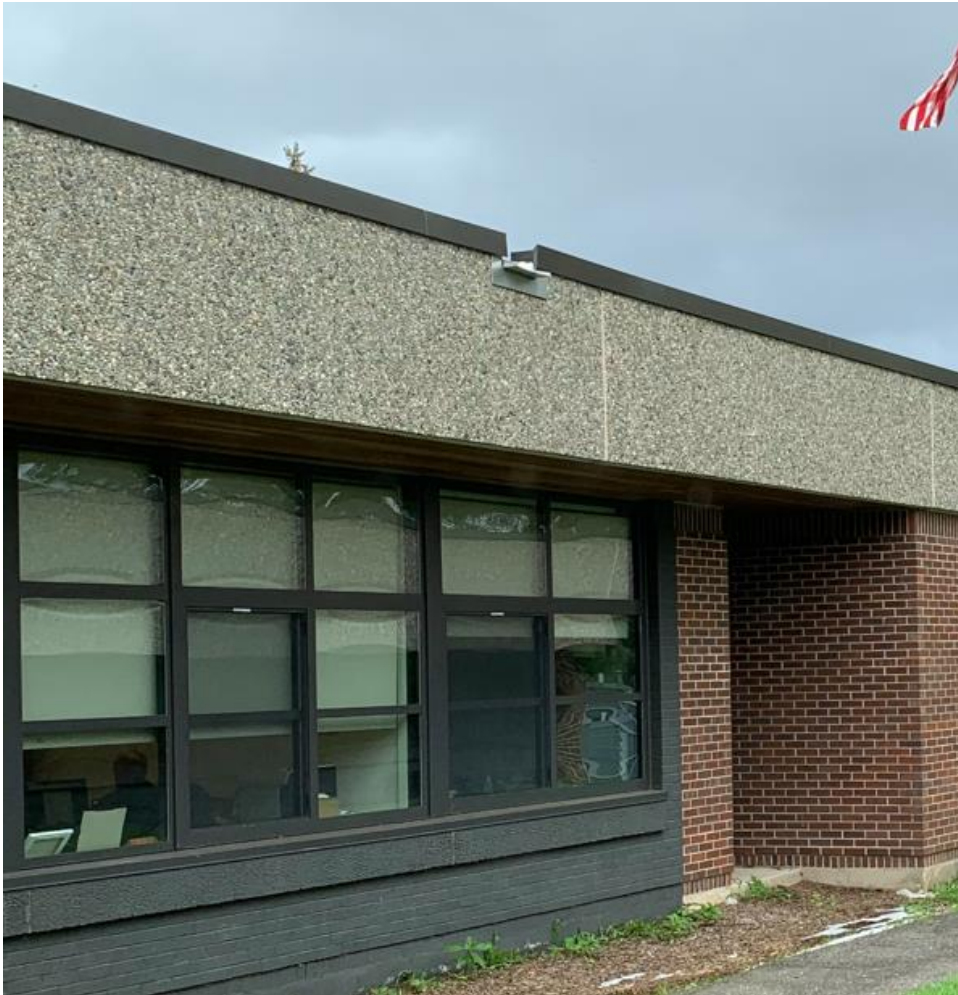
Exterior Envelope ~ Roof and windows replaced & in good/fair condition overall, wood soffit has decay and insect concern, masonry in fair/good condition – repointing/caulking plan req.

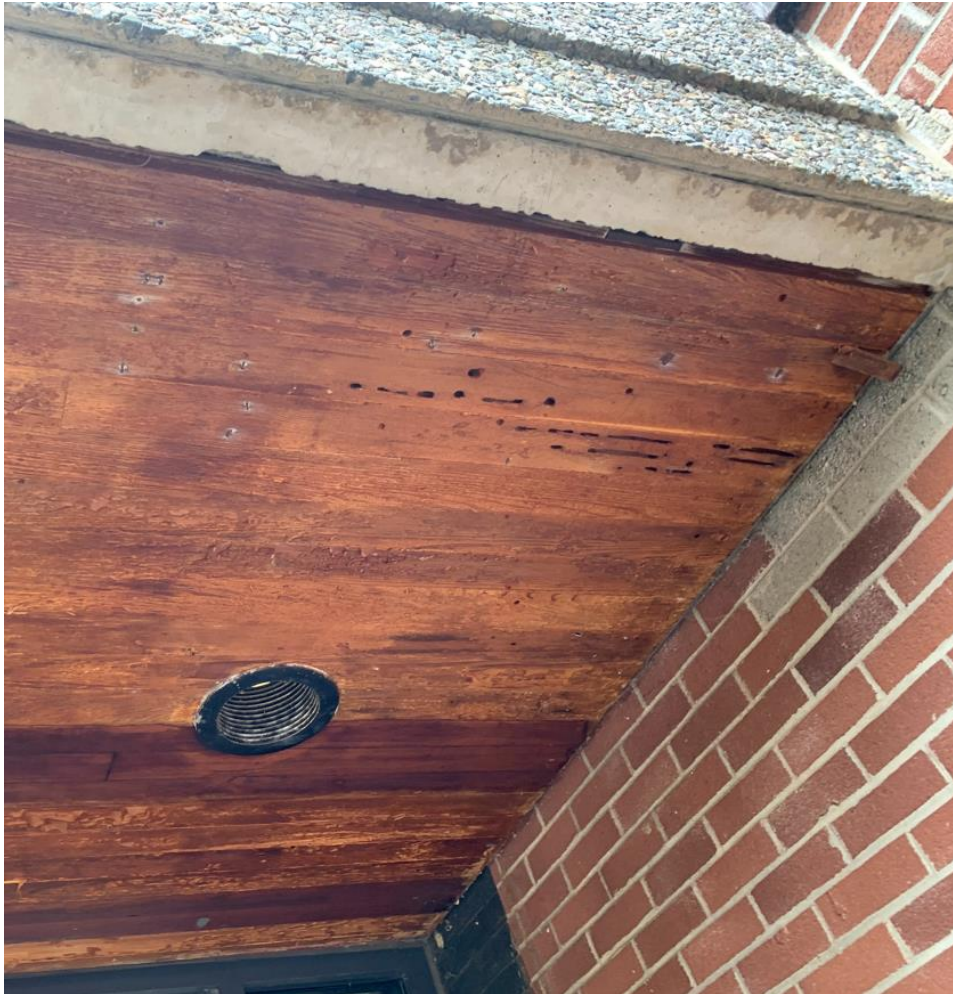
Exterior Envelope ~ Roof and windows replaced & in good/fair condition overall, wood soffit has decay and insect concern, masonry in fair/good condition – repointing/caulking plan req.

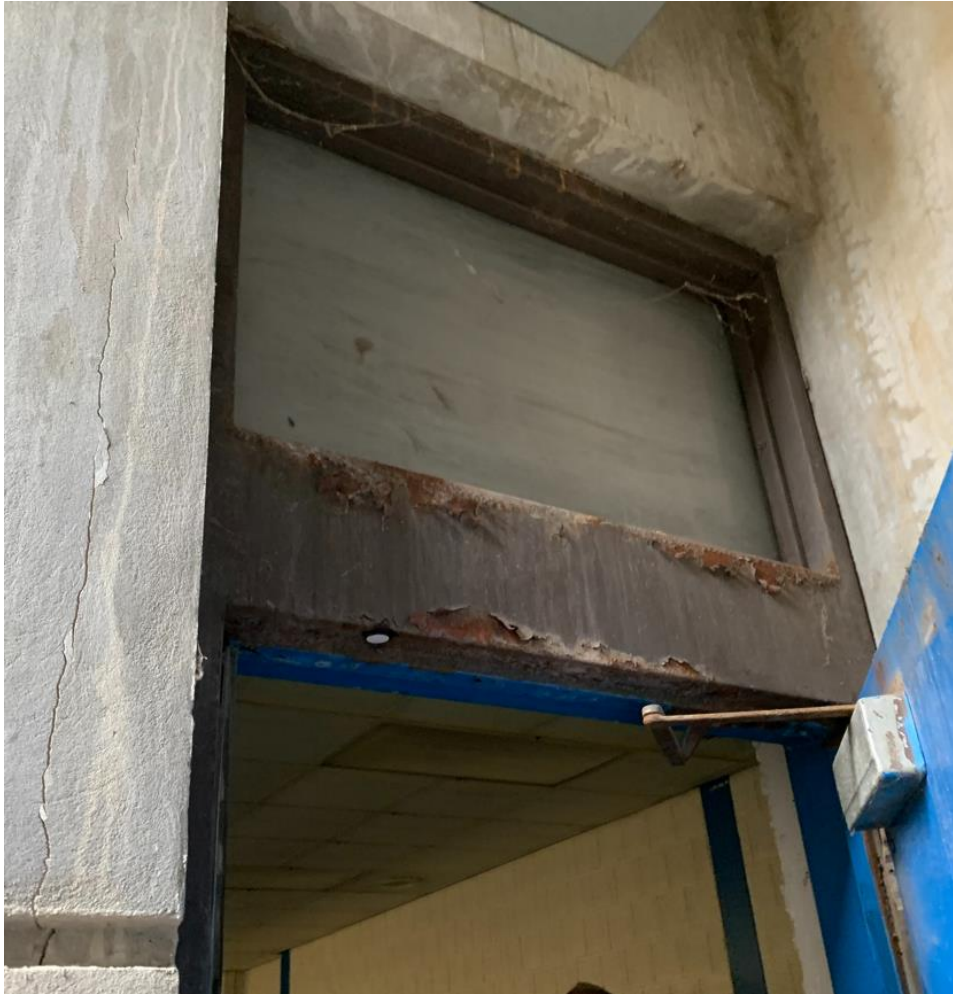
Exterior Envelope ~ Roof and windows replaced & in good/fair condition overall, wood soffit has decay and insect concern, masonry in fair/good condition – repointing/caulking plan req.

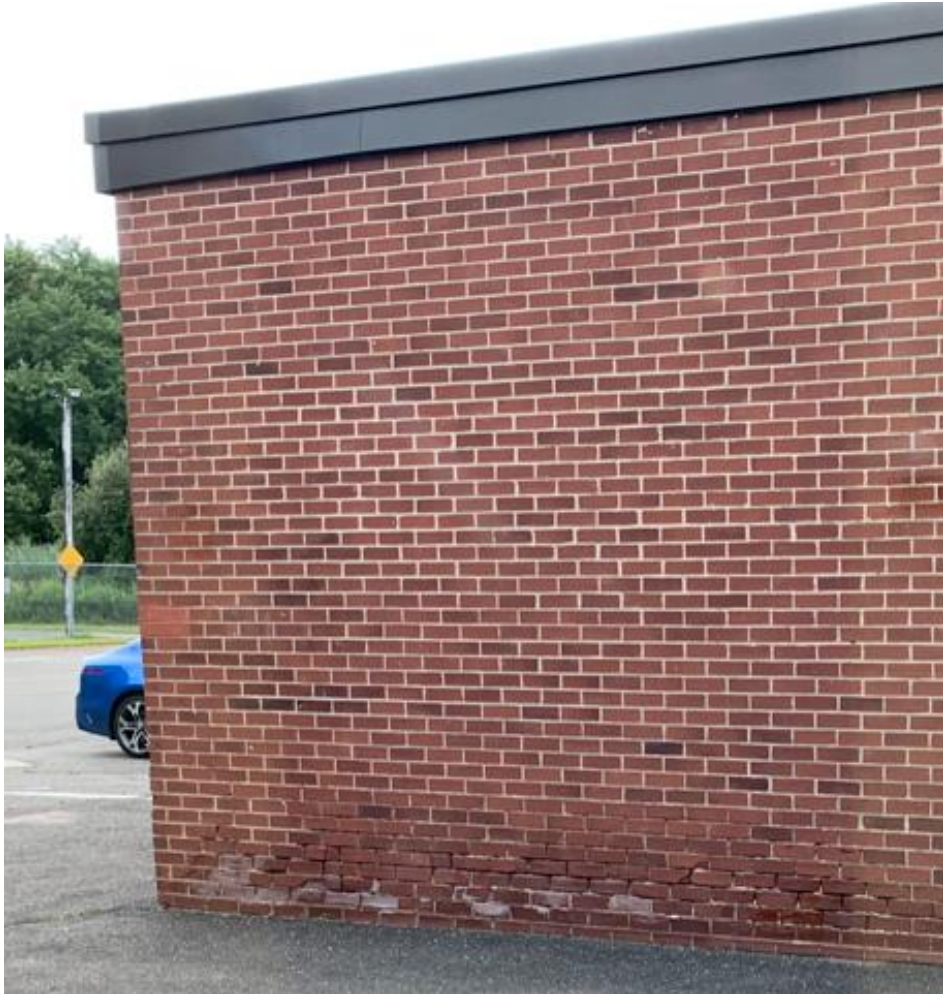
Exterior Envelope ~ Roof and windows replaced & in good/fair condition overall, wood soffit has decay and insect concern, masonry in fair/good condition – repointing/caulking plan req.

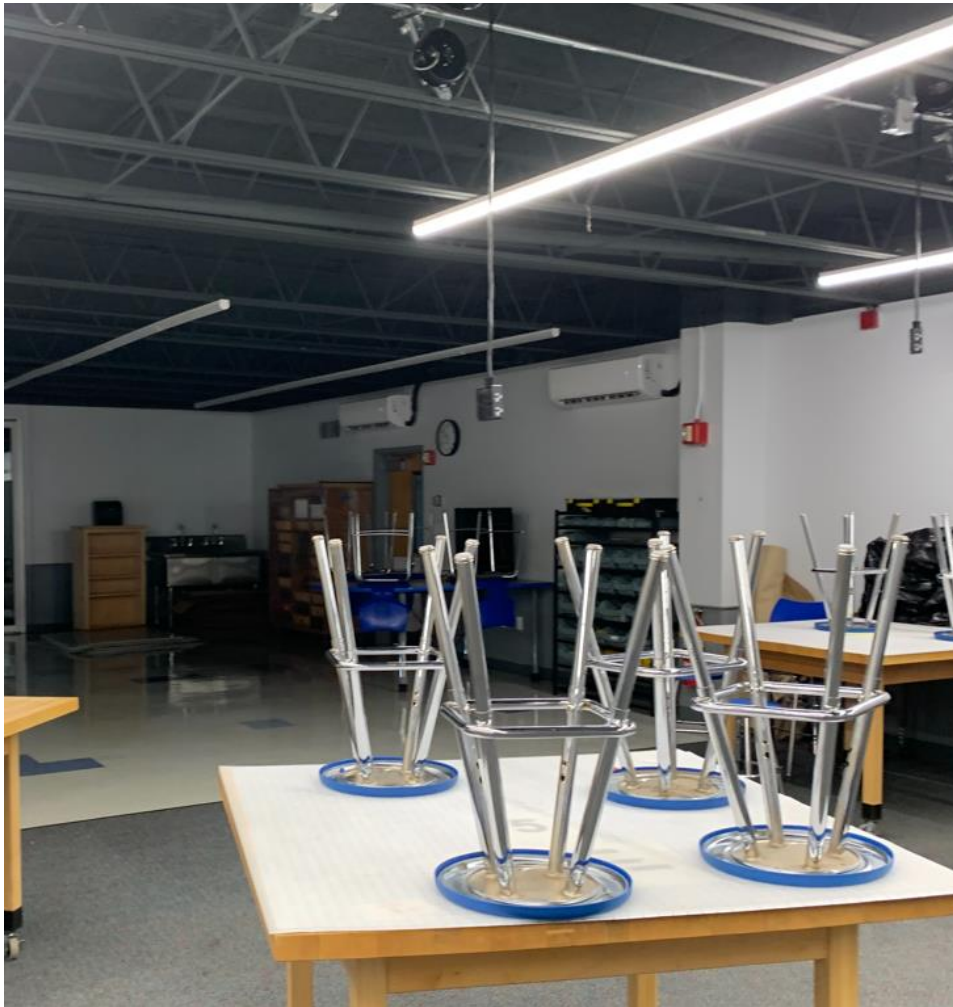
- 1** *Exterior Envelope* ~ Roof and windows replaced & in good/fair condition overall, wood soffit has decay and insect concern, masonry in fair/good condition – repointing/caulking plan req.
- 2** *Interior* ~ Several modifications and improvement (learning commons, project lead the way), block wall cracks @ “new” gym, sag to ceiling tile representative of humidity concerns. Remaining original portions (1960/71) in fair to poor condition, past useful life (millwork, finishes, equipment).

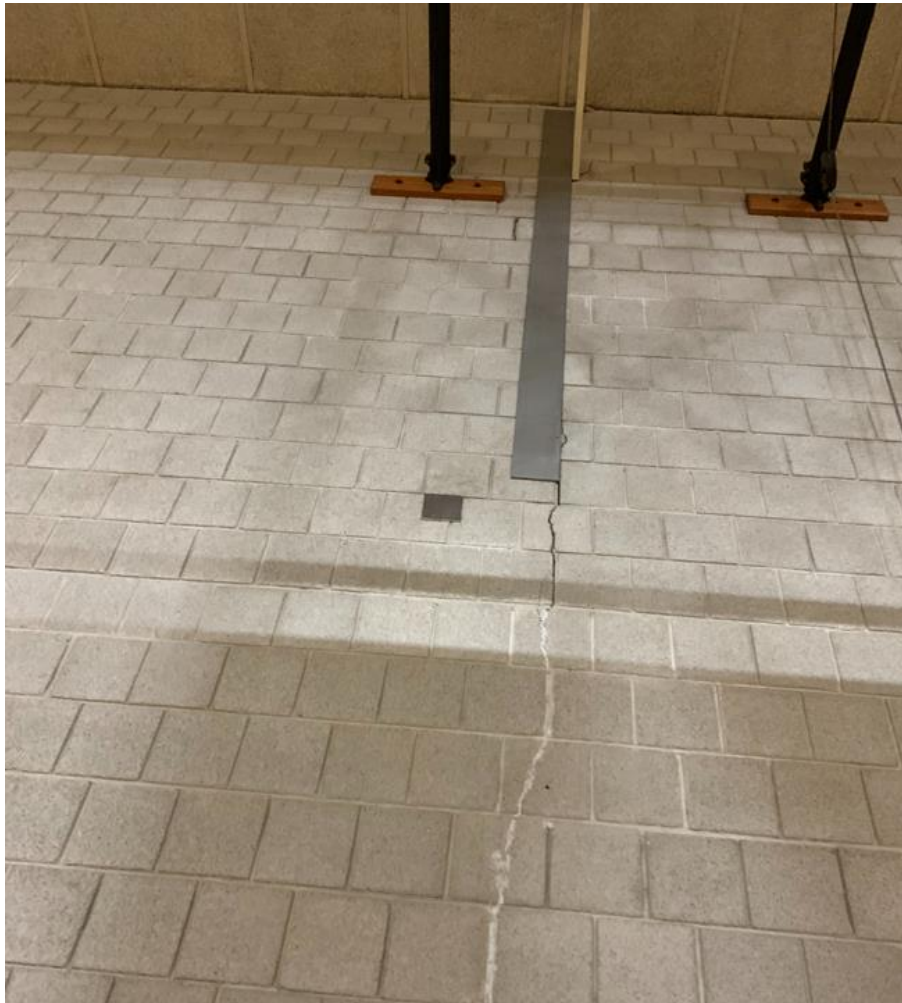
Exterior Envelope ~ Roof and windows replaced & in good/fair condition overall, wood soffit has decay and insect concern, masonry in fair/good condition – repointing/caulking plan req.

Interior ~ Several modifications and improvement (learning commons, project lead the way), block wall cracks @ “new” gym, sag to ceiling tile representative of humidity concerns. Remaining original portions (1960/71) in fair to poor condition, past useful life (millwork, finishes, equipment).

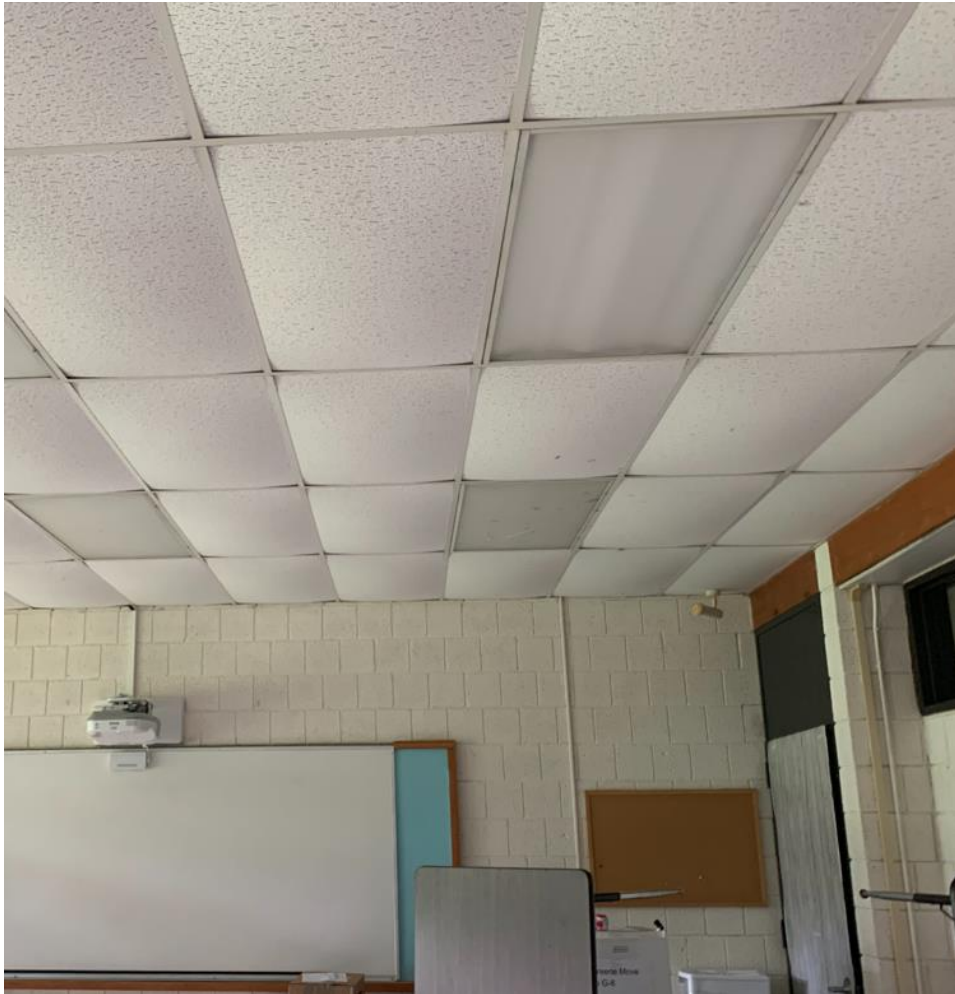
Exterior Envelope ~ Roof and windows replaced & in good/fair condition overall, wood soffit has decay and insect concern, masonry in fair/good condition – repointing/caulking plan req.

Interior ~ Several modifications and improvement (learning commons, project lead the way), block wall cracks @ “new” gym, sag to ceiling tile representative of humidity concerns. Remaining original portions (1960/71) in fair to poor condition, past useful life (millwork, finishes, equipment).

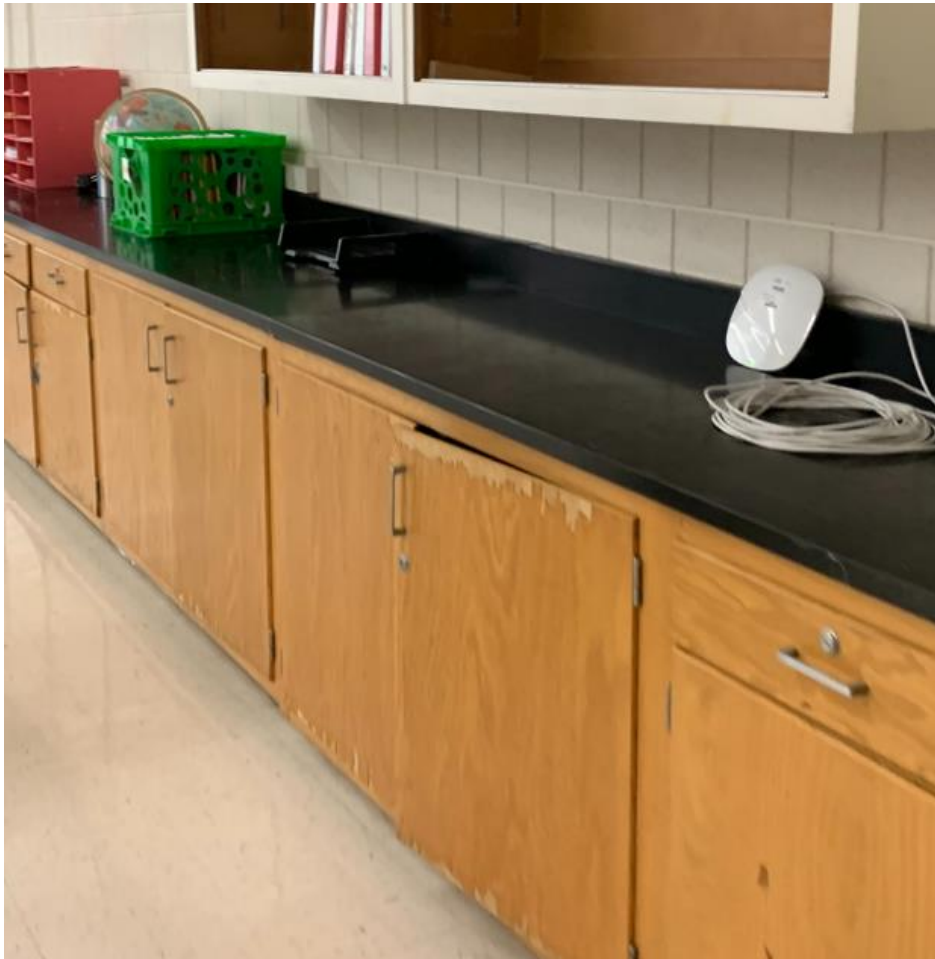
- 1** *Exterior Envelope* ~ Roof and windows replaced & in good/fair condition overall, wood soffit has decay and insect concern, masonry in fair/good condition – repointing/caulking plan req.
- 2** *Interior* ~ Several modifications and improvement (learning commons, project lead the way), block wall cracks @ “new” gym, sag to ceiling tile representative of humidity concerns. Remaining original portions (1960/71) in fair to poor condition, past useful life (millwork, finishes, equipment).

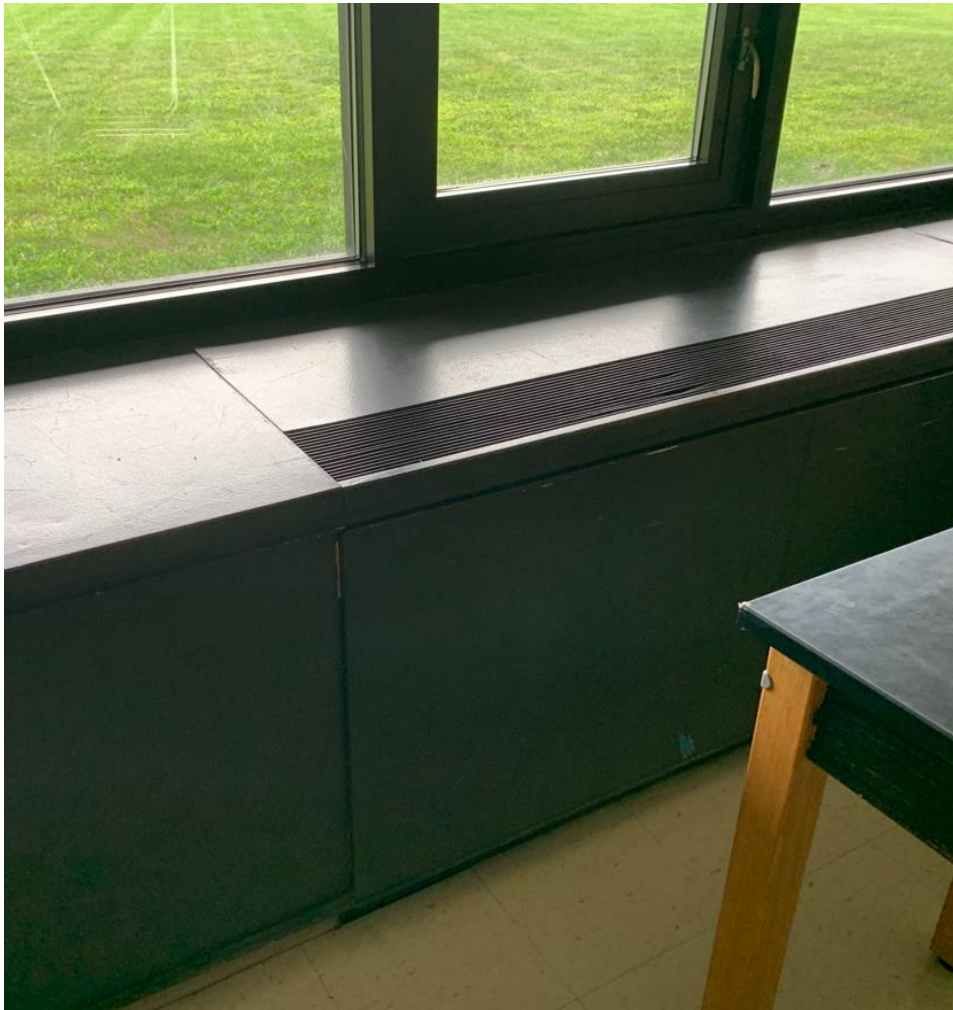
Exterior Envelope ~ Roof and windows replaced & in good/fair condition overall, wood soffit has decay and insect concern, masonry in fair/good condition – repointing/caulking plan req.

Interior ~ Several modifications and improvement (learning commons, project lead the way), block wall cracks @ “new” gym, sag to ceiling tile representative of humidity concerns. Remaining original portions (1960/71) in fair to poor condition, past useful life (millwork, finishes, equipment).

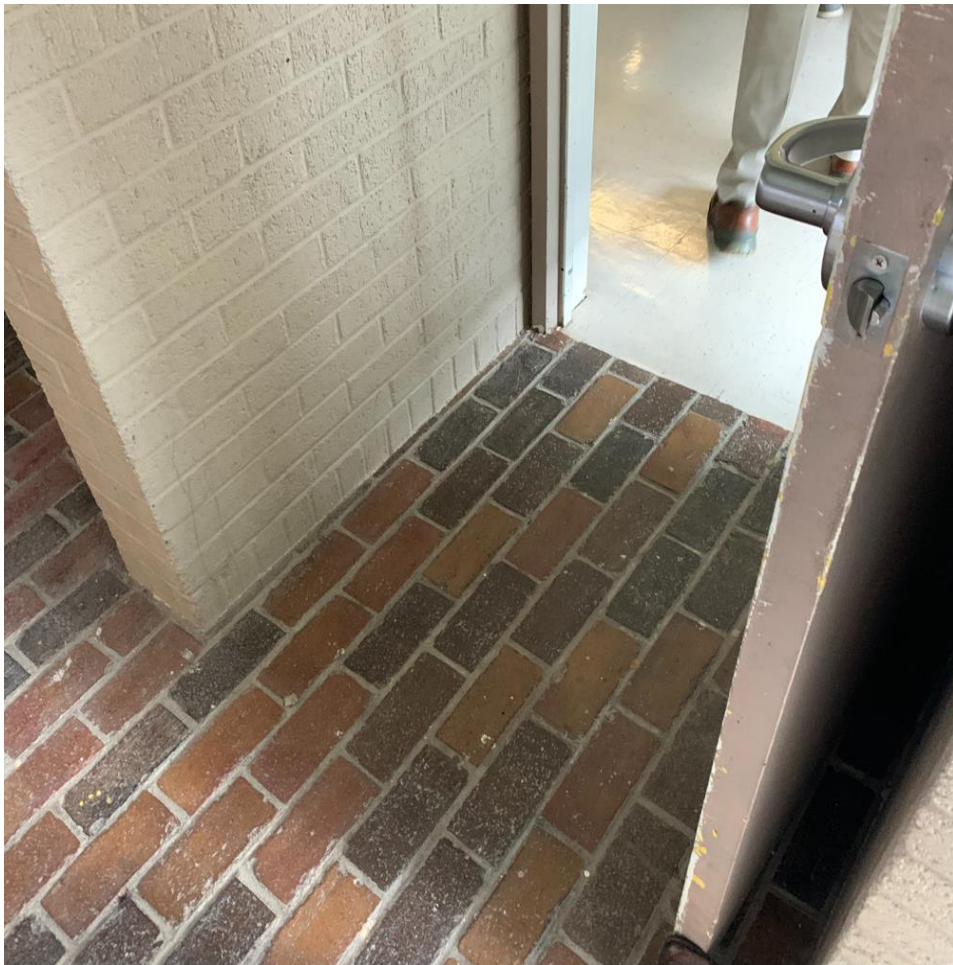
Exterior Envelope ~ Roof and windows replaced & in good/fair condition overall, wood soffit has decay and insect concern, masonry in fair/good condition – repointing/caulking plan req.

Interior ~ Several modifications and improvement (learning commons, project lead the way), block wall cracks @ “new” gym, sag to ceiling tile representative of humidity concerns. Remaining original portions (1960/71) in fair to poor condition, past useful life (millwork, finishes, equipment).

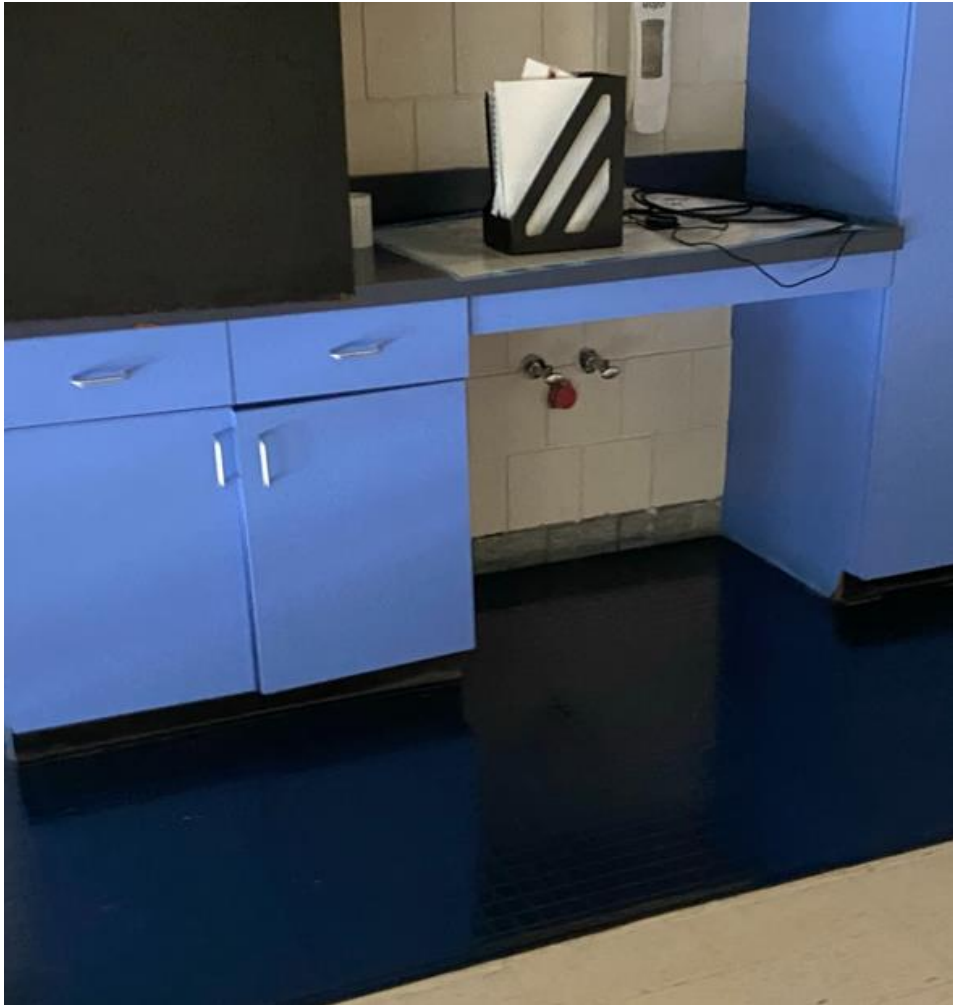
- 1** **Exterior Envelope** ~ Roof and windows replaced & in good/fair condition overall, wood soffit has decay and insect concern, masonry in fair/good condition – repointing/caulking plan req.
- 2** **Interior** ~ Several modifications and improvement (learning commons, project lead the way), block wall cracks @ “new” gym, sag to ceiling tile representative of humidity concerns. Remaining original portions (1960/71) in fair to poor condition, past useful life (millwork, finishes, equipment).
- 3** **Fire Protection** ~ None.
Plumbing ~ Limited number of fixtures in classrooms, some not functioning due to sanitary line issues, original distribution piping

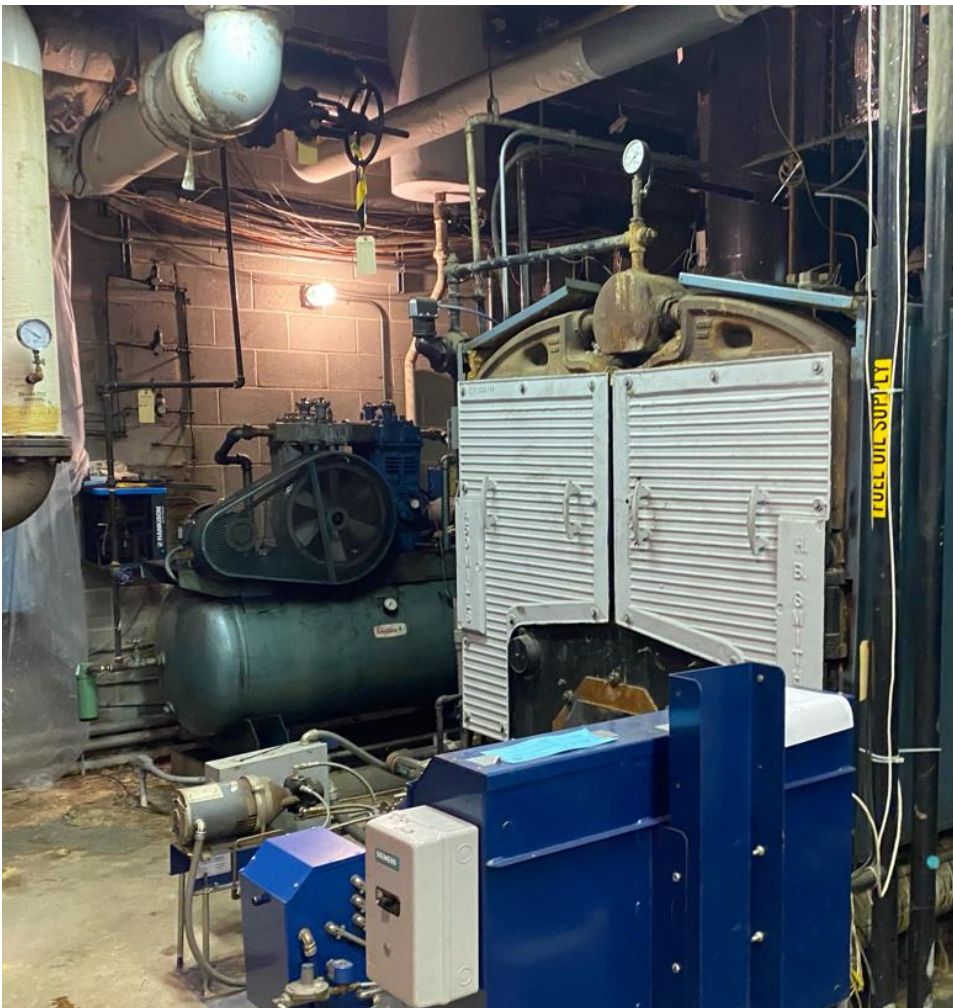
- 1** **Exterior Envelope** ~ Roof and windows replaced & in good/fair condition overall, wood soffit has decay and insect concern, masonry in fair/good condition – repointing/caulking plan req.
- 2** **Interior** ~ Several modifications and improvement (learning commons, project lead the way), block wall cracks @ “new” gym, sag to ceiling tile representative of humidity concerns. Remaining original portions (1960/71) in fair to poor condition, past useful life (millwork, finishes, equipment).
- 3** **Fire Protection** ~ None.
- 4** **Plumbing** ~ Limited number of fixtures in classrooms, some not functioning due to sanitary line issues, original distribution piping
- 4** **HVAC** ~ Humidity control concerns throughout building, no AC in Gym or Cafeteria space, combination of pneumatic and electronic controls, majority of systems past useful life.

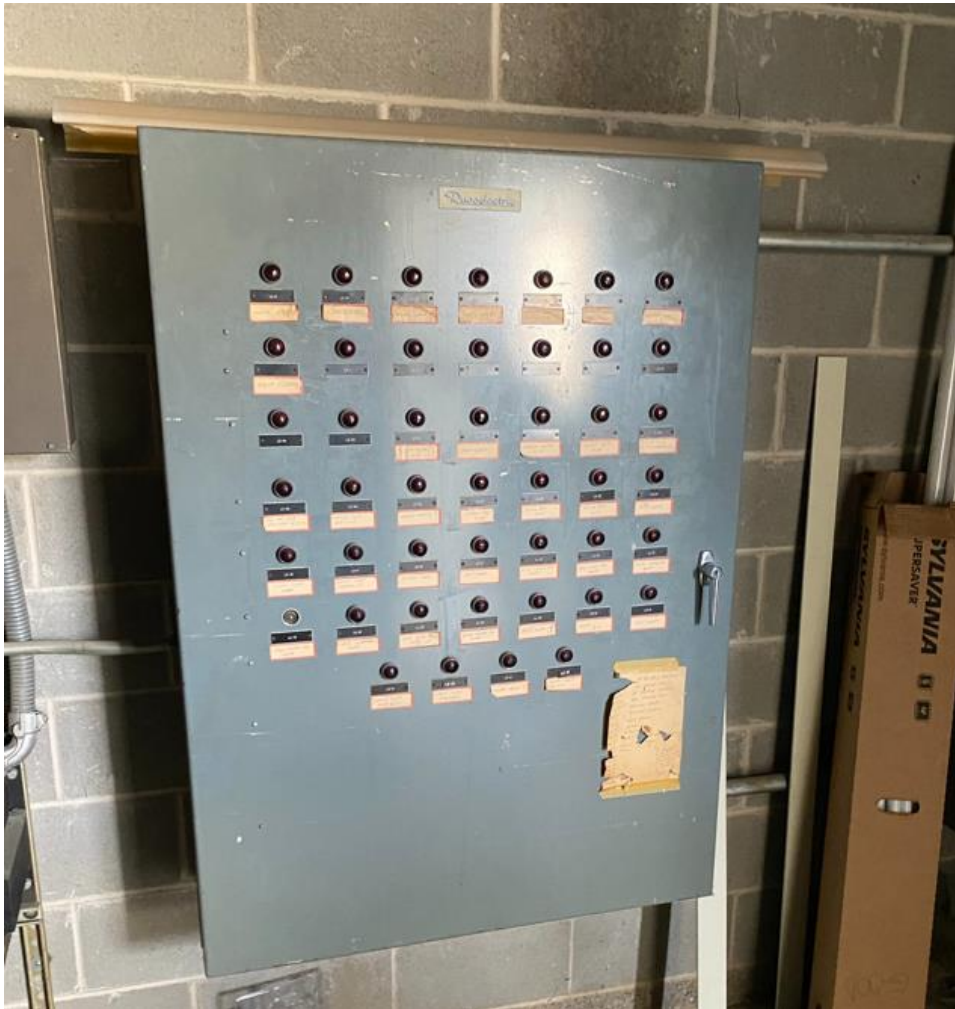
- 1** **Exterior Envelope** ~ Roof and windows replaced & in good/fair condition overall, wood soffit has decay and insect concern, masonry in fair/good condition – repointing/caulking plan req.

- 2** **Interior** ~ Several modifications and improvement (learning commons, project lead the way), block wall cracks @ “new” gym, sag to ceiling tile representative of humidity concerns. Remaining original portions (1960/71) in fair to poor condition, past useful life (millwork, finishes, equipment).

- 5** **HVAC** ~ Humidity control concerns throughout building, no AC in Gym or Café space, combination of pneumatic and electronic controls, majority of systems past useful life.

- 5** **Electrical** ~ Mostly fluorescent lighting, LED replacement program, original electrical distribution with limited expansion
- 5** **Fire Alarm** ~ Panel failing, frequent false/problem alarms
