Appendix

APPENDIX
VINTAGE PLANS

APPENDIX
EXISTING CONDITIONS SUMMARY

HURLBUTT ELEMENTARY SCHOOL
EXISTING CONDITIONS SUMMARY

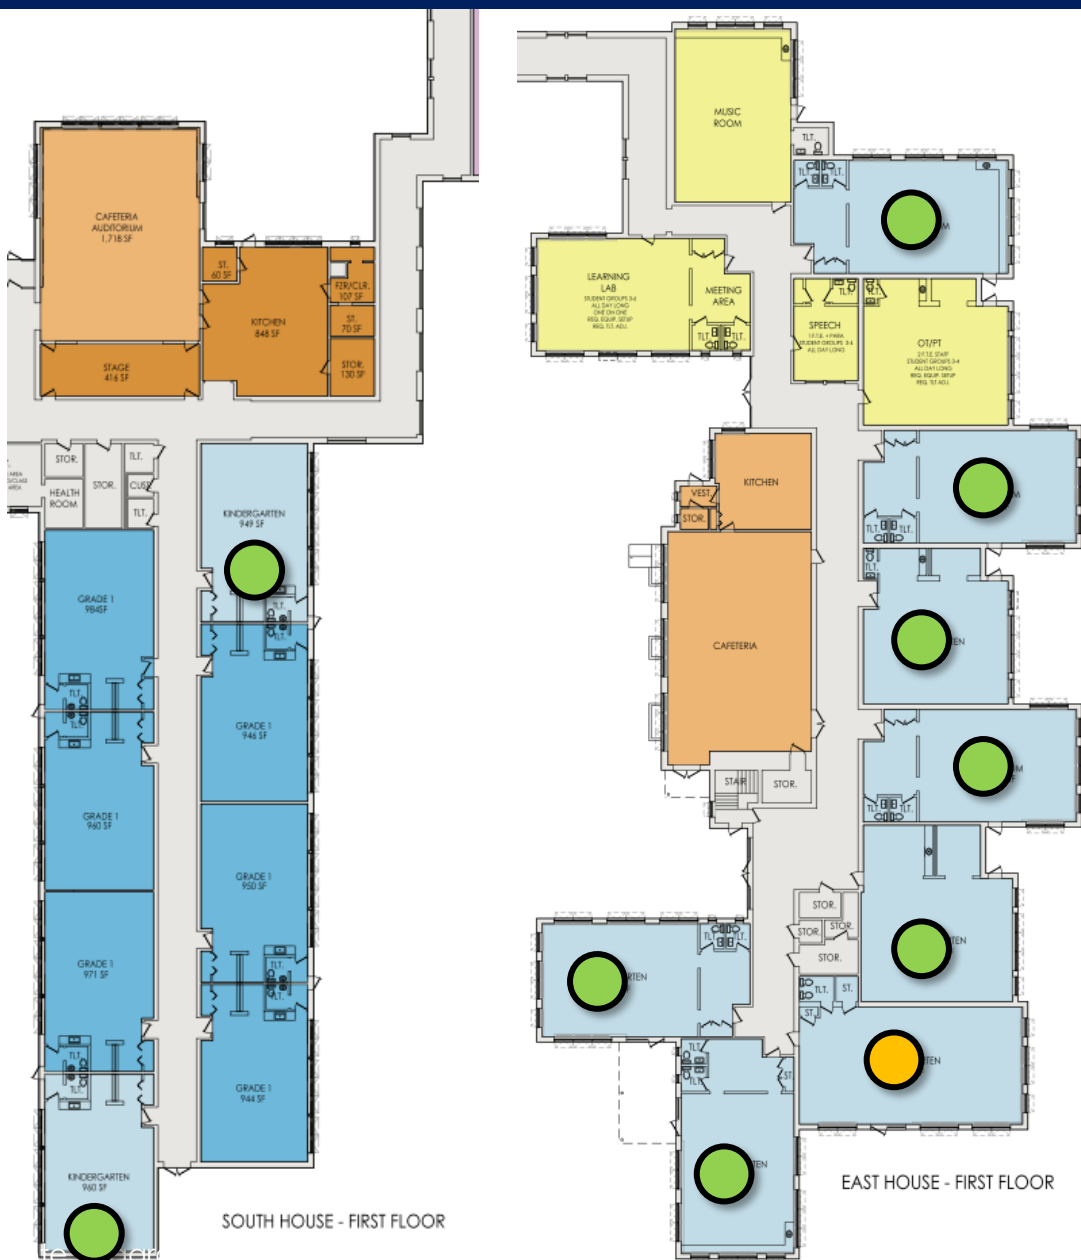
Kindergarten & Pre-K

- ① State Standard ~1,100 to 1,200SF
- ② Meet or below the SF standard
- ③ SF above standard

Use	Amt.	Avg. Size	St. Std.	Curr Enr.	Avg. Class	Weston
Grade Level	C.R.	Area SF	Area SF	Students	Students	Class Size
Pre-Kindergarten	3	1,121	1,100 - 1,200	30	10	15-20
Kindergarten	7	1,096	1,100 - 1,200	126	18	15-20
Grade 1	8	924	800-900	146	18	18-20
Grade 2	7	818	800-900	154	22	20-24

10 Classrooms in Total
 8 out of 10 meet space standard, two below.
Average SF of 1,104 SF
 Avg. St. Std. 1,150 SF ~ 4% below the avg. standard

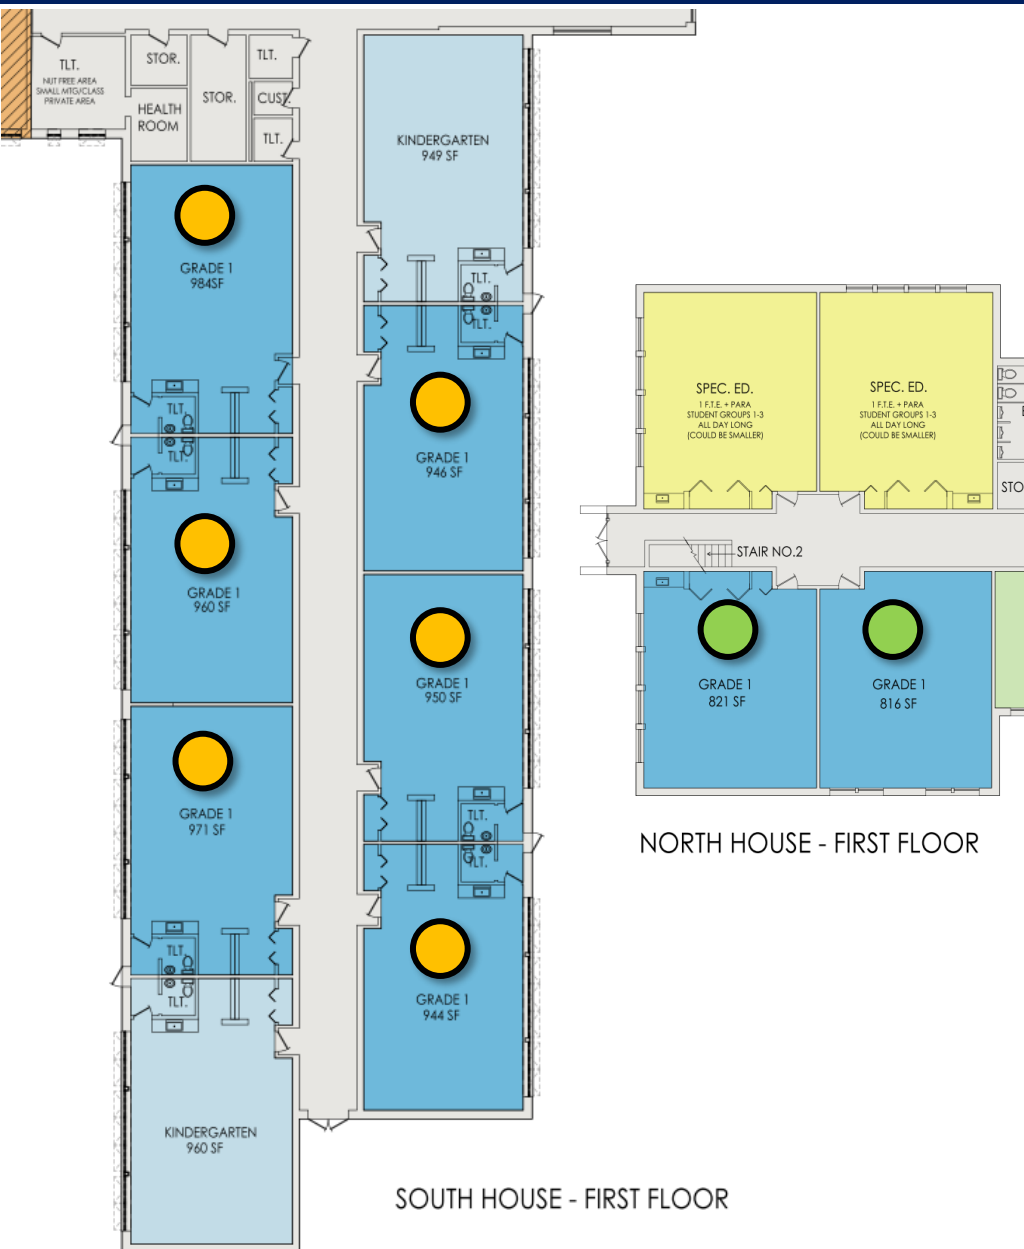
Grade 1 (South & North House)

- ① State Standard ~ 800-900 SF
- ② Meet or below the SF standard
- ③ SF above standard

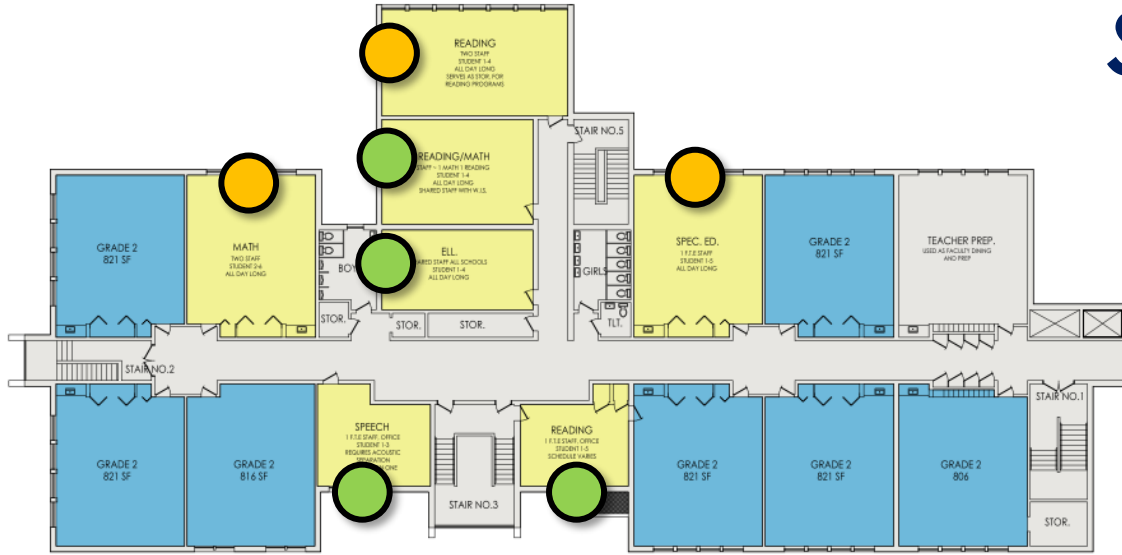
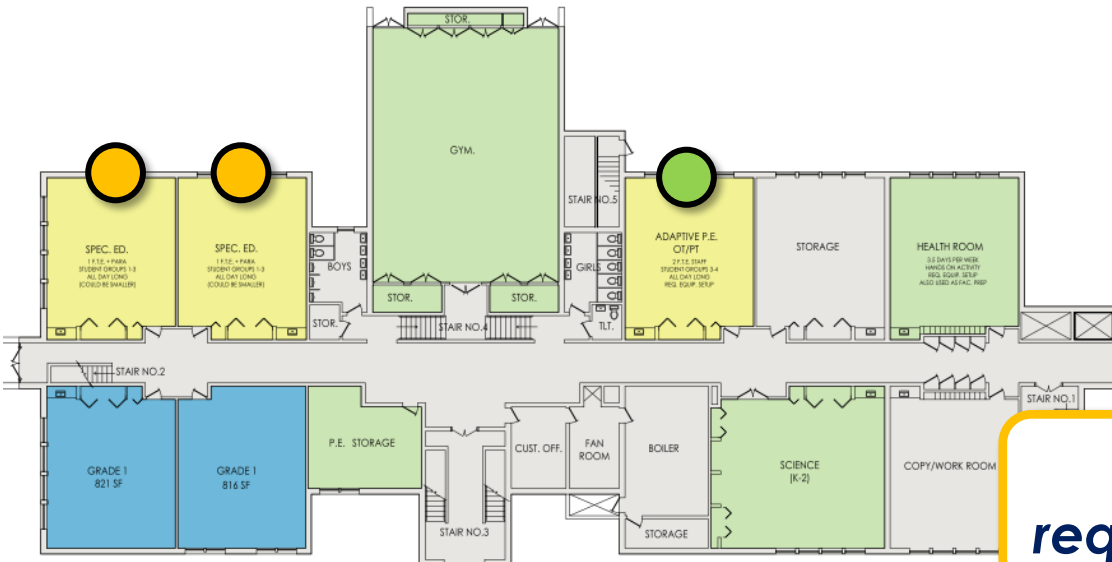
Specialized Education (Multiple Houses)

Useable Area Analysis				
Spec. Ed. Uses	Area	Occ.	Stand.	Delta
Math	821	2-6	400	421
Speech	416	1-3	250	166
Reading	383	1-5	250	133
Spec. Ed.	821	1-5	250	571
ELL	485	1-4	250	235
Reading/Math	637	1-4	250	387
Reading	799	1-4	250	549
Spec. Ed.	821	1-3	250	571
Spec. Ed.	821	1-3	250	571
Adaptive PE	821	3-4	600	221
Learning Lab	1,106	3-6	900	206
Speech	312	3-4	250	62
OT/PT	970	3-4	900	70
Gross Floor Area	9,213	0	5,050	4,163

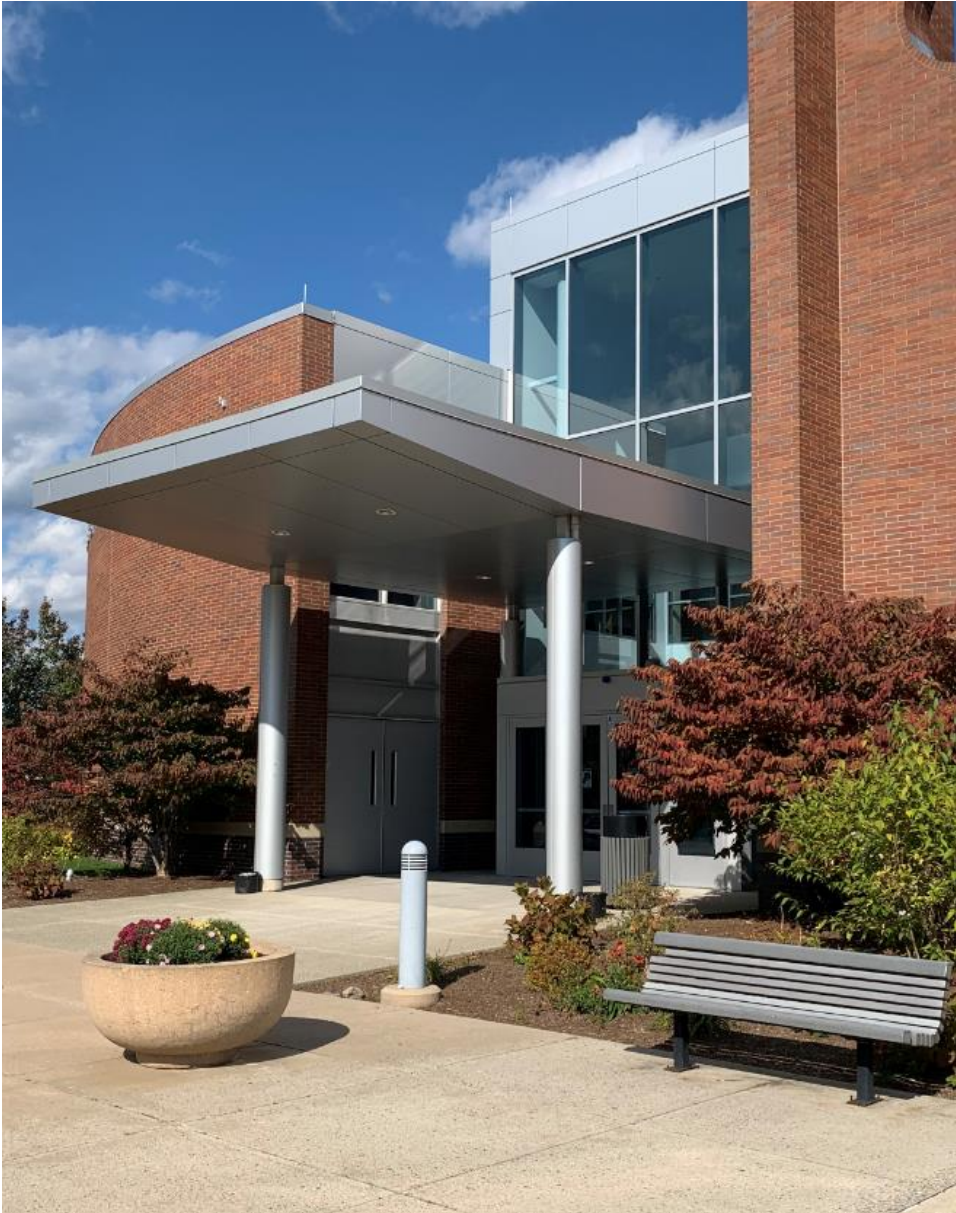
Summary Comments

- 1 Useable area ratio less than typical**
(Generous horizontal & vertical circulation, Main Entry/Lobby, 4 stairs, underutilized space)
- 2 Majority of classrooms slightly larger than average standard** *(Evenly distributed throughout)*
- 3 Core spaces larger than typically found**
(Cafeteria, Media/Learning Commons, "specials")
- 4 Dedicated educational space for "specials"**
(Music, Art, Gym, Science, Spanish, Health, gifted/talented)
- 5 Adapted Typ. Classroom for special education**
(Small group instruction in space larger than required, specific needs per grade level).

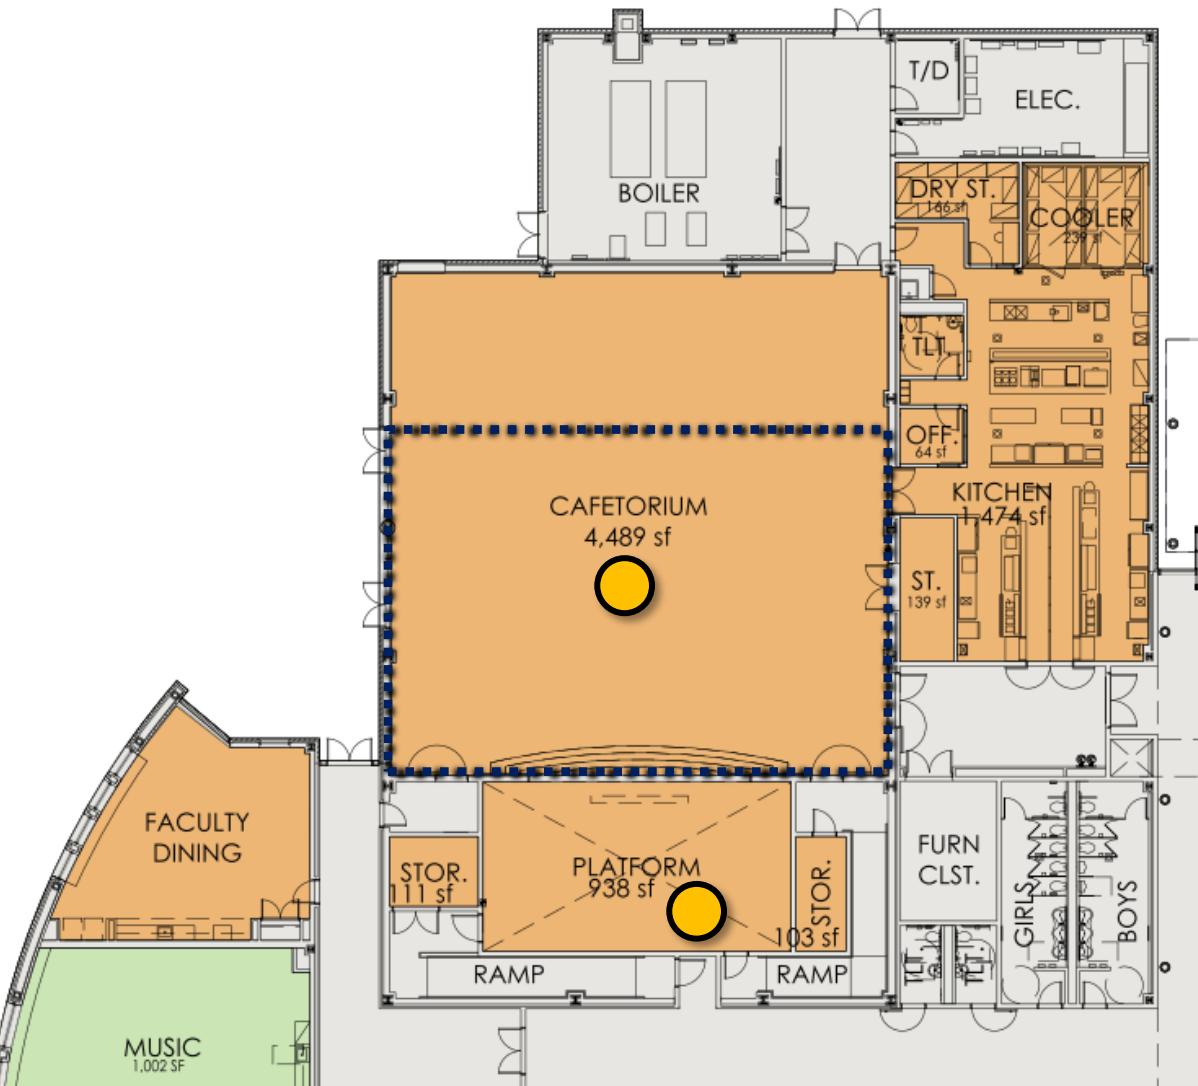
Cafeteria

- 1 State Standard ~SF based on 3 lunch periods and 17.5 SF/Seat
- 2 Meet or below the SF standard
- 3 SF above standard

Area Calculation

$17.5 \text{ sf/seat} \times 532/3 \sim 3,015 \text{ SF}$
