# JMM WETLAND CONSULTING SERVICES, LLC

**RE: *Site Investigation***  
The Moore Property, Proposed Town Dog Park  
Weston, Connecticut

*JMM Job # 22-3060-WES-2*

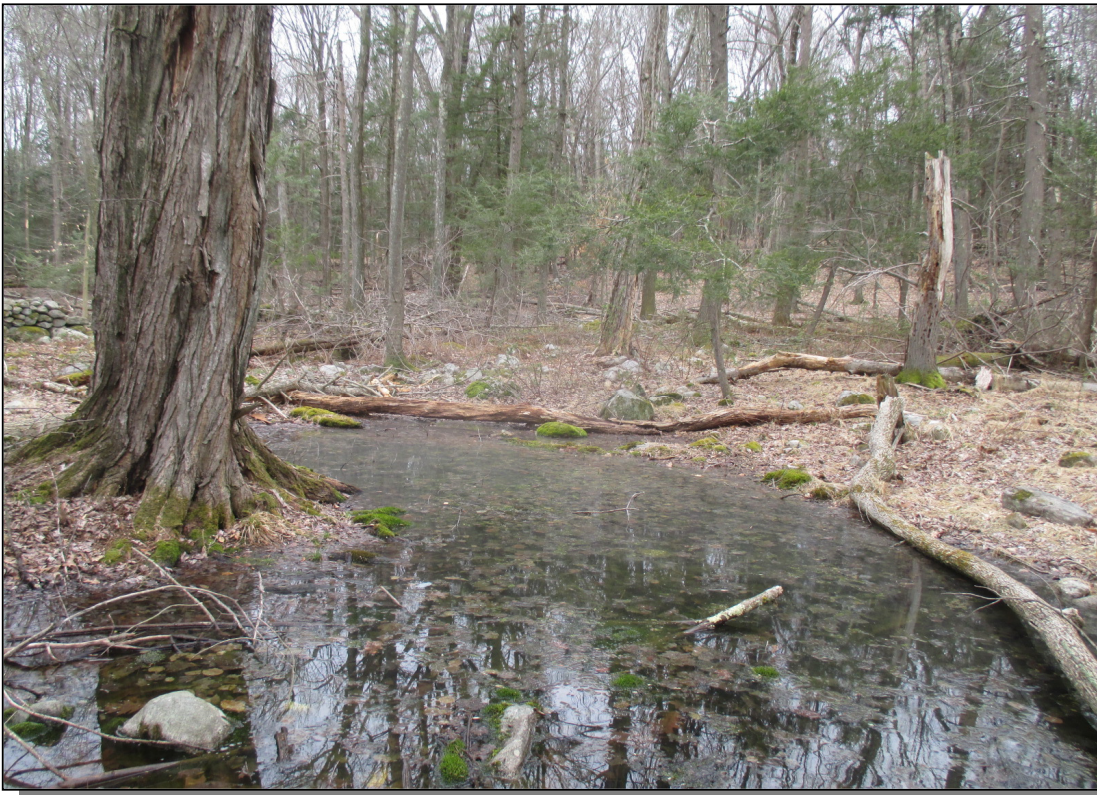
*Photo 1:* View of regulated wetland in the southern part of site adjacent to Davis Hill Road (JMM photo taken 4/18/2022); facing southwesterly

- The submitted site plan entitled *Overall Site Plan, “Weston Dog Park, Davis Hill Road & Lord’s Highway East, Weston, CT”*, prepared for the Town of Weston, and by McChord Engineering Associates, Inc., dated May 26<sup>th</sup>, 2021, and revised through March 23<sup>rd</sup>, 2022, showed only one partially delineated wetland area to the east of the proposed dog park area. The two wetland areas observed by JMM are located along the eastern and southeastern portions of the site and adjacent Davis Hill Road (see photos 1-2, attached). The partial wetland boundary shown on the plan does not reflect the full extent of wetlands observed in the field, which will place the proposed activities in a much closer proximity to regulated wetlands than put forth by the applicant (see Figure 3, attached). Additionally, a *seasonally saturated to seasonally flooded* wooded swamp located in the southeastern part is not shown at all on the submitted plan. It is worth

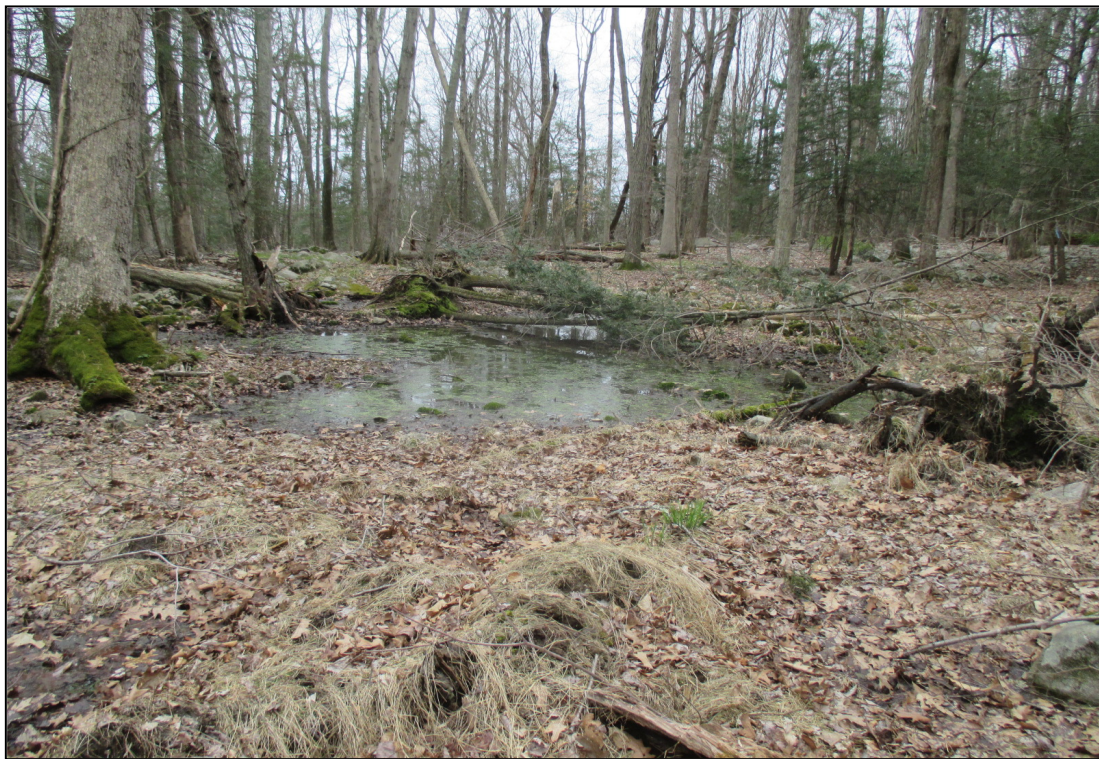
*Photo 2:* View of regulated wetland in southern part adjacent to Davis Hill Road not delineated (JMM photo taken 4/18/2022); facing southwesterly

noting that this area contains potential vernal pool habitat, as defined in the Inland Wetlands and Watercourses Regulations for the Town of Weston (effective date: March 6, 2011). It is JMM's recommendation that this area be examined for amphibian breeding to determine if the area is an active vernal pool able to sustain obligate vernal pool species (e.g., wood frog, spotted salamander, fairy shrimp, etc.).

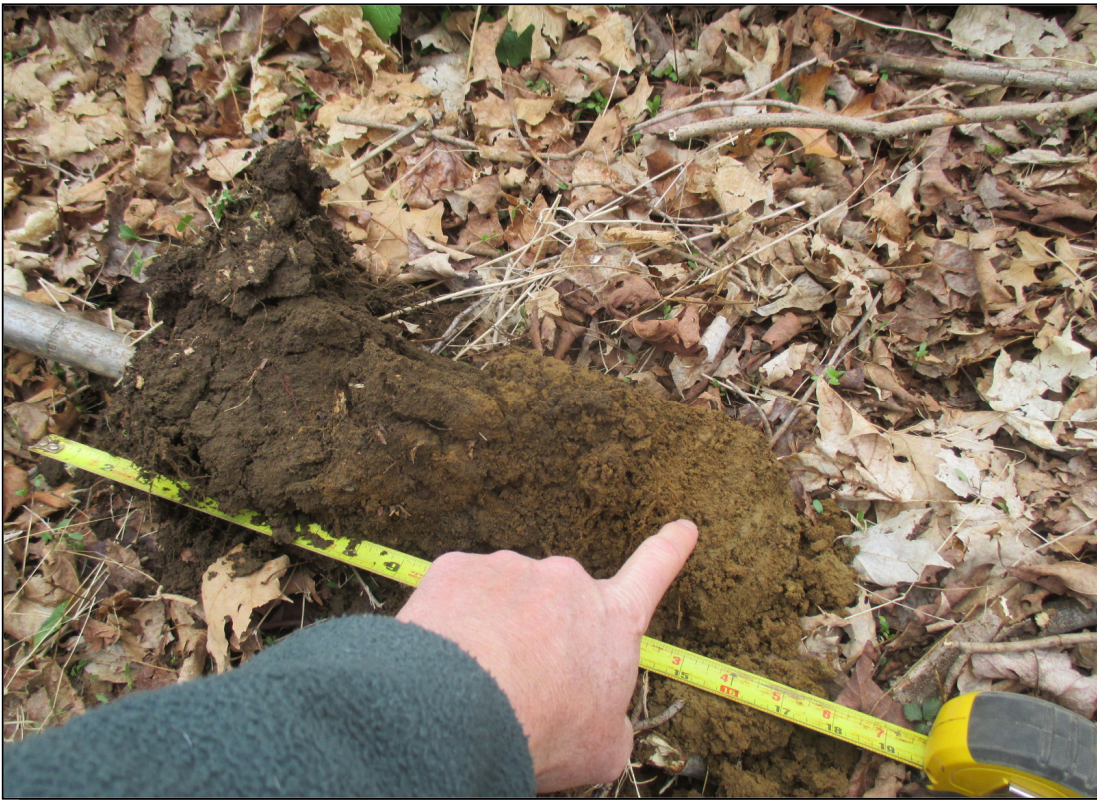
*Photo 3: View of soil profile in vicinity of underground detention system (Note redoximorphic features at 16-inches) (JMM photo taken 4/18/2022)*

- During the April 18<sup>th</sup> site visit JMM dug two shallow test pits (approximately 30-inches deep) in the vicinity of the proposed below-ground infiltrator/detention system, proposed to handle runoff from the driveway, cul-de-sac and parking areas. Moderately well drained soils were observed, with common, medium, distinct redoximorphic features (i.e., mottles) observed between 16 to 23-inches (see photos 3-4). It should be noted that the depth of the redox features conflicts with that reported by the Town, which was at 39-inches. Based on our soil test pit depths at the proposed infiltration system area, the depth of 39-inches to redox features appears to be incorrect, and should be re-examined. As proposed the below ground infiltrator will not function as designed and potentially have a downgradient impact to regulated wetlands and watercourses. It is JMM’s opinion that this method of stormwater control must be re-evaluated.

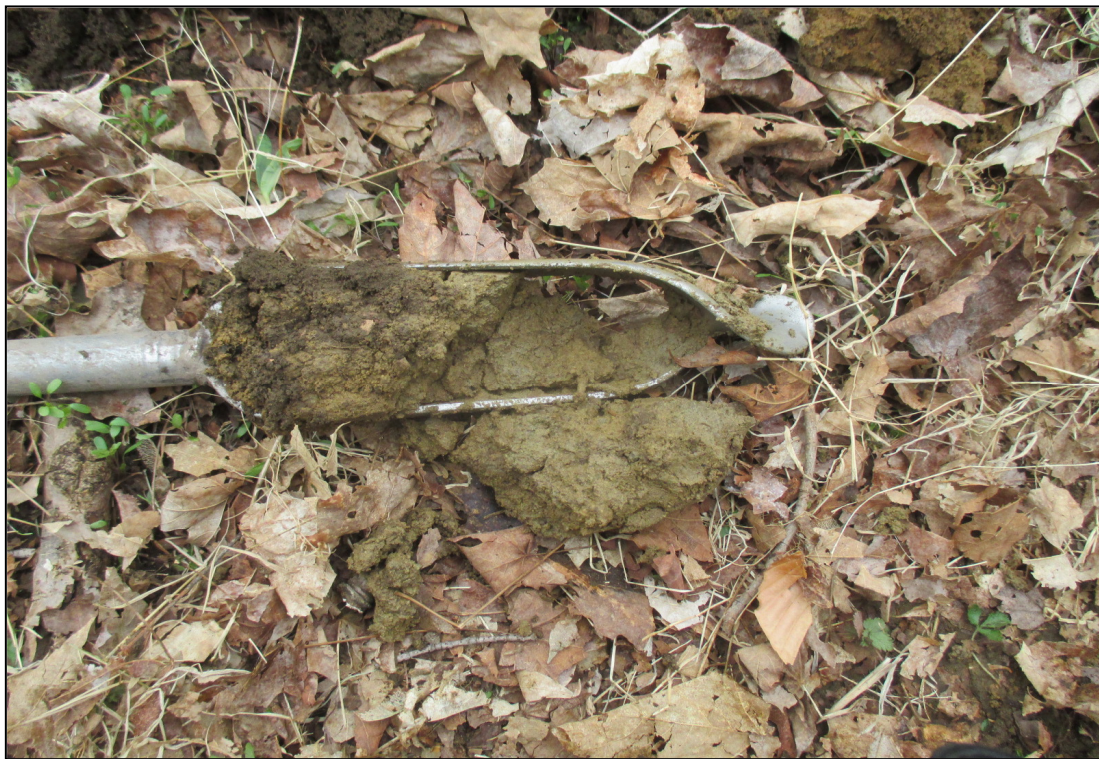
*Photo 4: View of redoximorphic features at 23-inches (JMM photo taken 4/18/2022)*
